JP Diagnostics *Leak Detection Report*

Date of Inspection: 2/21/2022 Time: 0900 Size: Siding Single Family Residential

Full Building Infrared Audit (FB.IR.AUD)

Water Leak Source and Origin Findings / Recommended Repairs

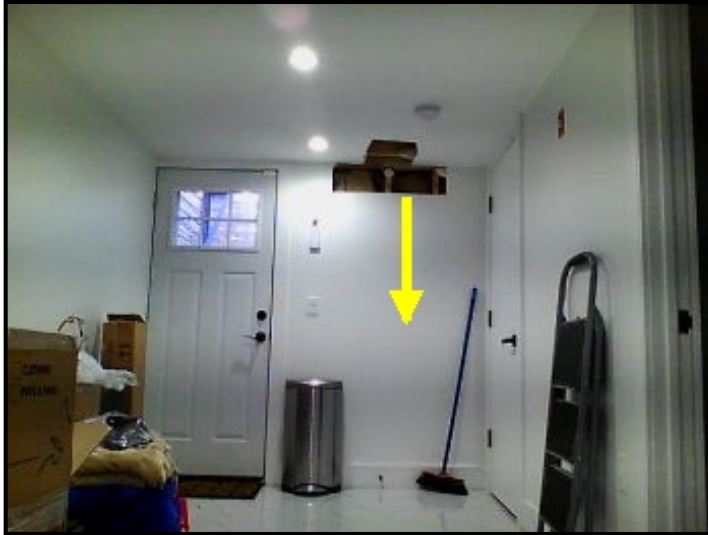
1. **Basement Wall Leak Source and Origin: Utility Connection Points.** Heavy wind-driven rain water is entering through the air handler support bracket anchor points as well as the electrical utility connection points to the rear facade, cascading down and depositing into the wall areas below causing minor damage to the surrounding drywall.

Water entry into wall area.

- a. Seal around air handler bracket anchor points through the siding.
- b. Seal around electrical utility connection points.

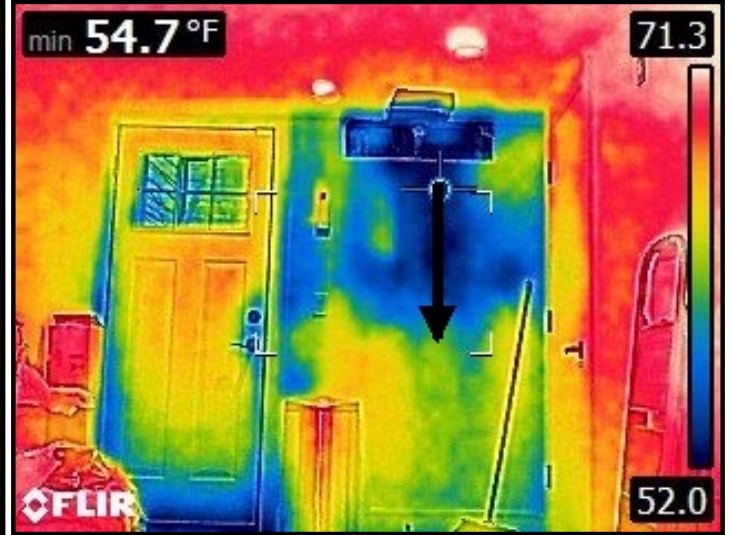
Infrared imaging of water entry into wall area.

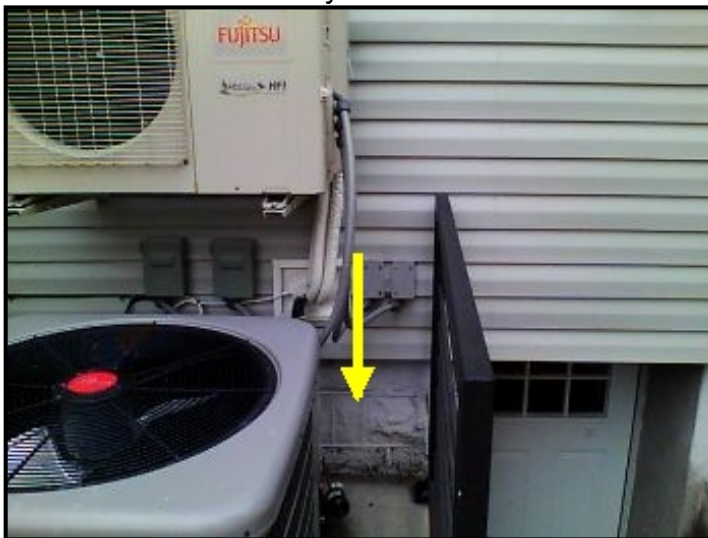
Water entering through siding around utility connection points and cascading down into the internal wall areas below.

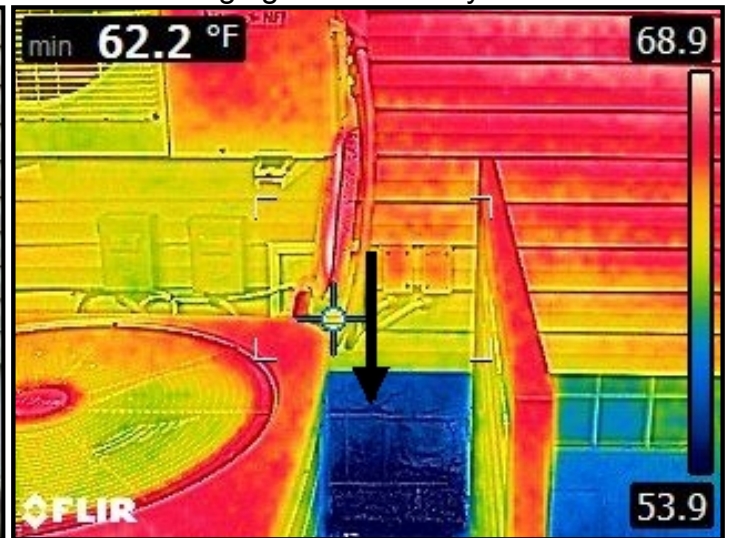
Infrared imaging of water entering through siding around utility connection points and cascading down into the internal wall areas below.

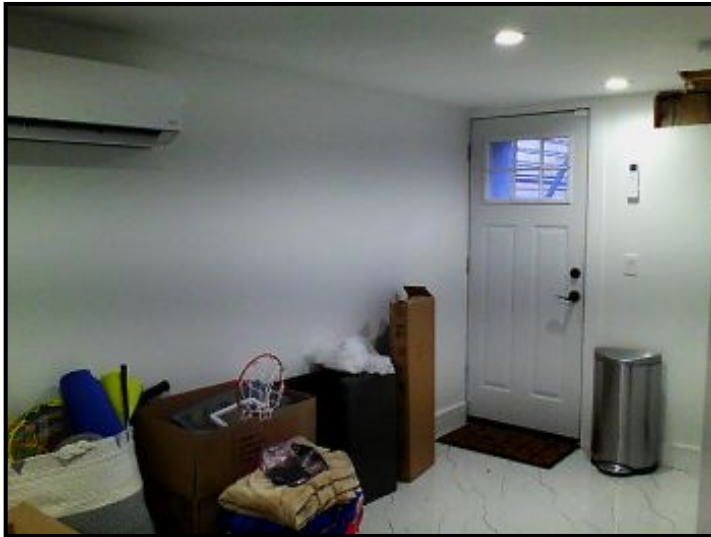
2. **Basement Wall Draft Entry Point#1: Temperature Differential: -9dF**

Draft Severity: MODERATE

Draft entry point.

- a. Excavate drywall area.
- b. Install proper R rated insulation within affected area.

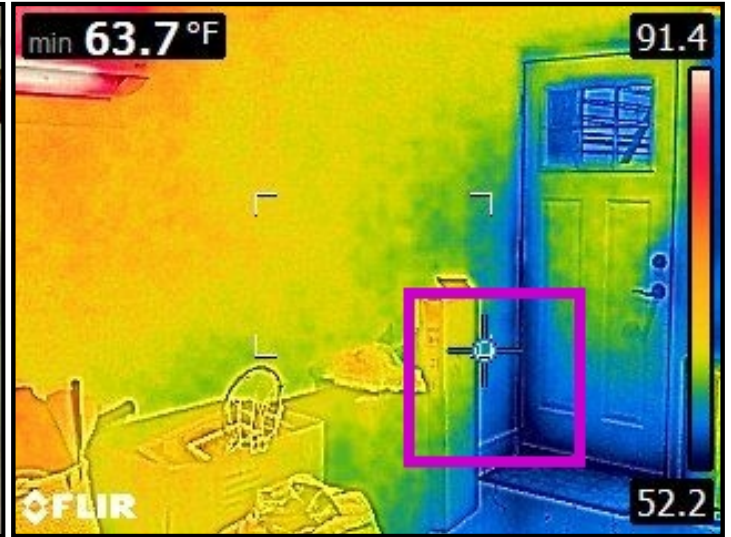
Infrared imaging of draft entry point.

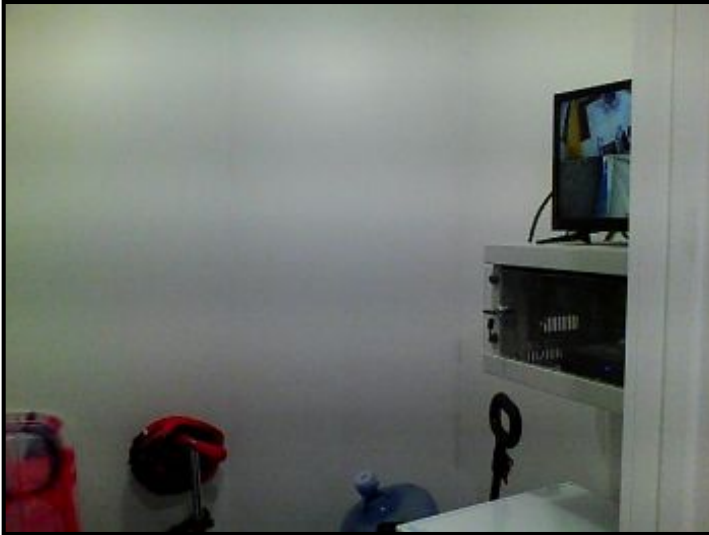
3. **Basement Wall Draft Entry Point#2: Temperature Differential: -18dF**

Draft Severity: HIGH

Draft entry point.

- a. Excavate drywall area.
- b. Install proper R rated insulation within affected area.

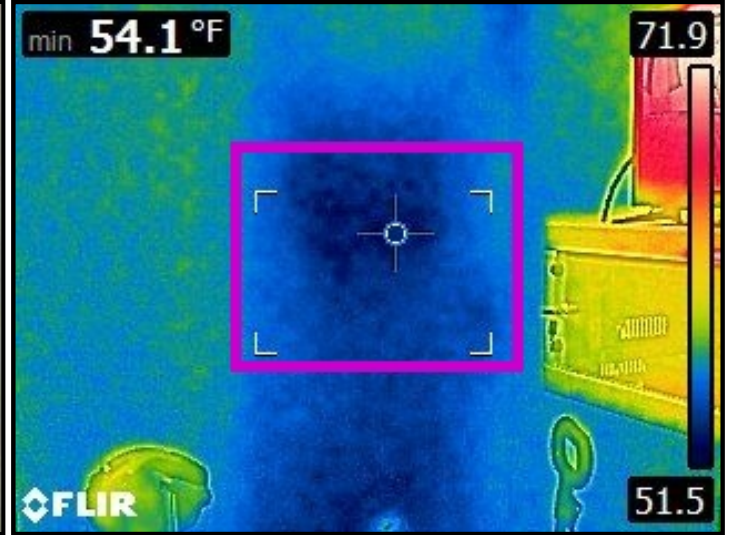
Infrared imaging of draft entry point.

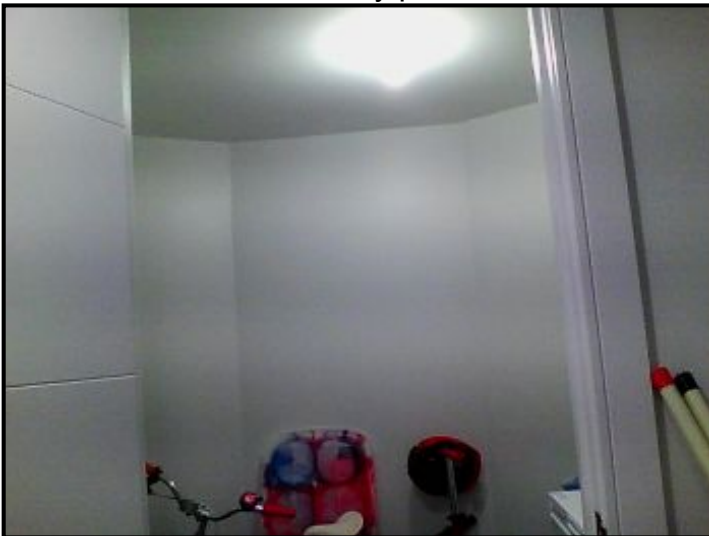
Draft entry point.

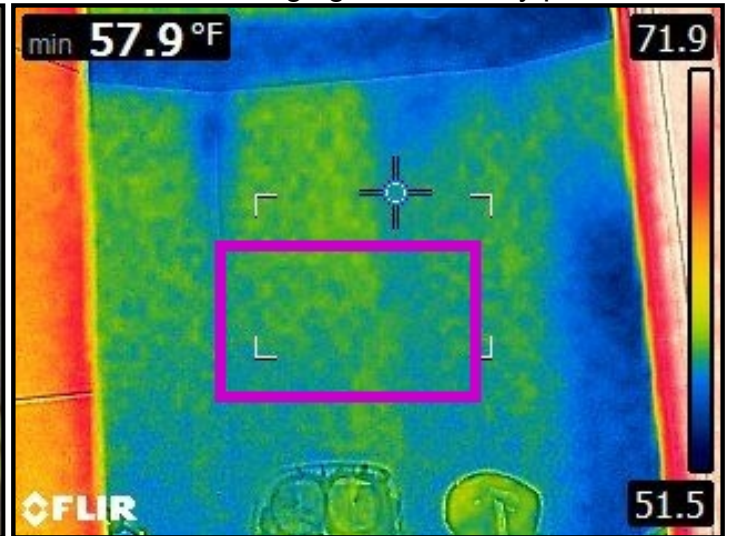
Infrared imaging of draft entry point.

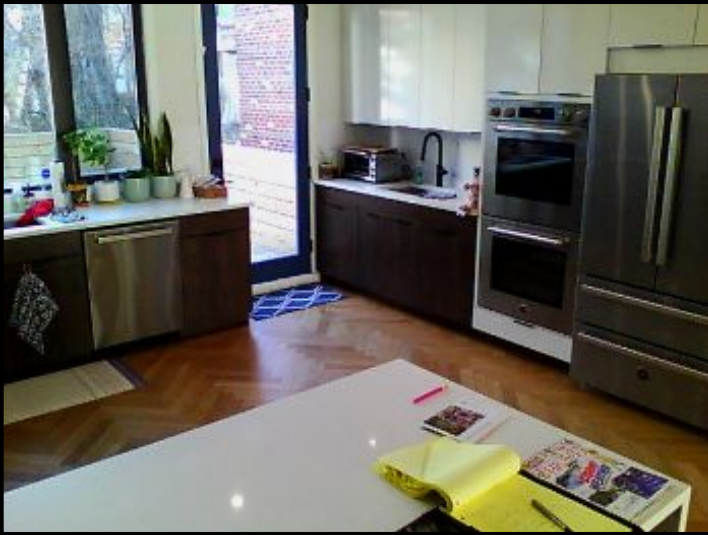
4. **Kitchen Floor/Wall Draft Entry Point: Temperature Differential: -21dF**

Draft Severity: EXTREME

Severe draft entry point.

- a. Remove cabinets from wall.
 - b. Excavate drywall.
 - c. Install proper R rated insulation within affected area.
-

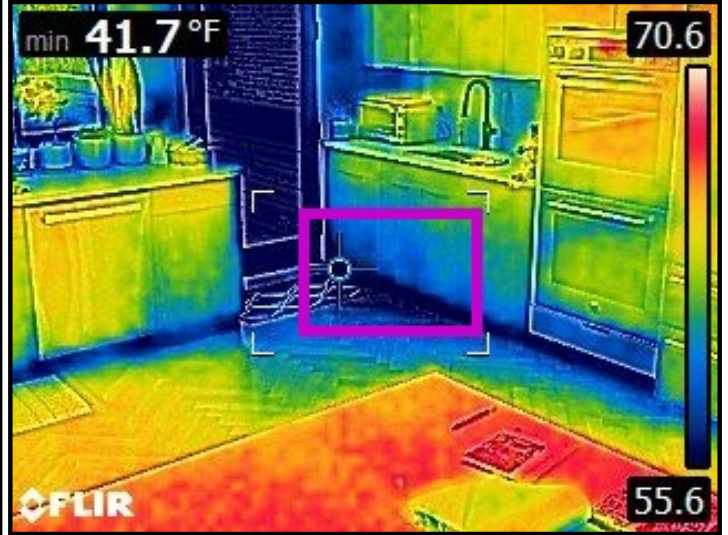
Infrared imaging of severe draft entry point.

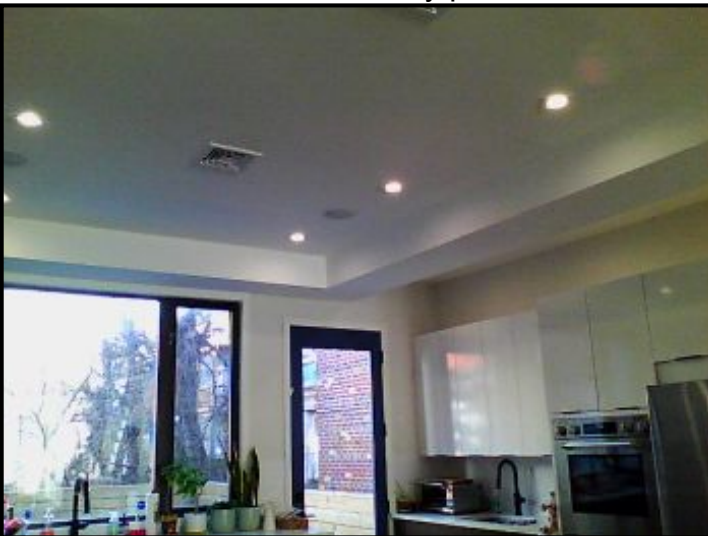
Severe draft entry point.

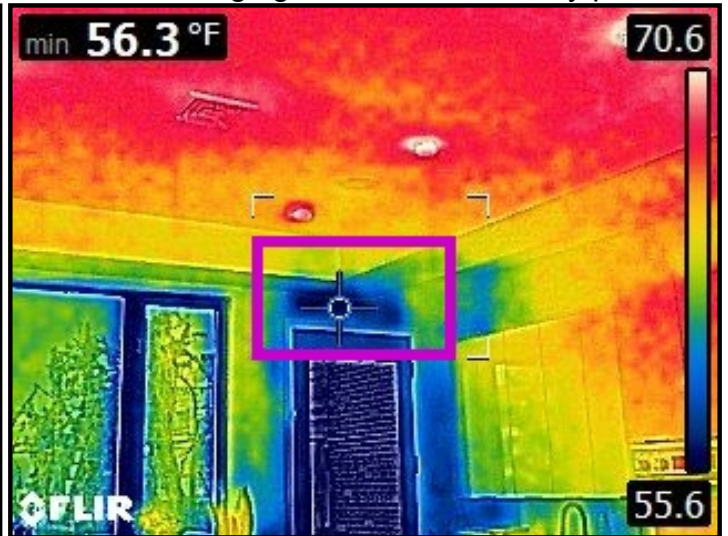
Infrared imaging of severe draft entry point.

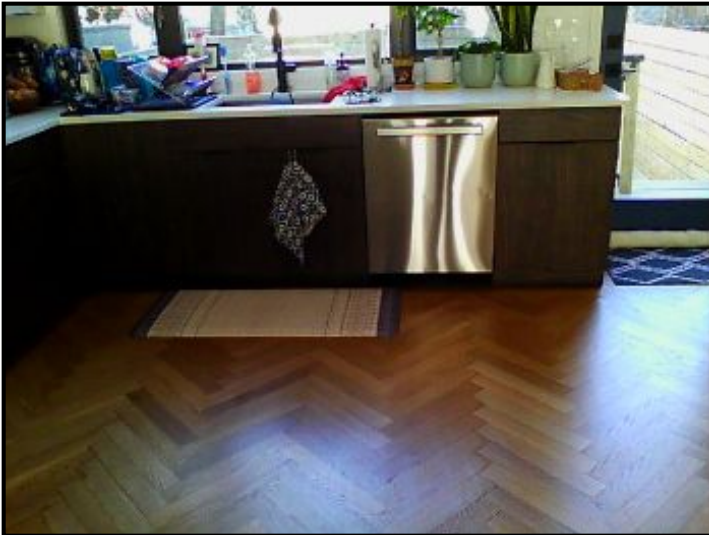
Severe draft entry point.

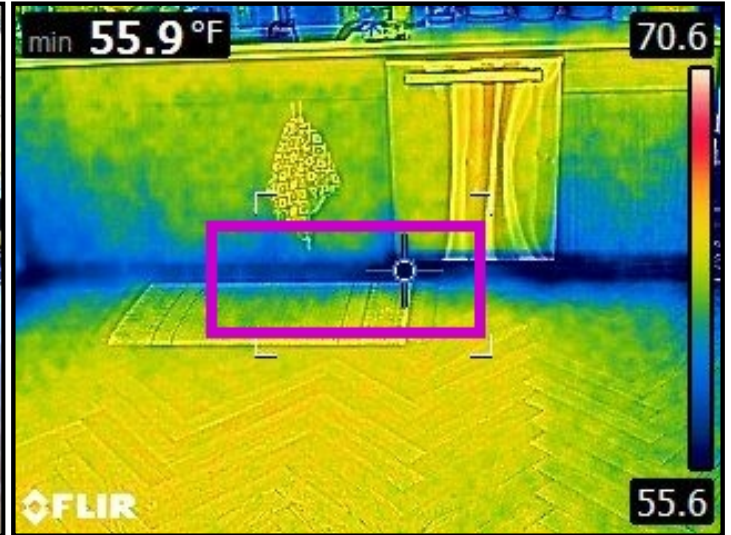
Infrared imaging of severe draft entry point.

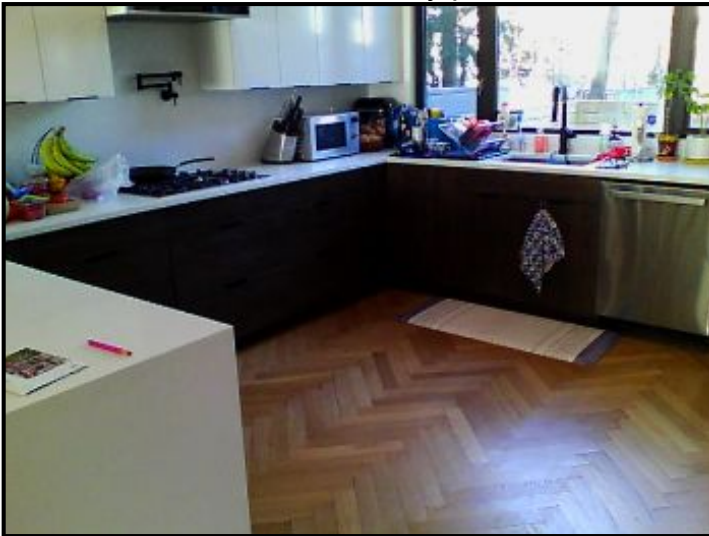
Severe draft entry point.

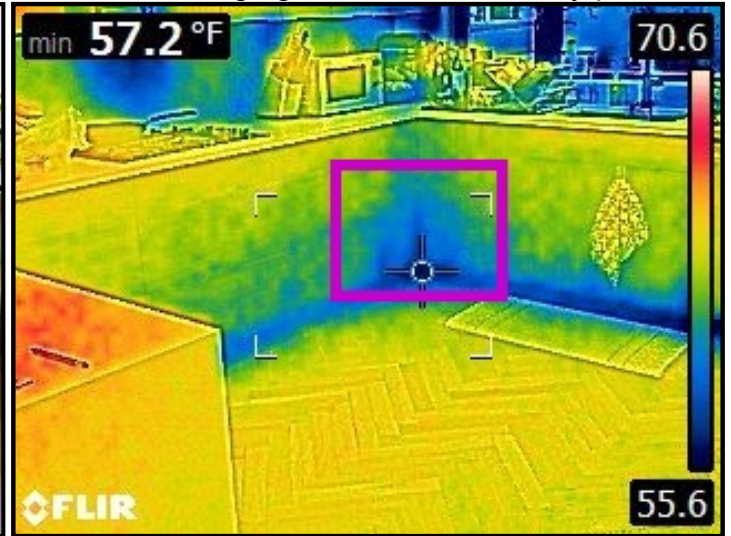
Infrared imaging of severe draft entry point.

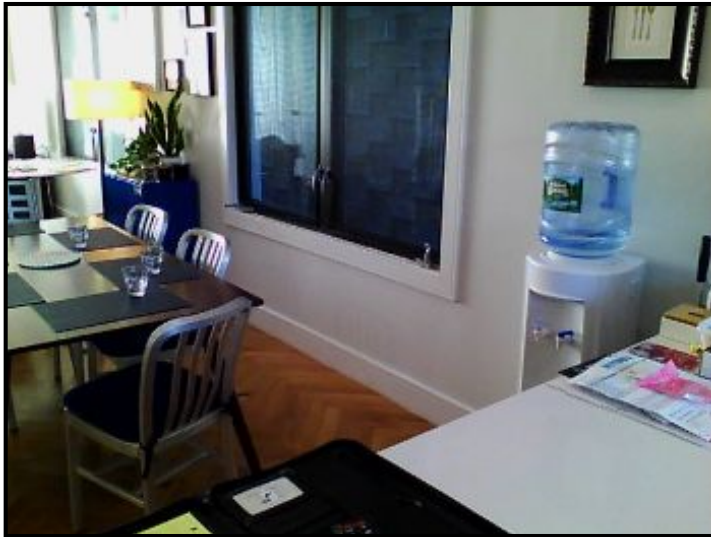
5. Living Room Window/Wall Draft Entry Point: **Temperature Differential: -19dF**
Draft Severity: HIGH

Draft entry point.

- a. Excavate drywall area.
 - b. Install proper R rated insulation within affected area.
-

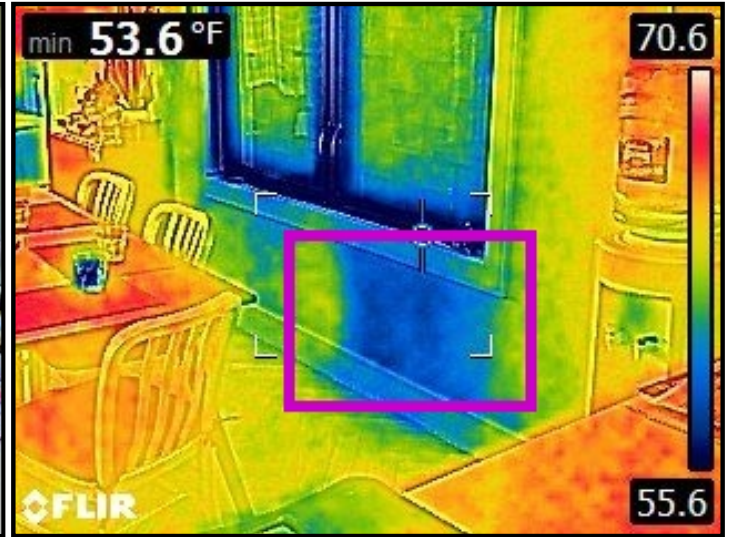
Infrared imaging of draft entry point.

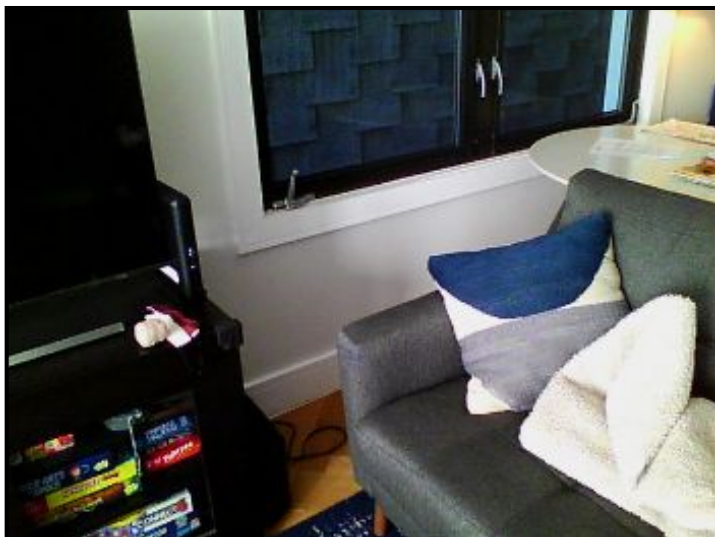
6. Living Room Floor/Wall Draft Entry Point: **Temperature Differential: -21dF**
Draft Severity: EXTREME

Draft entry point.

- a. Excavate drywall area.
 - b. Install proper R rated insulation within affected area.
-

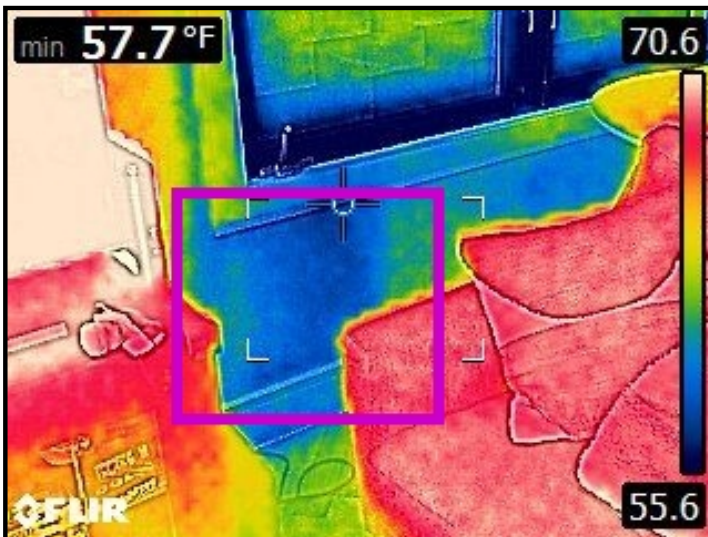
Infrared imaging of draft entry point.

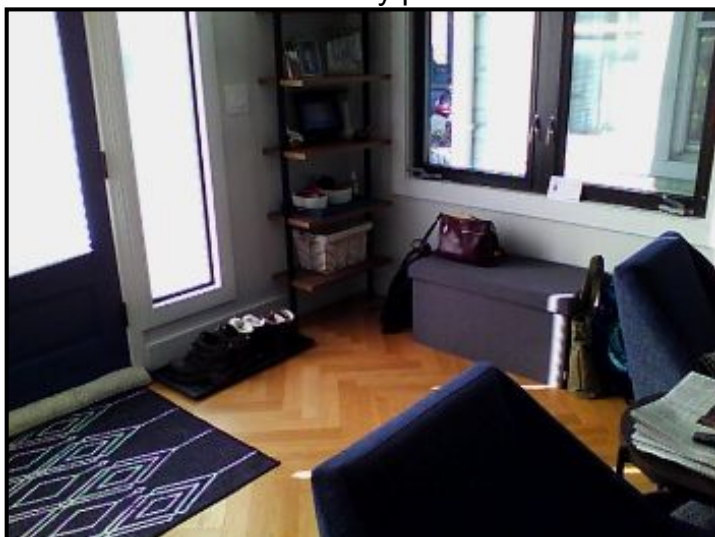
Severe draft entry point.

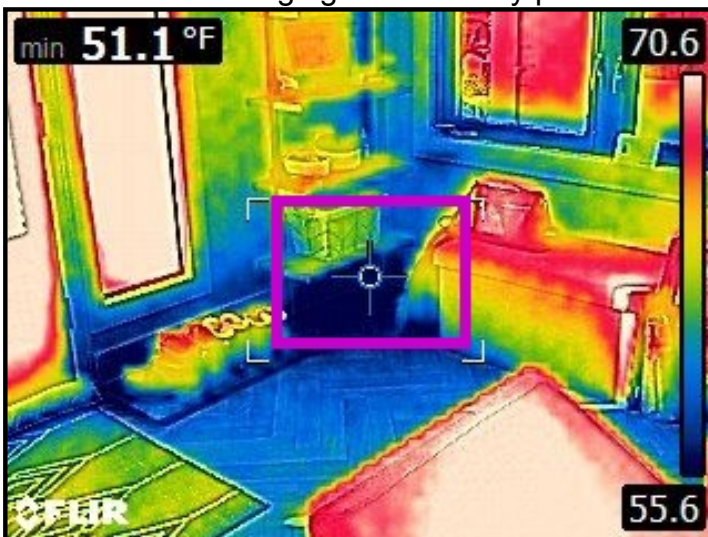
Infrared imaging of severe draft entry point.

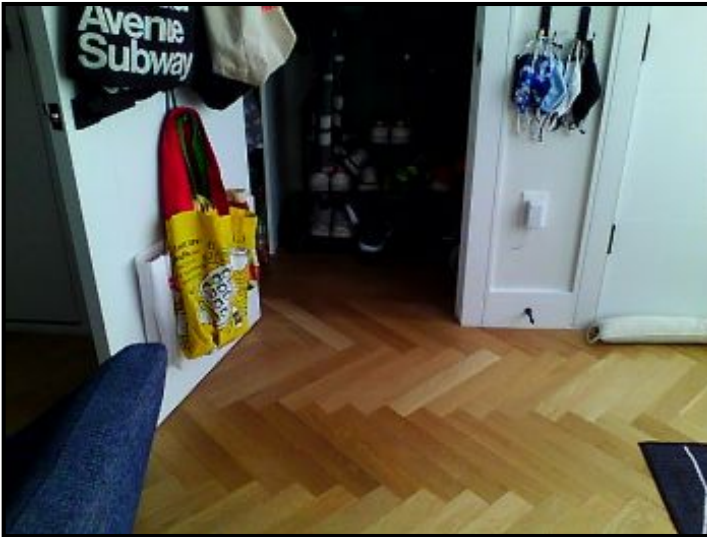
7. Living Room Closet Draft Entry Points: **Temperature Differential: -27dF**
Draft Severity: EXTREME

Severe draft entry point.

- a. Excavate drywall area.
 - b. Install proper R rated insulation within affected area.
-

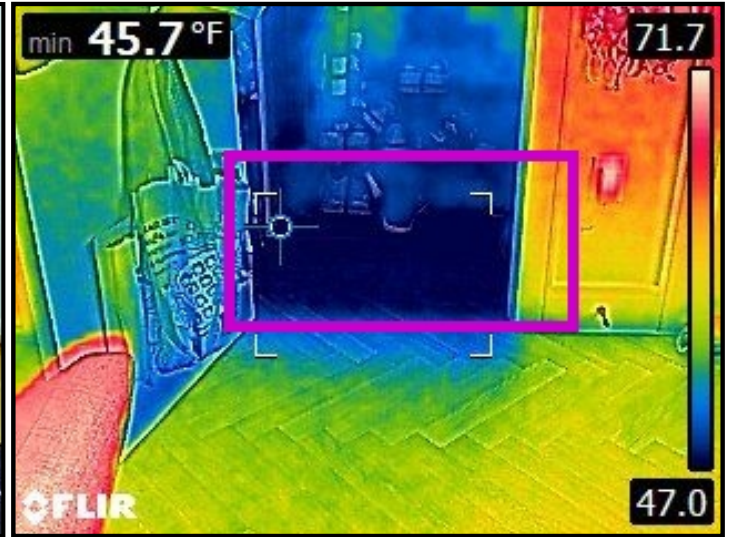
Infrared imaging of severe draft entry point.

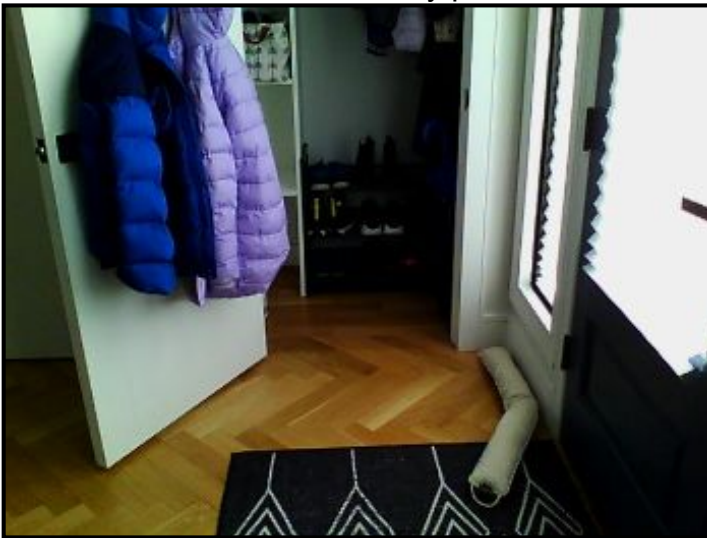
Severe draft entry point.

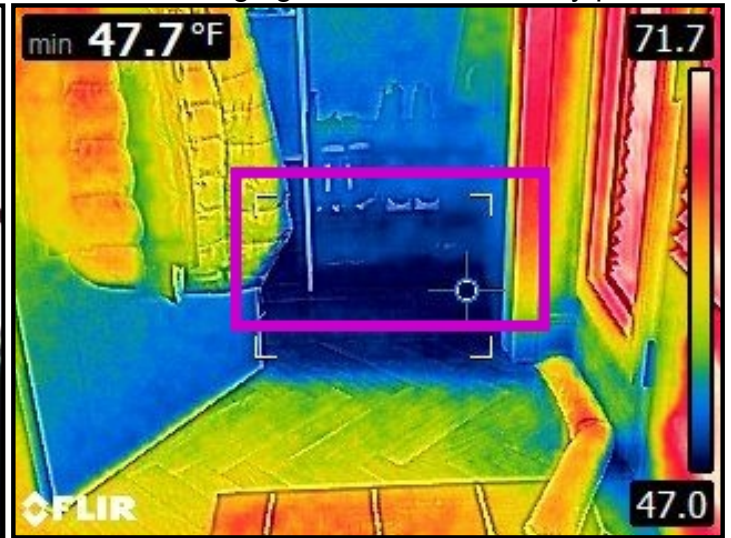
Infrared imaging of severe draft entry point.

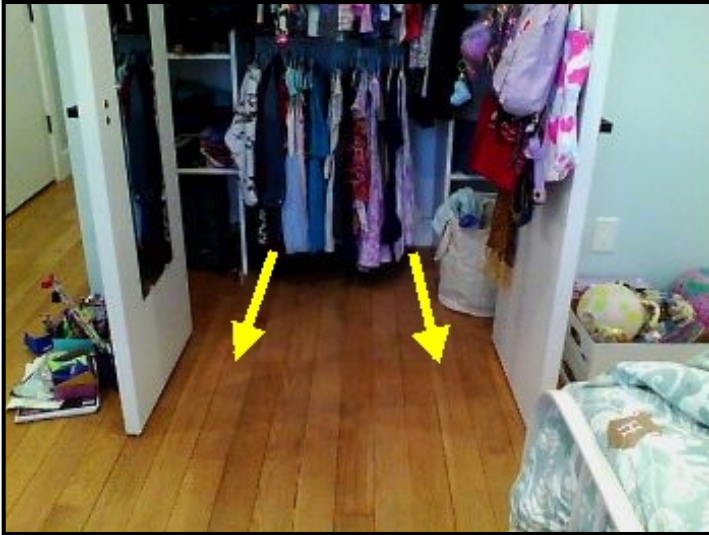
8. Second Floor Daughters' Room Closet Floor Leak Source and Origin: **Above Terrace Facade/Window Frame.** Heavy wind-driven rain water is entering through the siding connection point to the window frame, cascading down and depositing within the third floor internal wall area below the window. Once inside the internal wall area, water is continuing down and depositing into the closet floor area below causing minor damage to the surrounding area.

Water entry point into closet wall area.

- a. Remove siding from around the window, as outlined.
- b. Waterproof and flash area accordingly.
- c. Reinstall siding system.

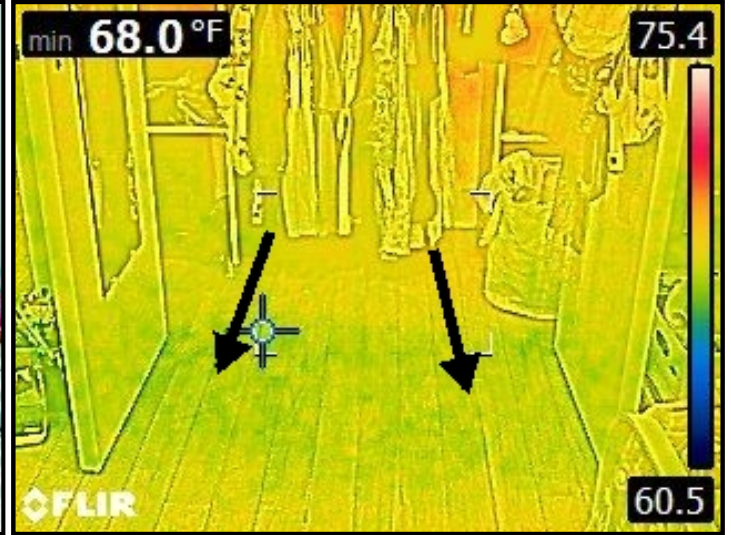
Infrared imaging of water entry point into closet wall area.

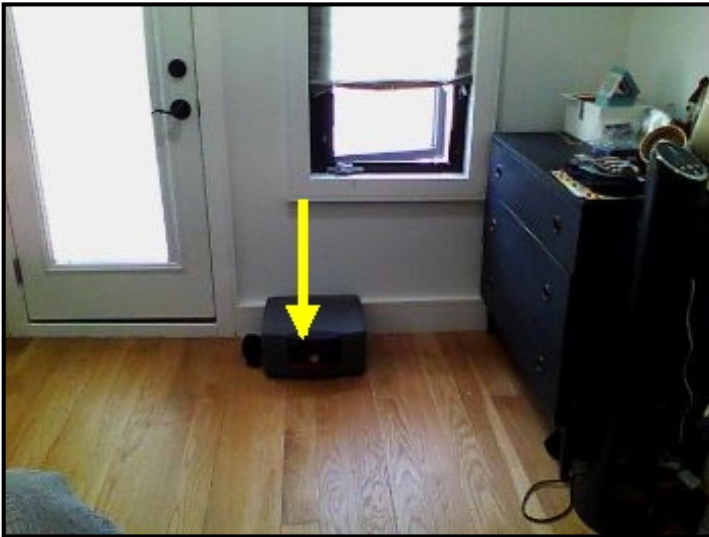
Water entering into wall area and cascading down into the second floor closet floor area.

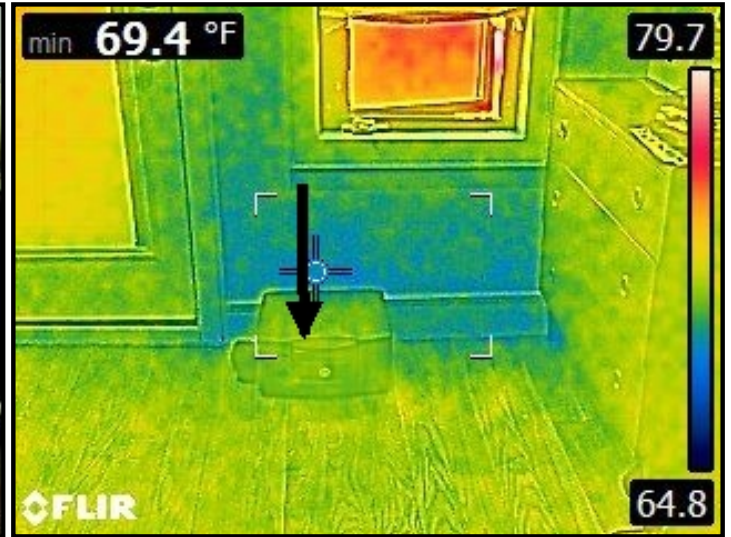
Infrared imaging of water entering into wall area and cascading down into the second floor closet floor area.

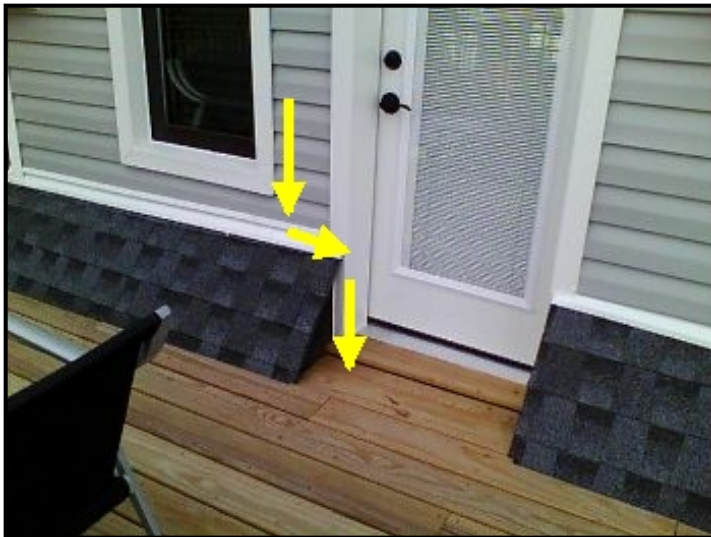
Water entering through facade area, backflowing into the internal wall and cascading down into the second floor closet floor area.

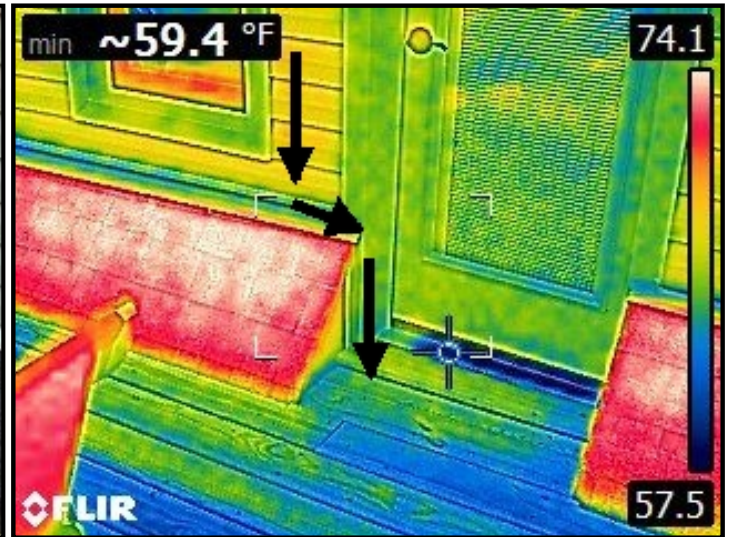
Infrared imaging of water entering through facade area, backflowing into the internal wall and cascading down into the second floor closet floor area.

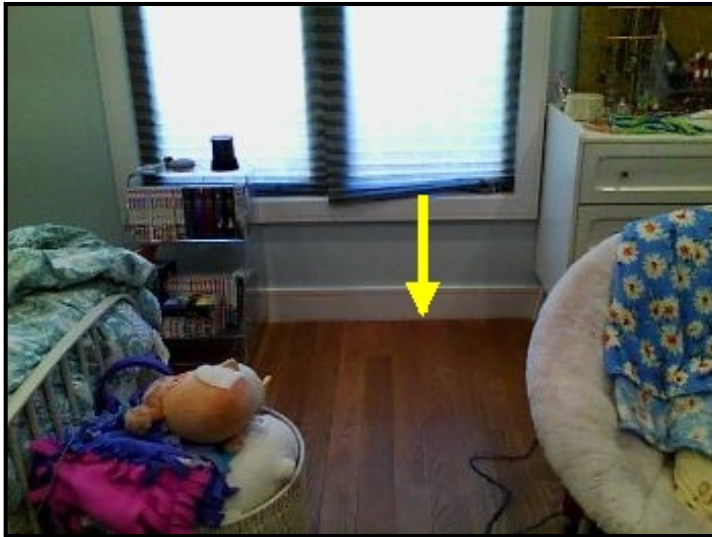
9. Second Floor Daughter's Room Window/Wall Leak Source and Origin: Window Sill/Facade Connection Point. Heavy wind-driven rain water is entering through the window sill connection point to the rear facade, backflowing into the substrate and cascading down into the internal wall area below not yet causing damage to the drywall system.

Water entry into lower wall area.

- a. Attempt to caulk window sill area from outside, if possible.
- b. If caulking application is not viable, siding must be removed from around the window sill and the area waterproofed/flashing as necessary.

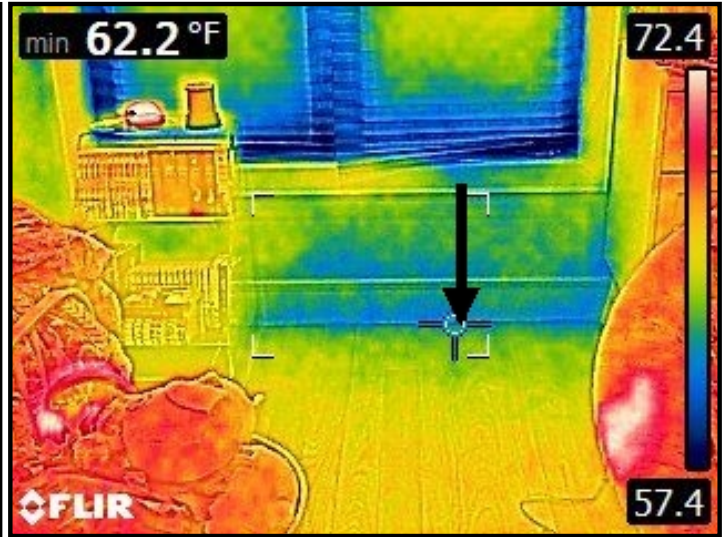
Infrared imaging of water entry into lower wall area.

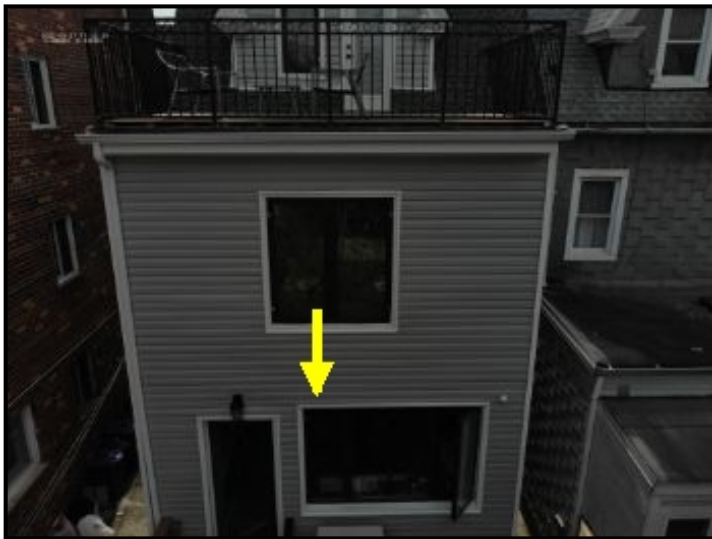
Water entering through window sill connection point to facade and backflowing into the internal wall area.

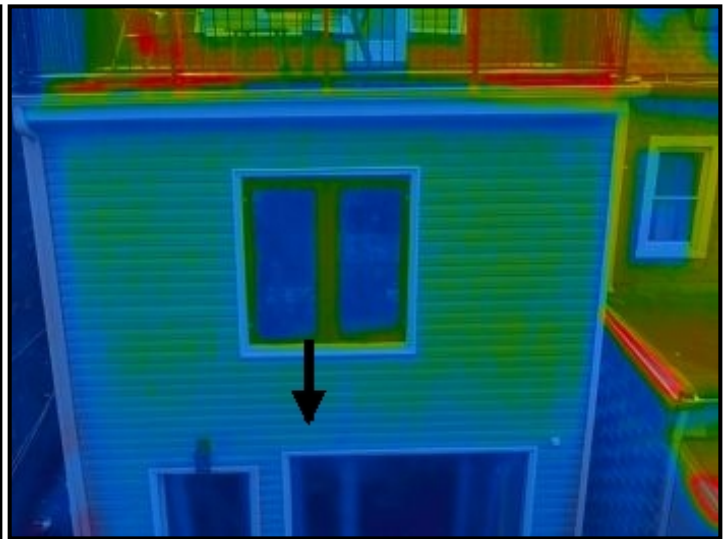
Infrared imaging of water entering through window sill connection point to facade and backflowing into the internal wall area.

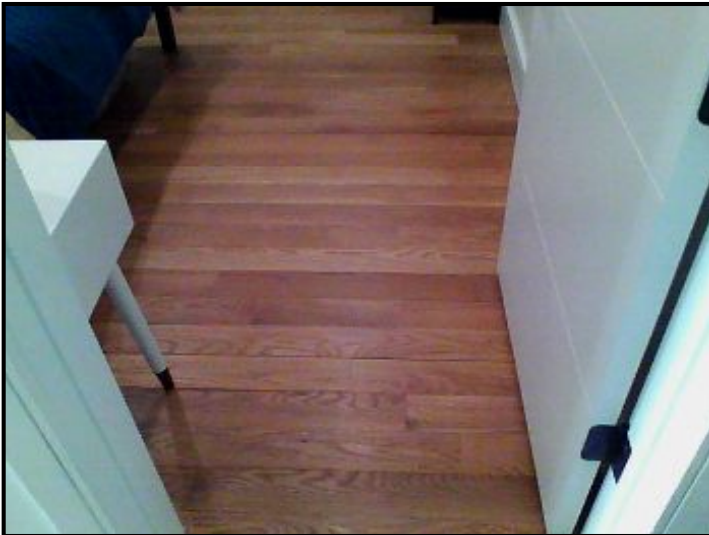
10. Floor Board Separation Source and Origin: Improper Installation of Hardwood System. All areas of floor board separation have been analyzed and confirmed to be without moisture entry within the area and humidity levels were at or below 60%. Based on all data available as well as the sporadic nature of the floor board separation points through the residence we believe the hardwood floor defect is due to improper installation of the system. We recommend followup scans within (7) days of a rain event to confirm these findings.

Floor board separation point. No indication of water entry within the area. Separation caused by improper installation.

- a. Conduct followup scans to confirm findings.
- b. If confirmed, replace hardwood floor board separation points as necessary.

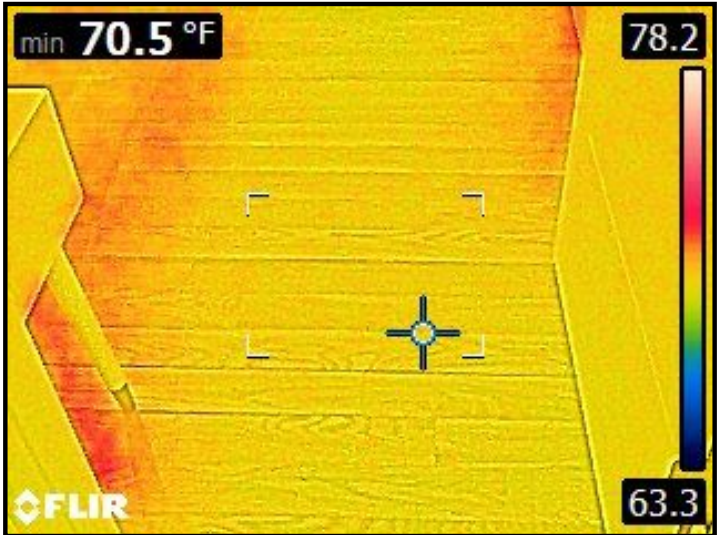
Infrared imaging of floor board separation point. No indication of water entry within the area. Separation caused by improper installation.

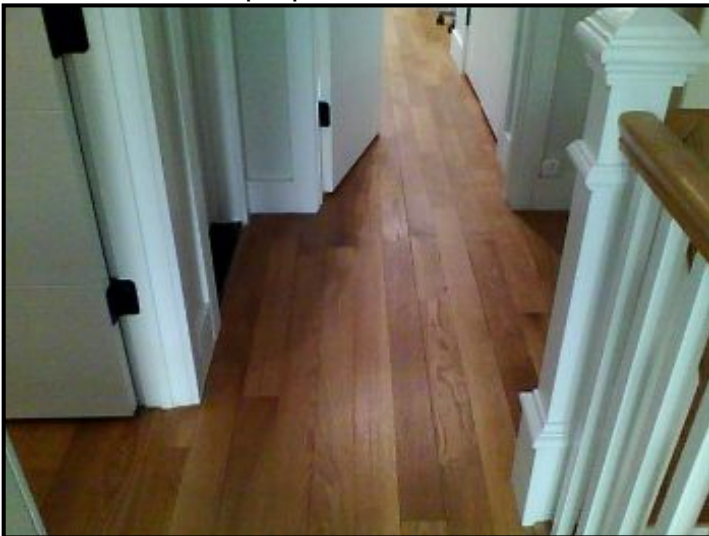
Floor board separation point. No indication of water entry within the area. Separation caused by improper installation.

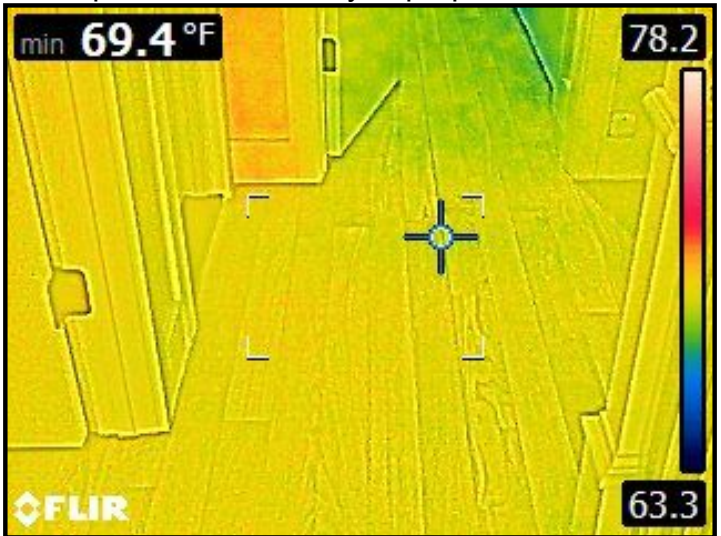
Infrared imaging of floor board separation point. No indication of water entry within the area. Separation caused by improper installation.

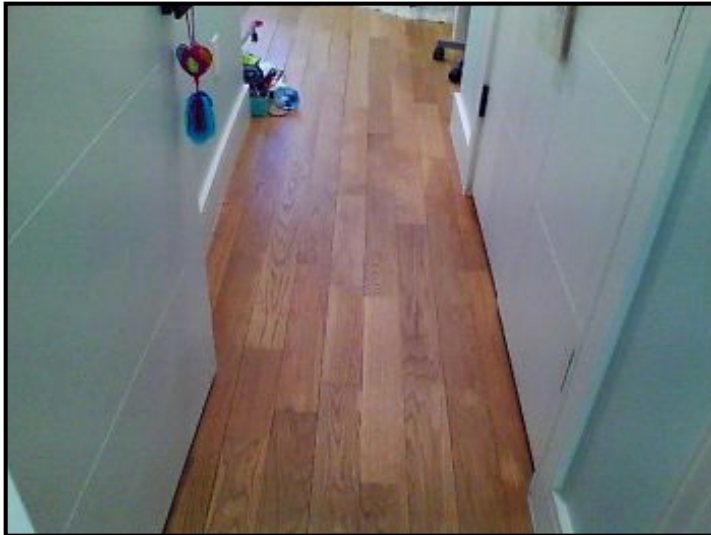
Floor board separation point. No indication of water entry within the area. Separation caused by improper installation.

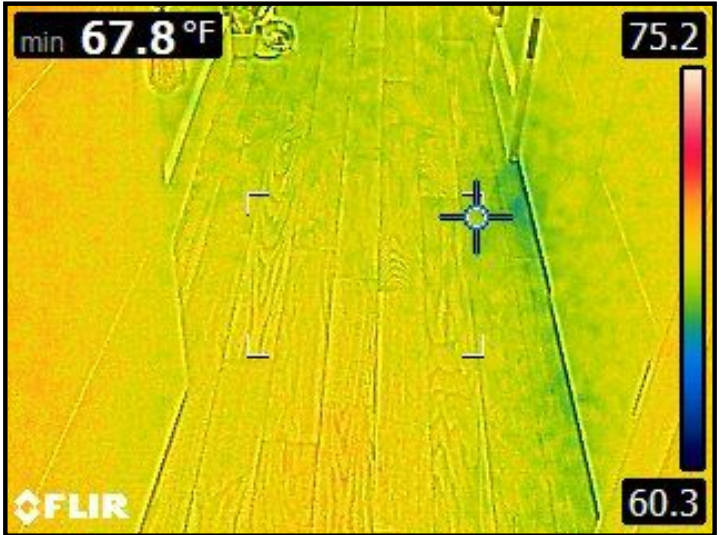
Infrared imaging of floor board separation point. No indication of water entry within the area. Separation caused by improper installation.

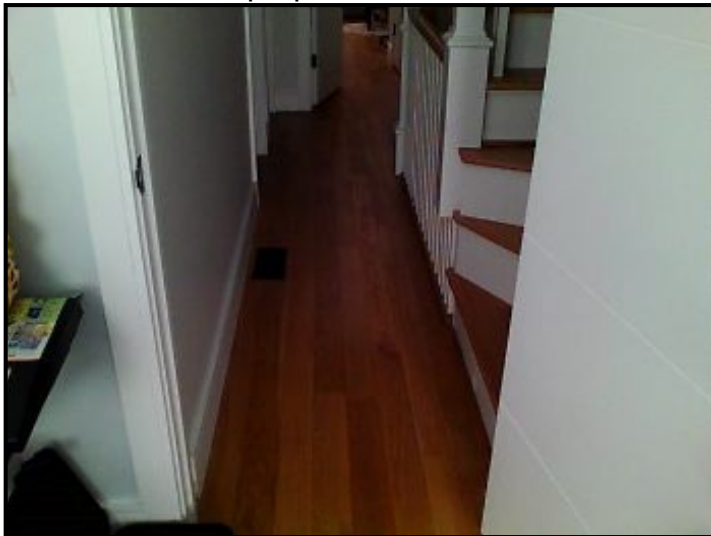
Floor board separation point. No indication of water entry within the area. Separation caused by improper installation.

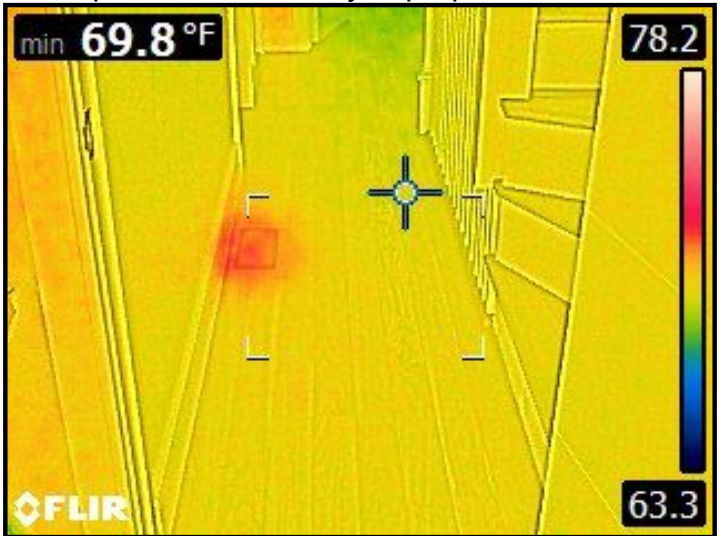
Infrared imaging of floor board separation point. No indication of water entry within the area. Separation caused by improper installation.

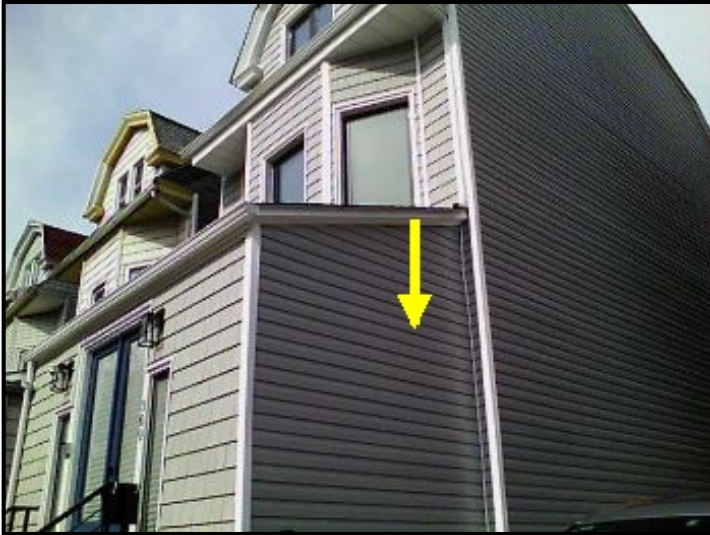
11. Attic Ceiling Leak#2 Source and Origin: Roof Shingle System. During heavy rain events, water is depositing onto the roofing system from the drain leader and in close proximity to the roof's edge causing water to overflow from the roof shingles and backflow into the siding system. Water entry is minor but present and has not yet migrated past the underlying waterproofing to the internal area of the residence. However, if not fixed, water will continue to enter and cause damage to the surrounding structure.

Water entry into side facade from above gutter leader deposit point draining into the roof substrate and depositing into the side facade.

- a. Reroute drain leader away from roof shingle edge either down the side of the building or directed towards the center of the roof by installing and 45degree leader joint.

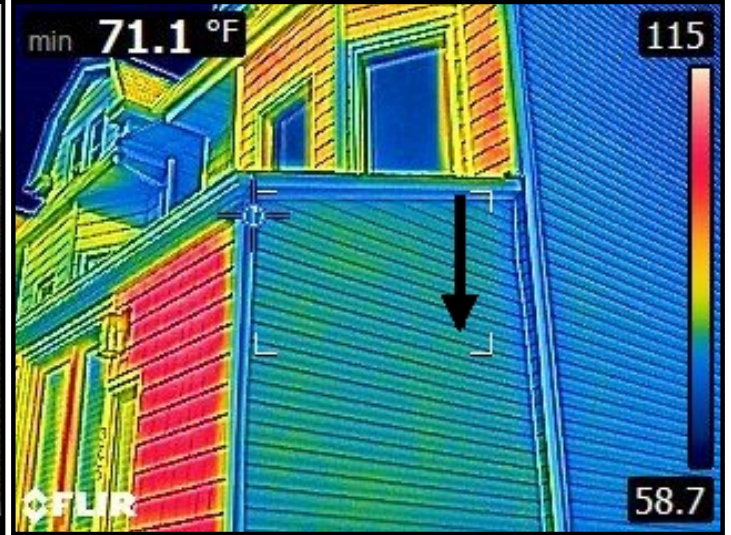
Infrared imaging of water entry into side facade from above gutter leader deposit point draining into the roof substrate and depositing into the side facade.
