JP Diagnostics *Leak Detection Report*

Date of Inspection: 6/20/2022 Time: 0900 Size: Brick / Masonry

Full Building Infrared Audit (FB.IR.AUD)

2065 West 7th Street, 2nd Floor, Brooklyn, NY 11223

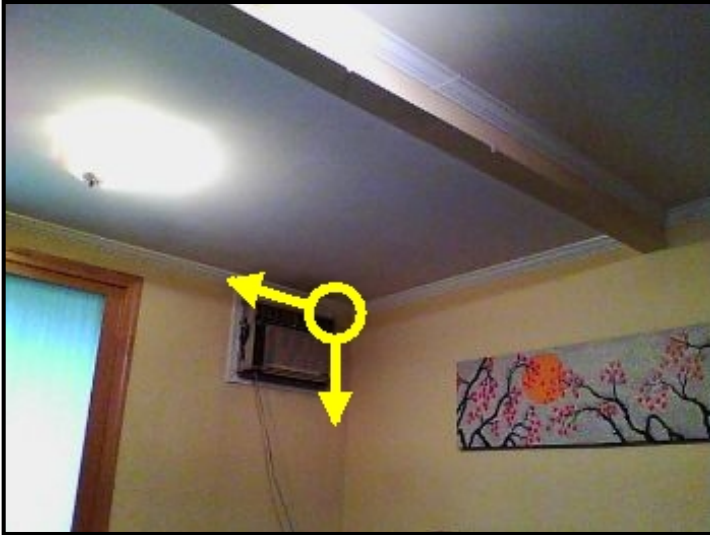
1. **Unit 1 Living Room Wall Leak Source and Origin: Rear Brick / Masonry Facade.** Heavy wind-driven rain water is entering through the rear masonry facade, backflowing into the substrate and cascading down into the internal wall area below causing minor damage to the surrounding AC sleeve area.

Water entry into corner wall area.

- a. Patch all masonry openings.
 - b. Waterproof area accordingly.
-

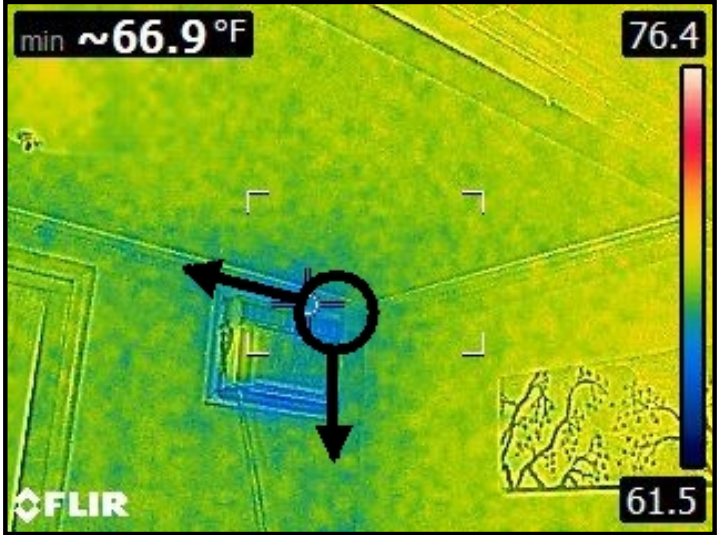
Infrared imaging of water entry into corner wall area.

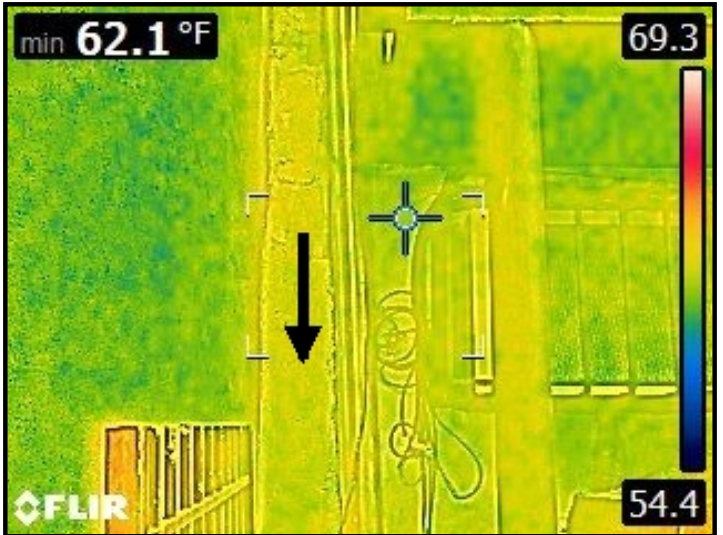
Water entering through rear facade and backflowing into the internal wall area.

Infrared imaging of water entering through rear facade and backflowing into the internal wall area.

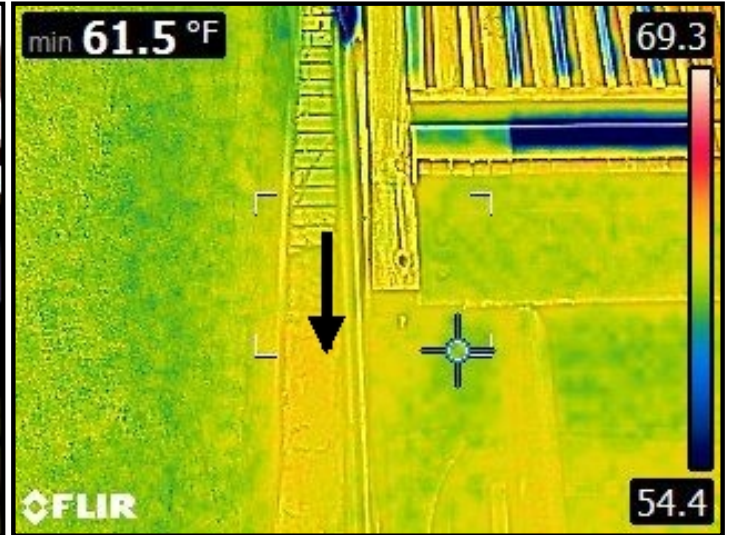
Water entering through rear facade and backflowing into the internal wall area.

Infrared imaging of water entering through rear facade and backflowing into the internal wall area.

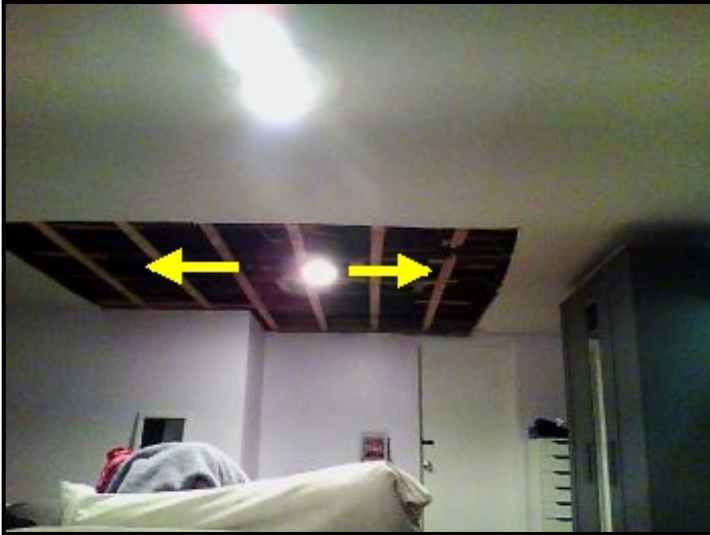
2. **Unit 1 Basement Ceiling Leak Source and Origin: Shower Stall Tile Wall.** During shower stall operation, water is entering through the deteriorated grout joints of the shower stall tile wall, backflowing into the substrate and cascading down into the ceiling area below causing minor damage to the surrounding area.

Water entry into ceiling area.

- a. Excavate tile from shower stall walls.
 - b. Waterproof area accordingly.
 - c. Install new tile system.
-

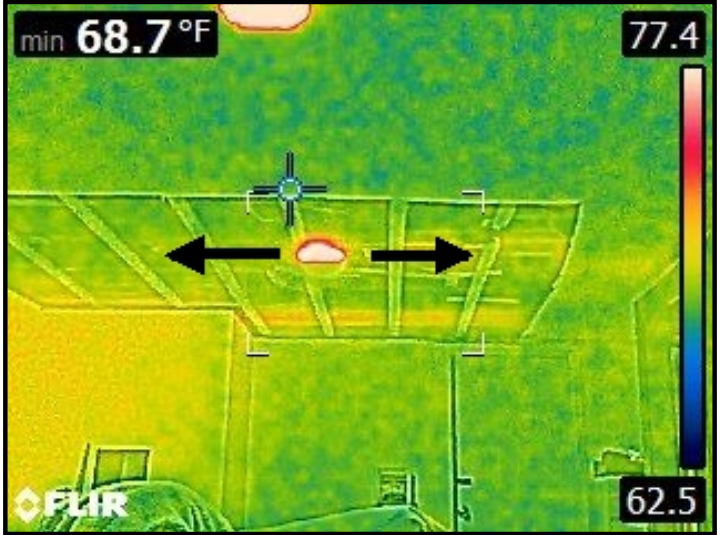
Infrared imaging of water entry into ceiling area.

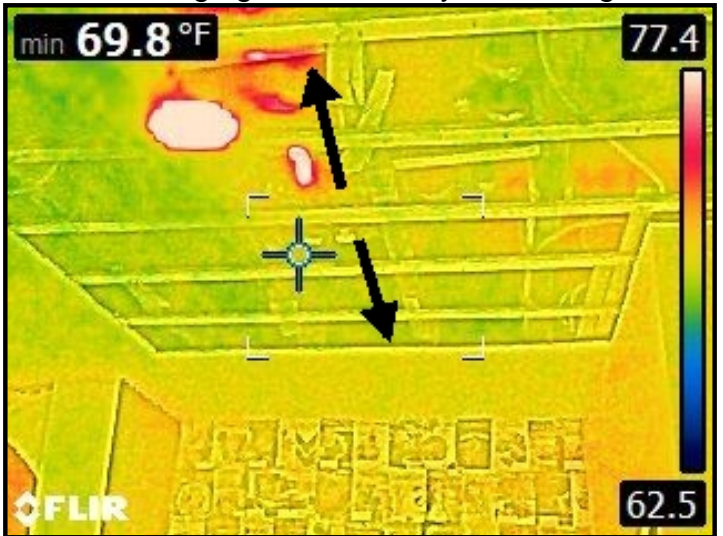
Water entry into ceiling area.

Infrared imaging of water entry into ceiling area.

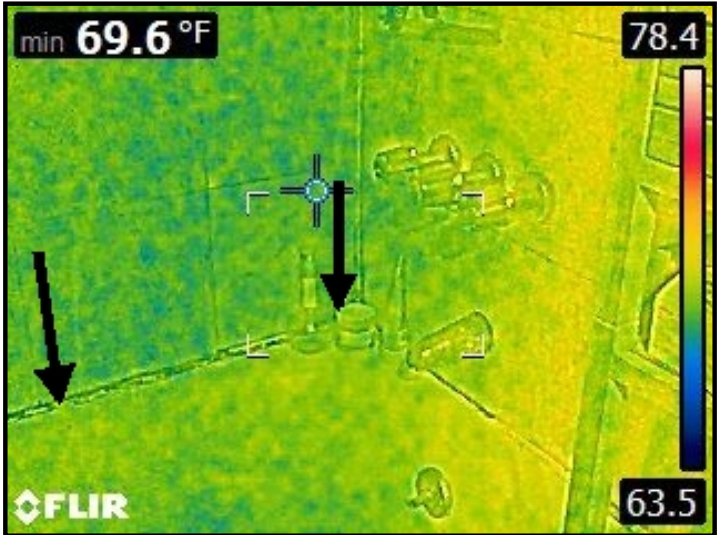
Water entering through shower stall tile wall area and cascading down into the ceiling area below.

Infrared imaging of water entering through shower stall tile wall area and cascading down into the ceiling area below.

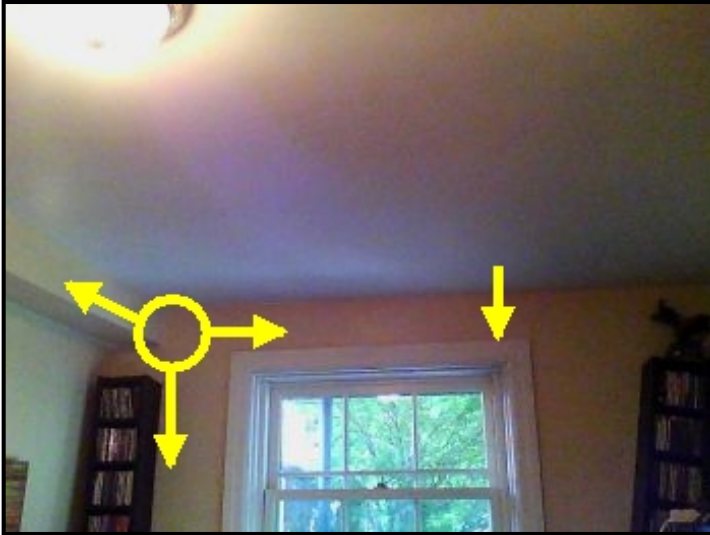
3. **Unit 1 Office Wall Leak Source and Origin: Rear Facade / Deck Connection Point.** Heavy wind-driven rain water is entering through the rear facade where the deck structure connects to the masonry facade, backflowing into the substrate and cascading down into the internal wall area below causing minor damage to the surrounding area.

Water entry into wall/ceiling area.

- a. Remove deck planks from rear facade area.
 - b. Waterproof rear facade area around deck connection point.
 - c. Reinstall planks as necessary.
-

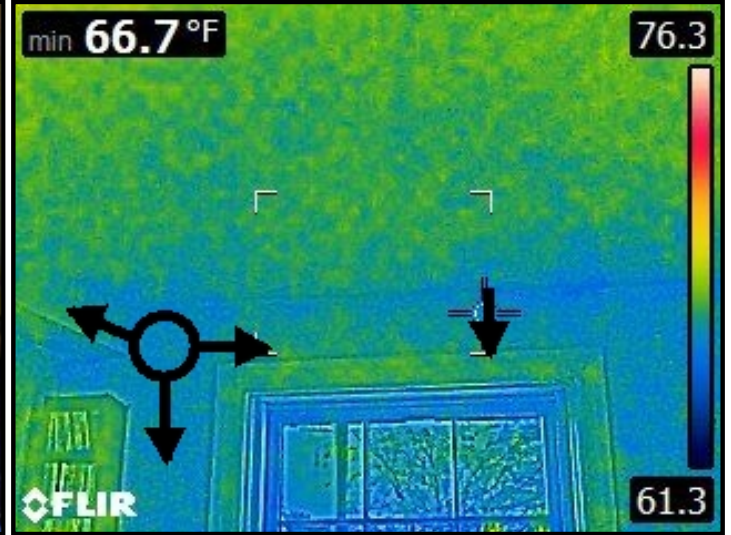
Infrared imaging of water entry into wall/ceiling area.

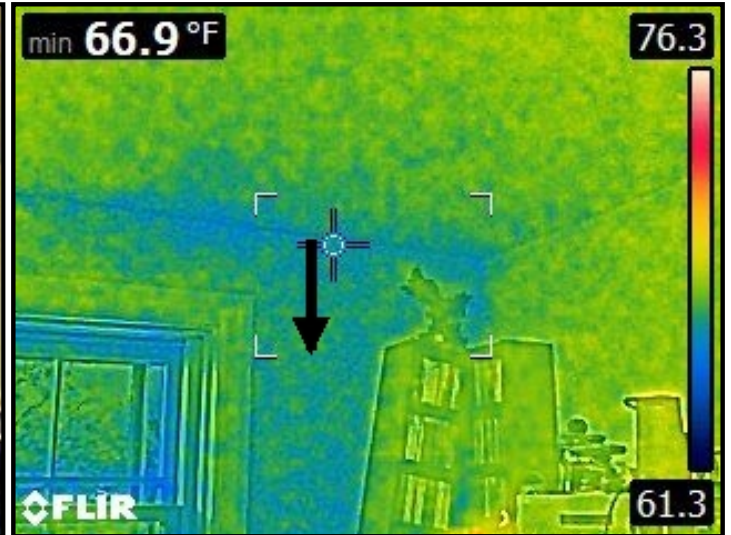
Water entry into wall/ceiling area.

Infrared imaging of water entry into wall/ceiling area.

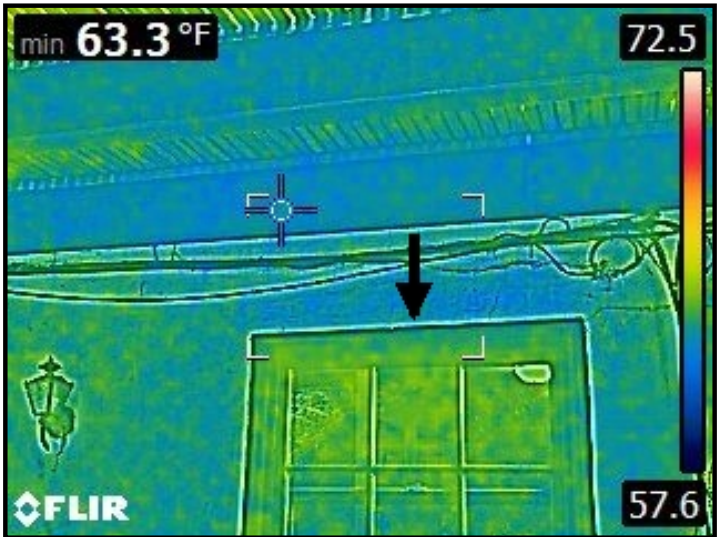
Water cascading down through rear facade and backflowing into the internal wall/ceiling area.

Infrared imaging of water cascading down through rear facade and backflowing into the internal wall/ceiling area.

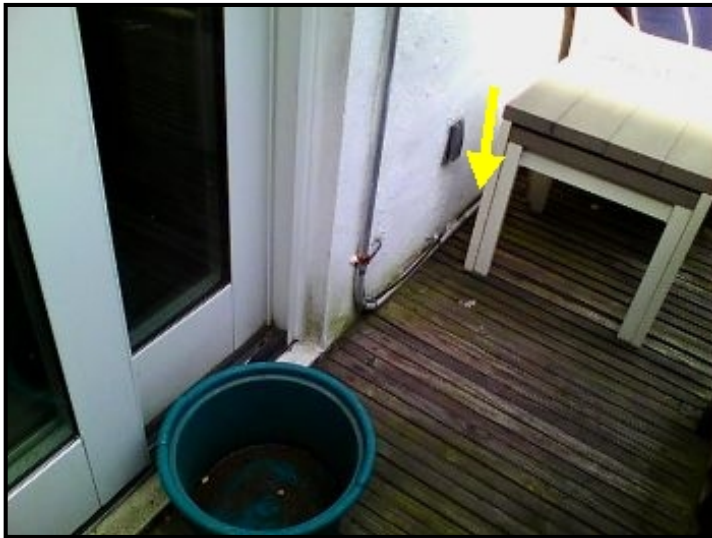
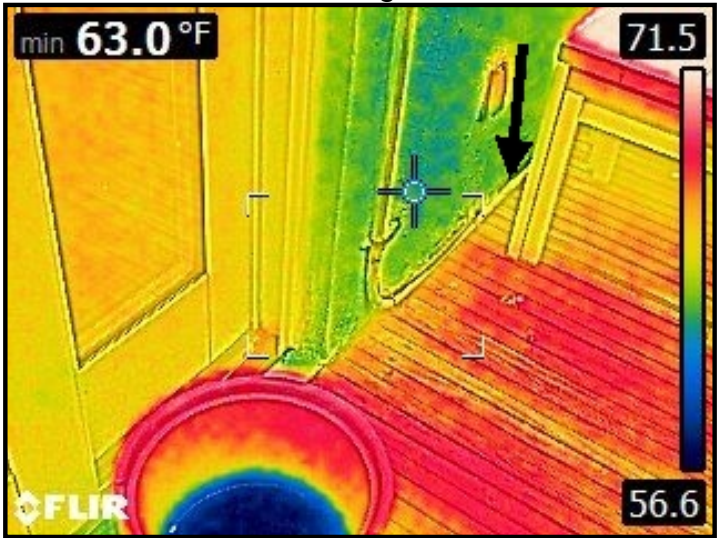
Water entering through rear facade connection point to the deck system and cascading down into the wall/ceiling area below.

Infrared imaging of water entering through rear facade connection point to the deck system and cascading down into the wall/ceiling area below.

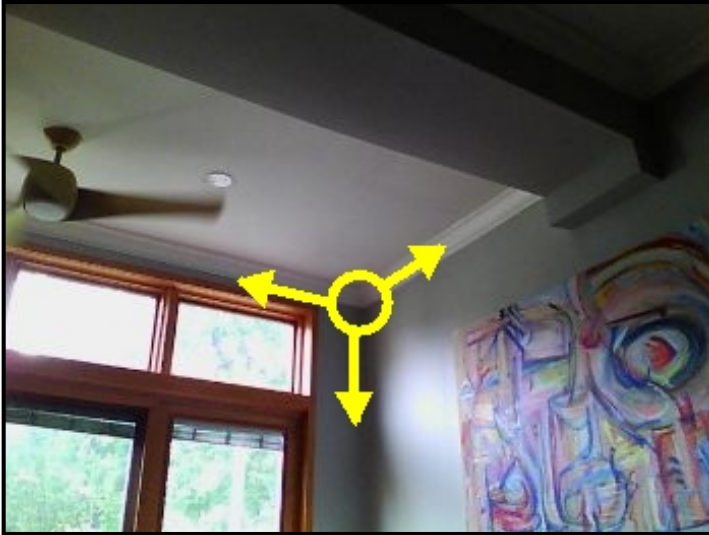
4. **Unit 2 Living Room Ceiling/Wall Leak Source and Origin: Rear Facade / Parapet Wall.** Heavy rain water is entering through the parapet wall coping stone joints as well as the inner and outer brick system, cascading down into the rear facade and backflowing into the internal ceiling/wall area causing minor damage to the surrounding area.

Water entry into corner wall/ceiling area.

- a. Seal inner and outer brick parapet wall area with RD Elastoflex or Silane Siloxane sx5000.
- b. Install aluminum flashing cap over parapet wall coping stone system.

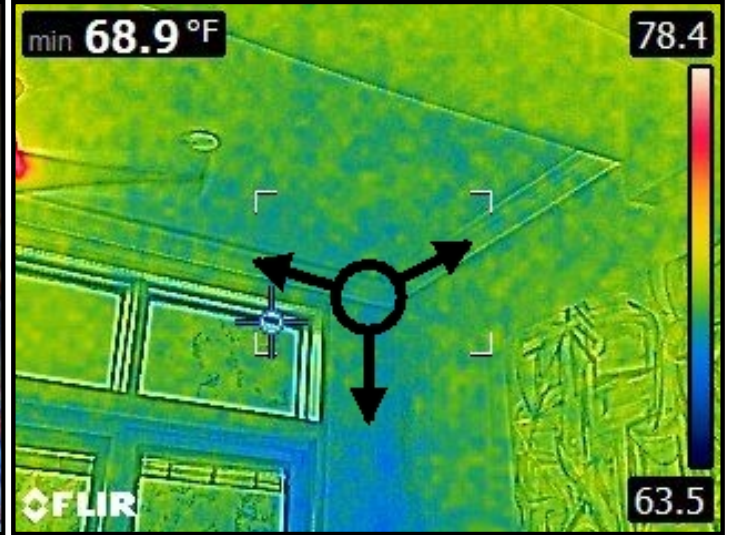
Infrared imaging of water entry into corner wall/ceiling area.

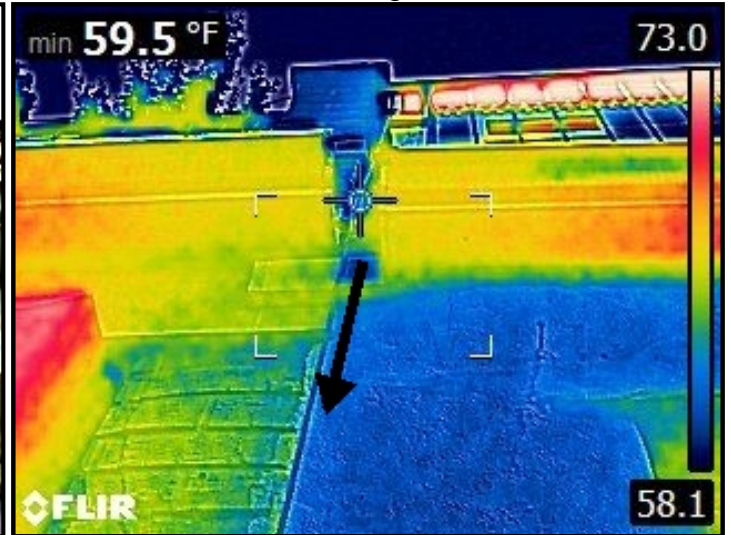
Water entering through the rear facade between the gutter trays and through the brick parapet wall above.

Infrared imaging of water entering through the rear facade between the gutter trays and through the brick parapet wall above.

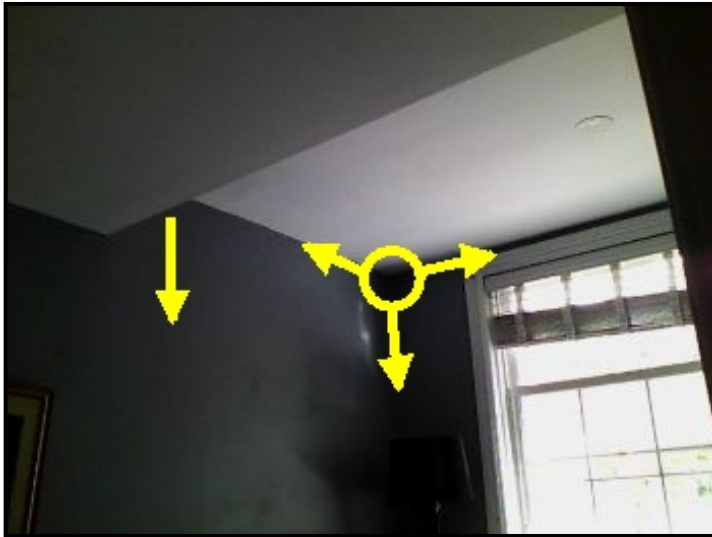
5. **Unit 2 Office Wall/Ceiling Leak Source and Origin: Parapet Wall / Brick Facade.** Heavy rain water is entering through the parapet wall coping stone joints as well as the inner and outer brick system, cascading down into the rear facade and backflowing into the internal ceiling/wall area causing minor damage to the surrounding area.

Water entry into ceiling/wall area.

- a. Seal inner and outer brick parapet wall area with RD Elastoflex or Silane Siloxane sx5000.
- b. Install aluminum flashing cap over parapet wall coping stone system.
- c. Seal entire side facade accordingly.

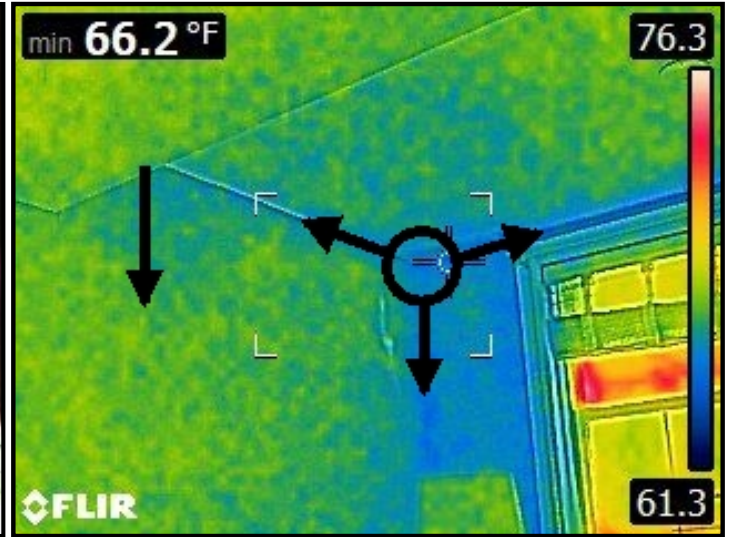
Infrared imaging of water entry into ceiling/wall area.

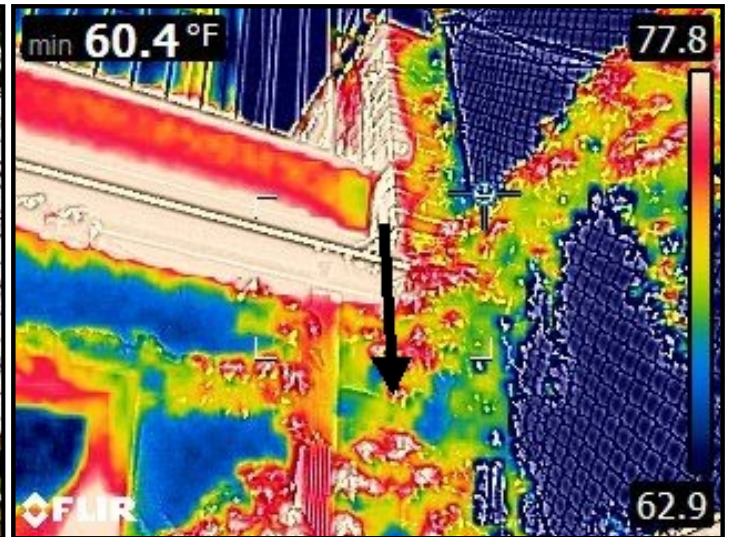
Water entering through parapet wall and cascading down into the ceiling/wall area below.

Infrared imaging of water entering through parapet wall and cascading down into the ceiling/wall area below.

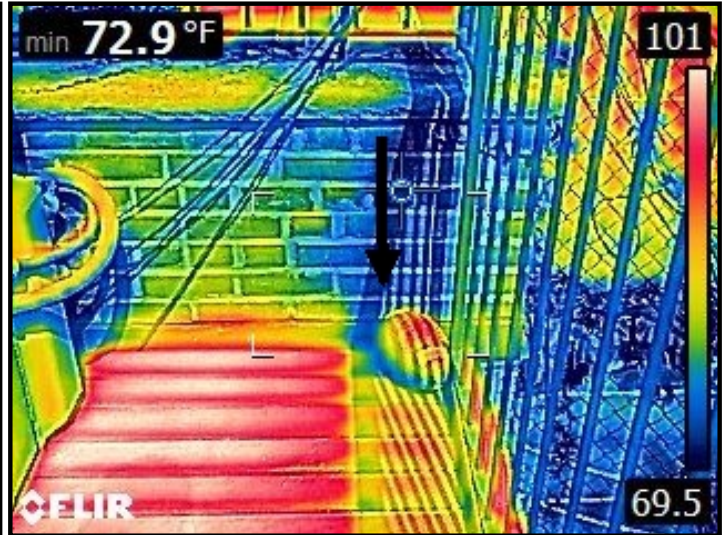
Water entering through parapet wall and cascading down into the ceiling/wall area below.

Infrared imaging of water entering through parapet wall and cascading down into the ceiling/wall area below.

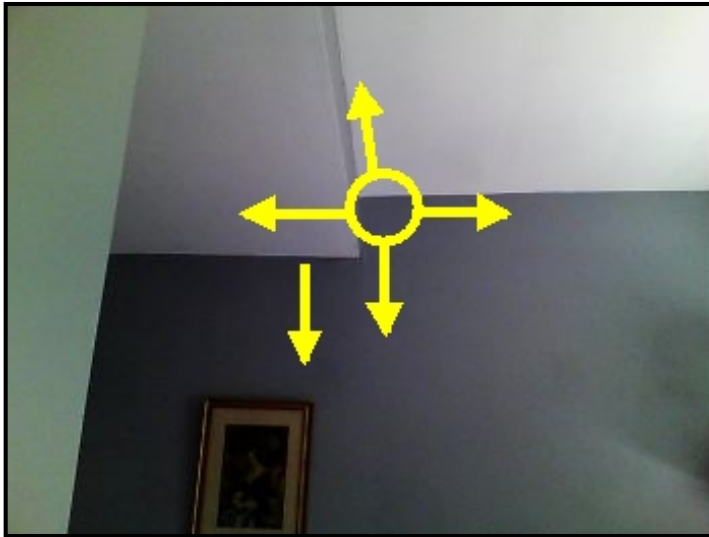
6. **Unit 2 Office Wall/Ceiling Leak#2 Source and Origin: Parapet Wall / Brick Facade / Roof Membrane.** Heavy wind-driven rain water is entering through the parapet wall brick and coping stone as well as the upper roof parapet wall / roof membrane connection point, cascading down through the side facade and depositing into the wall/ceiling area below causing minor damage to the surrounding area.

Water entry into ceiling/wall area.

- a. Seal inner and outer brick parapet wall with RD Elastoflex or Silane Siloxane sx5000.
- b. Install aluminum flashing cap over parapet wall coping stone system.
- c. Install aluminum flashing cap over upper roof parapet wall system.
- d. Seal entire side facade accordingly.

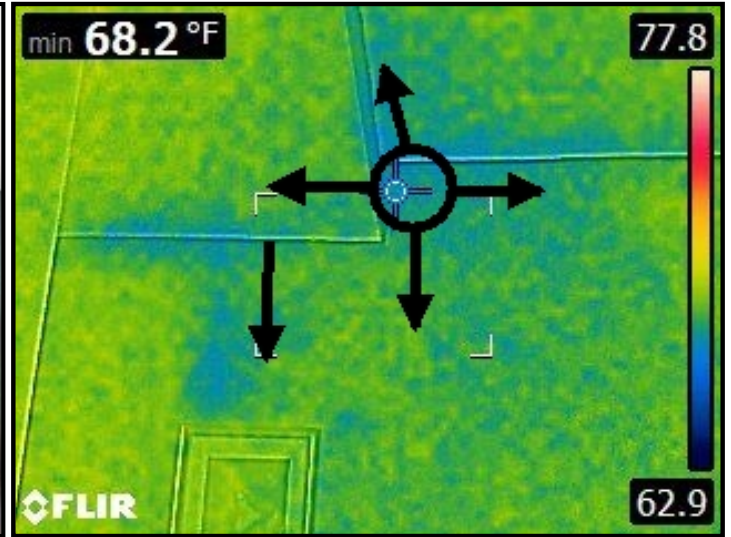
Infrared imaging of water entry into ceiling/wall area.

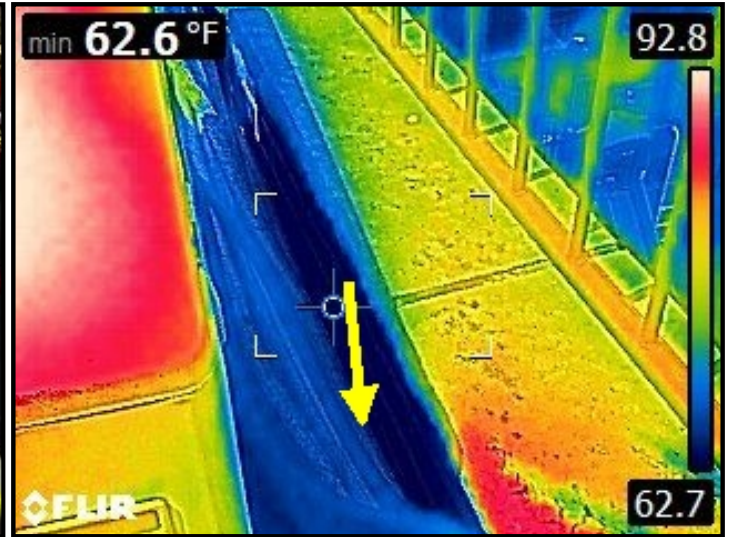
Water entering through parapet wall coping stone system and cascading down into the ceiling/wall area below.

Infrared imaging of water entering through parapet wall coping stone system and cascading down into the ceiling/wall area below.

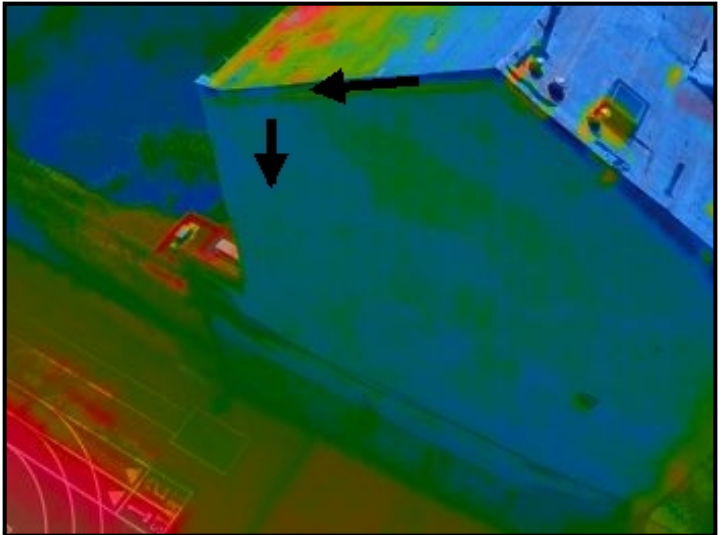
Water entering through the roof membrane/upper roof parapet wall coping stone and cascading down through the side facade eventually depositing into the ceiling/wall area below.

Infrared imaging of water entering through the roof membrane/upper roof parapet wall coping stone and cascading down through the side facade eventually depositing into the ceiling/wall area below.

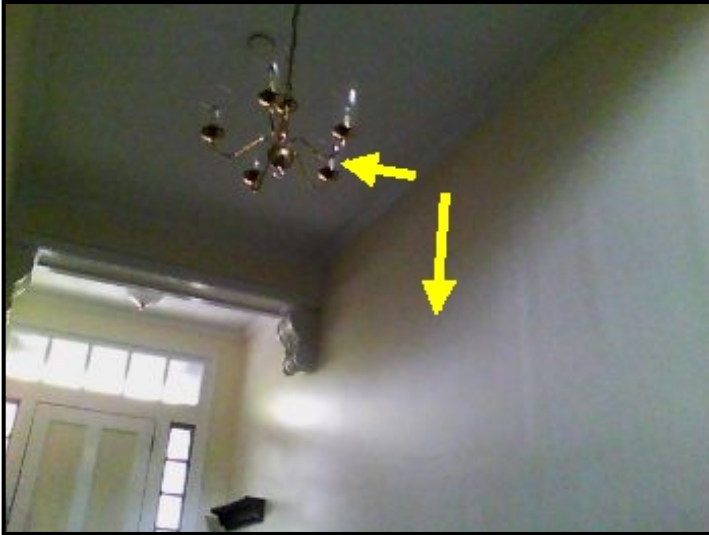
7. **Stairwell Wall Leak#1 Source and Origin: Side Facade / Roof Membrane System.** Heavy wind-driven rain water is entering through the roof membrane system connection point to the coping stone of the upper roof parapet wall. Water is seeping into the membrane system, cascading down along the roof pitch and entering into the internal facade system. Once inside the masonry side facade, water is continuing down and depositing into the first floor stairwell wall area, not yet causing damage to the surrounding area. Further, during the infrared scanning process of the roofing system, significant moisture was found entering into the membrane system but not yet causing damage to the internal structure. It is hard to say whether the water entry is only due to the coping stone/membrane joint or widespread water entry into the roof membrane joints.

Water entry into wall area.

- a. Inspect upper roof membrane system for overall integrity due to significant moisture entry into the membrane system.
- b. If roof membrane is viable, install aluminum flashing cap over parapet wall system to prevent water entry into roof membrane connection point to coping stone.
- c. If roof membrane system is not viable, recommend full roof replacement.
- d. Seal entire side facade accordingly.

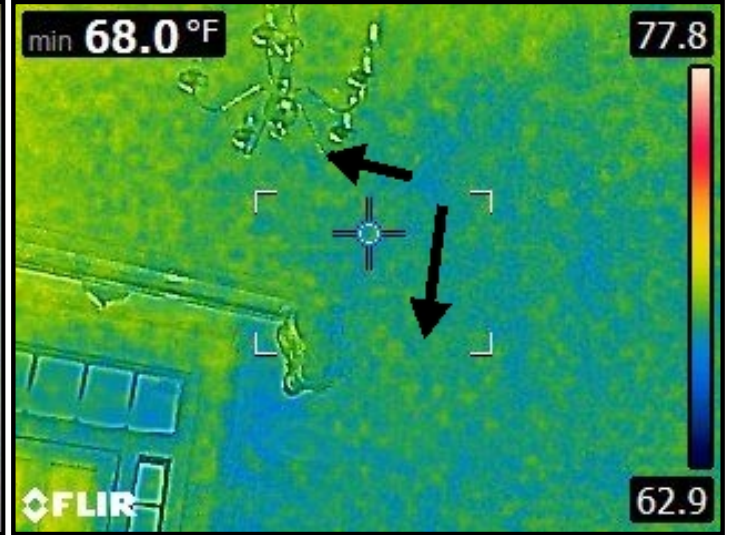
Infrared imaging of water entry into wall area.

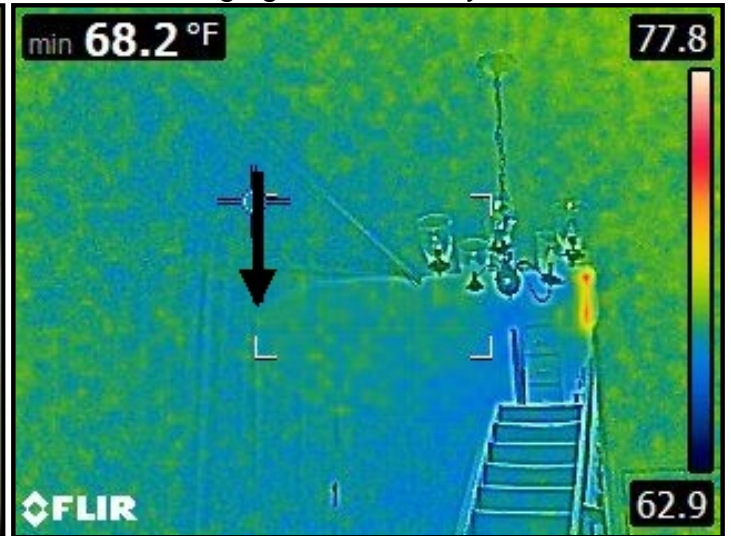
Water entry into wall area.

Infrared imaging of water entry into wall area.

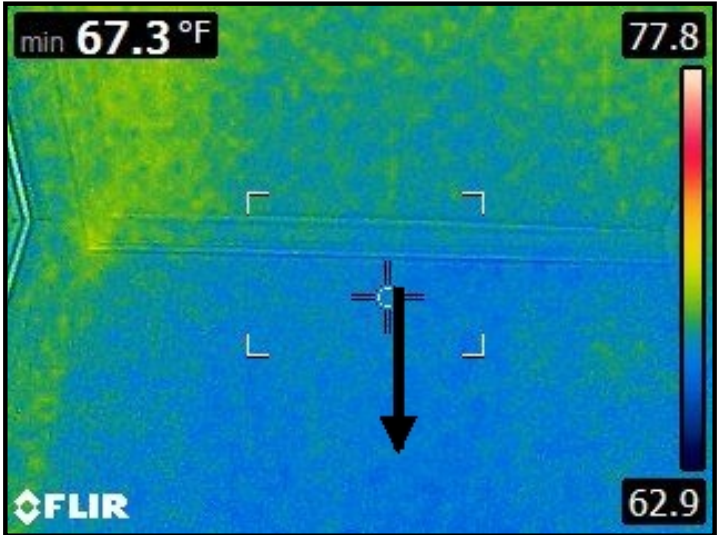
Water entry into wall area.

Infrared imaging of water entry into wall area.

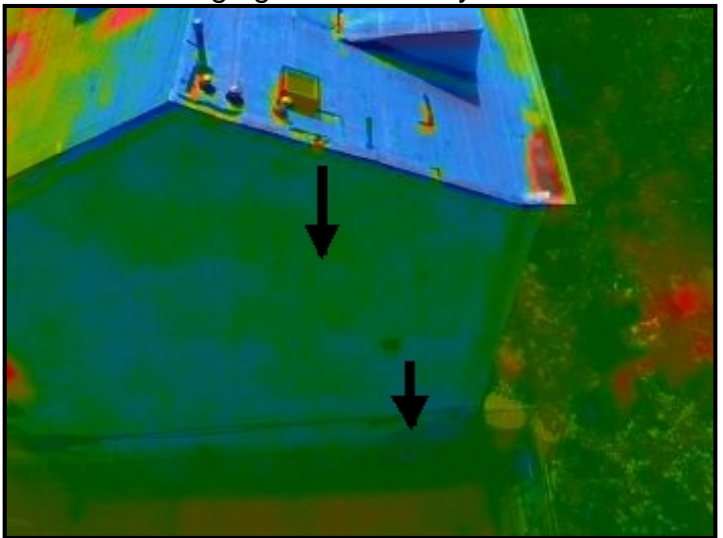
Water entering through roof membrane/parapet wall coping stone connection point, cascading down through the side facade and depositing into the internal wall areas below.

Infrared imaging of water entering through roof membrane/parapet wall coping stone connection point, cascading down through the side facade and depositing into the internal wall areas below.

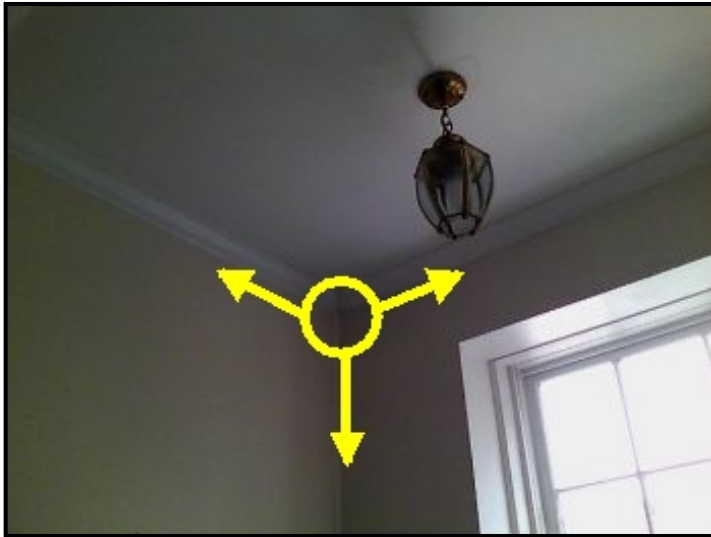
8. Stairwell Wall Leak#2 Source and Origin: Roof Membrane / Parapet Wall / Side Facade. Heavy wind-driven rain water is entering through the upper roof membrane system connection point to the parapet wall coping stone, seeping into the roof membrane system and cascading down along the roof pitch where it is consolidating at the edge of the roof behind the gutter system. Once within this corner area, water is backflowing into the substrate and cascading down into the internal wall area causing significant damage to the surrounding drywall system.

Severe water entry into corner wall area.

- a. Inspect upper roof membrane system for overall integrity due to significant moisture entry into the membrane system.
- b. If roof membrane is viable, install aluminum flashing cap over parapet wall system to prevent water entry into roof membrane connection point to coping stone.
- c. If roof membrane system is not viable, recommend full roof replacement.
- d. Seal entire side facade accordingly.

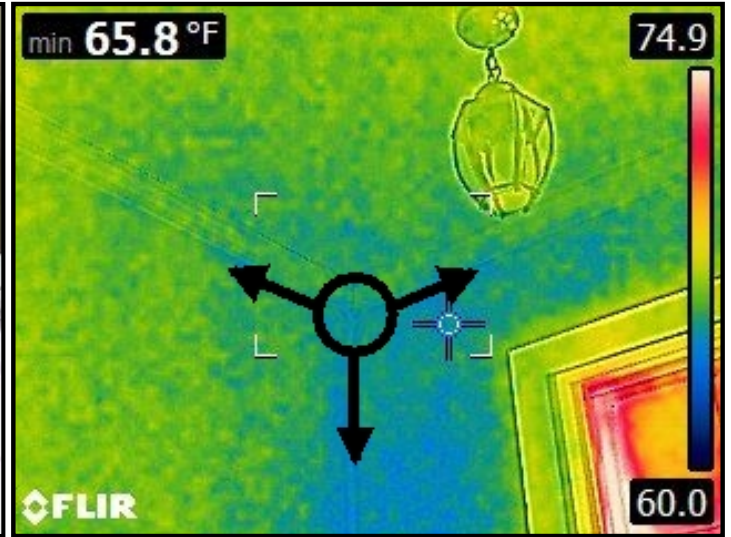
Infrared imaging of severe water entry into corner wall area.

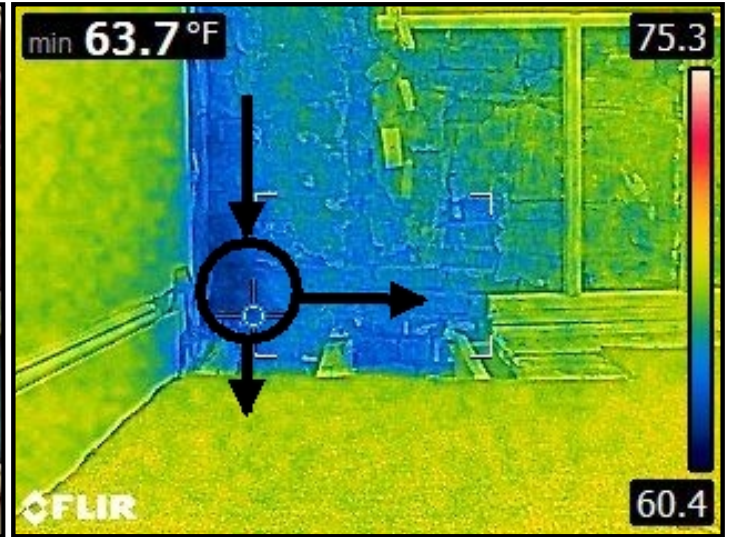
Water cascading down through wall area.

Infrared imaging of water cascading down through wall area.

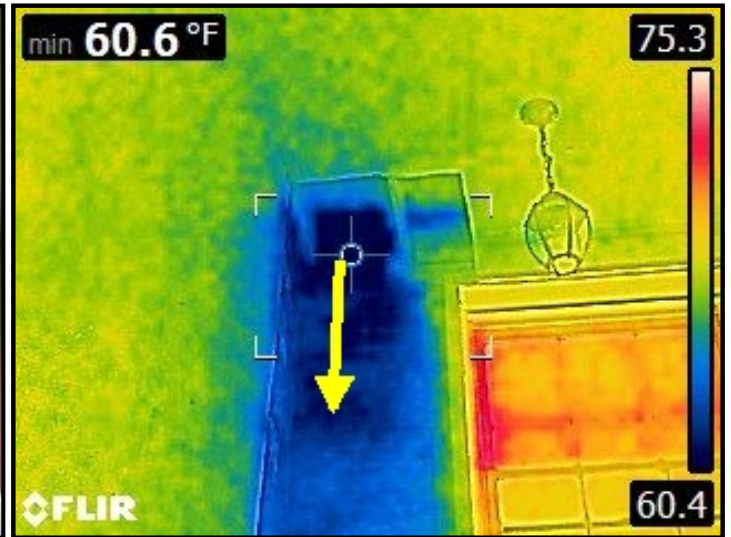
Severe water entry into corner wall area from upper roof membrane system.

Infrared imaging of severe water entry into corner wall area from upper roof membrane system.

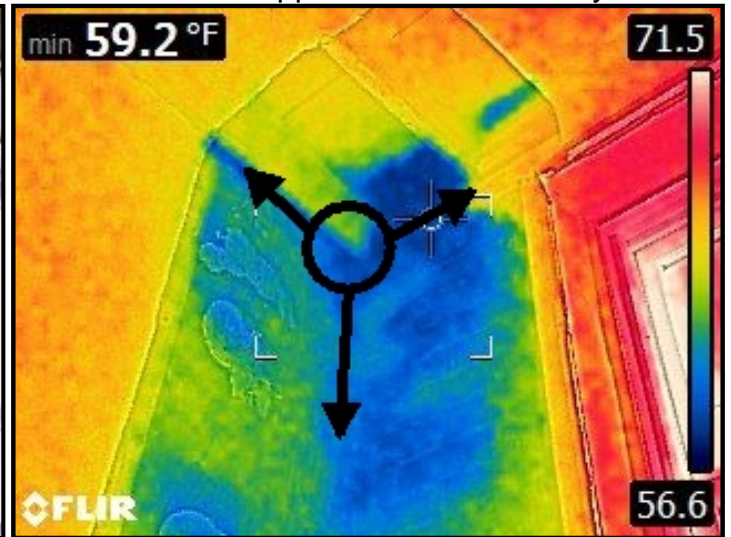
Severe water entry into corner wall area from upper roof membrane system.

Infrared imaging of severe water entry into corner wall area from upper roof membrane system.

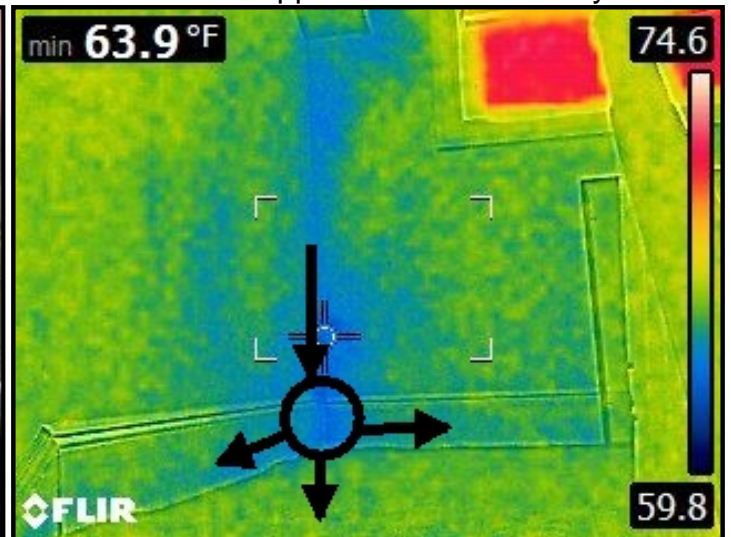
Severe water entry into corner wall area from upper roof membrane system.

Infrared imaging of severe water entry into corner wall area from upper roof membrane system.

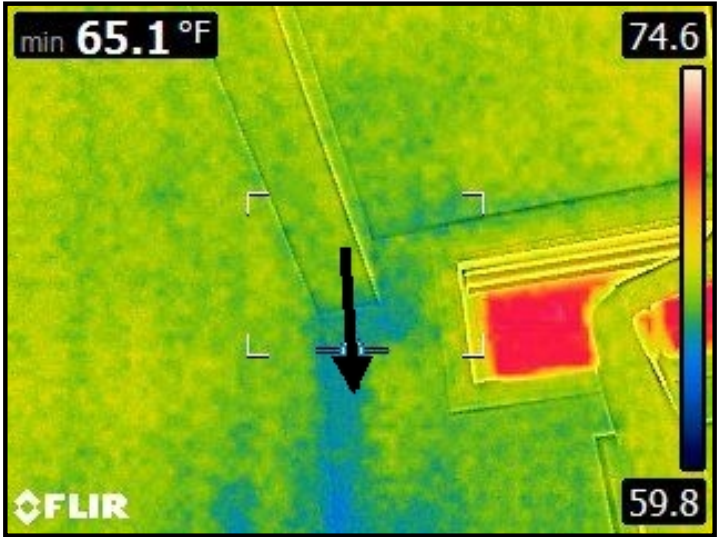
Severe water entry into corner wall area from upper roof membrane system.

Infrared imaging of severe water entry into corner wall area from upper roof membrane system.

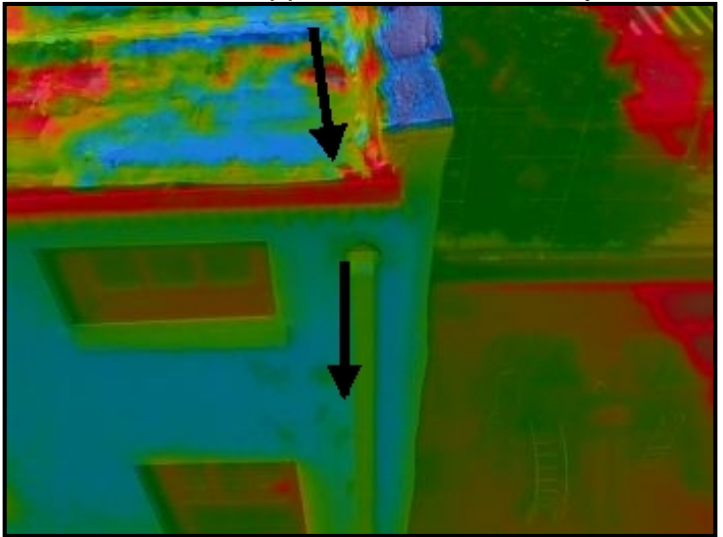
Water cascading down through the roof membrane system and depositing into the internal wall area below.

Infrared imaging of water cascading down through the roof membrane system and depositing into the internal wall area below.

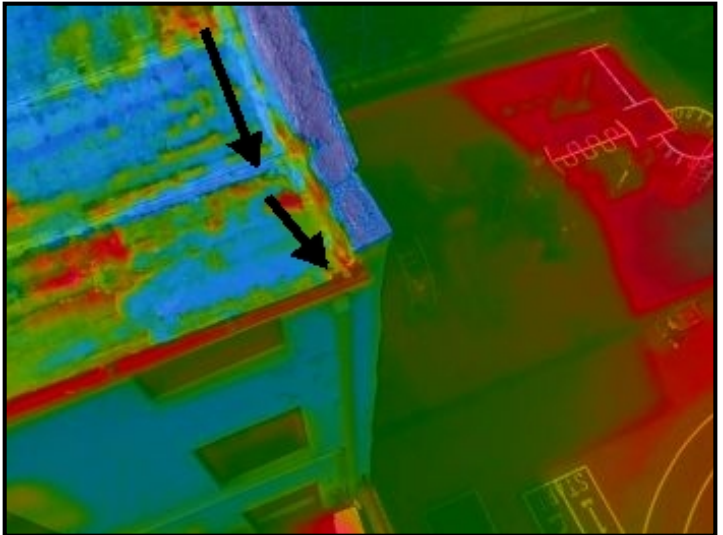
Water cascading down through the roof membrane system and depositing into the internal wall area below.

Infrared imaging of water cascading down through the roof membrane system and depositing into the internal wall area below.

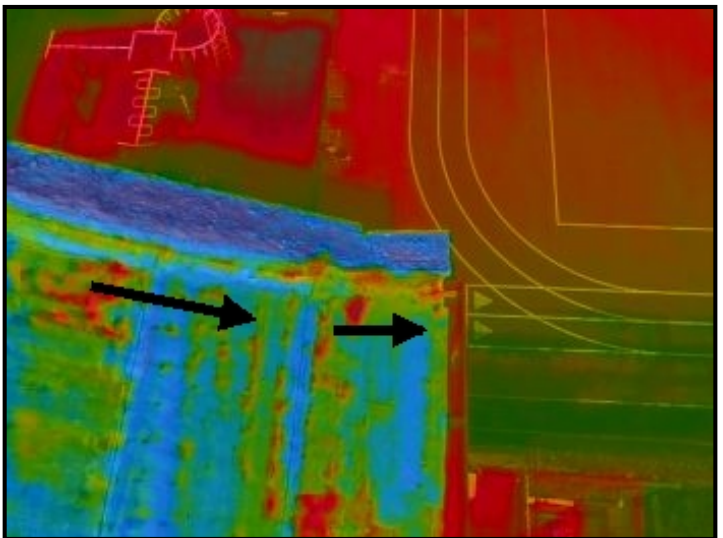
Water cascading down through the roof membrane system and depositing into the internal wall area below.

Infrared imaging of water cascading down through the roof membrane system and depositing into the internal wall area below.

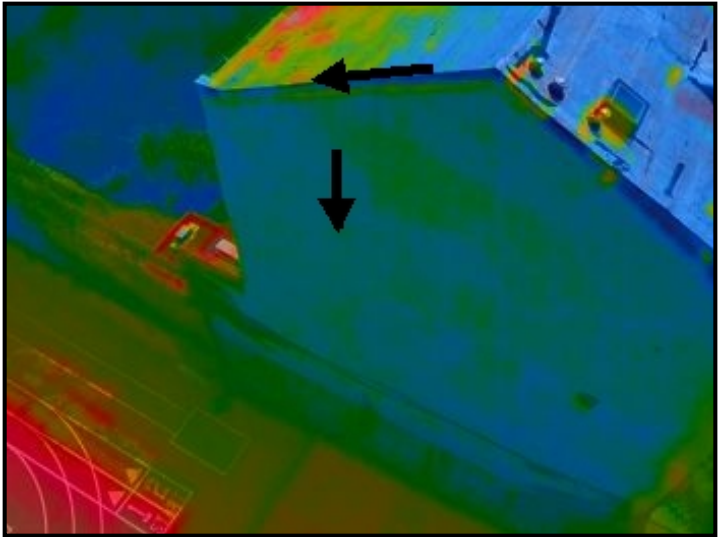
Water entering through roof membrane system/coping stone connection point, cascading down through the roof and depositing into the rear facade and internal wall area below.

Infrared imaging of water entering through roof membrane system/coping stone connection point, cascading down through the roof and depositing into the rear facade and internal wall area below.

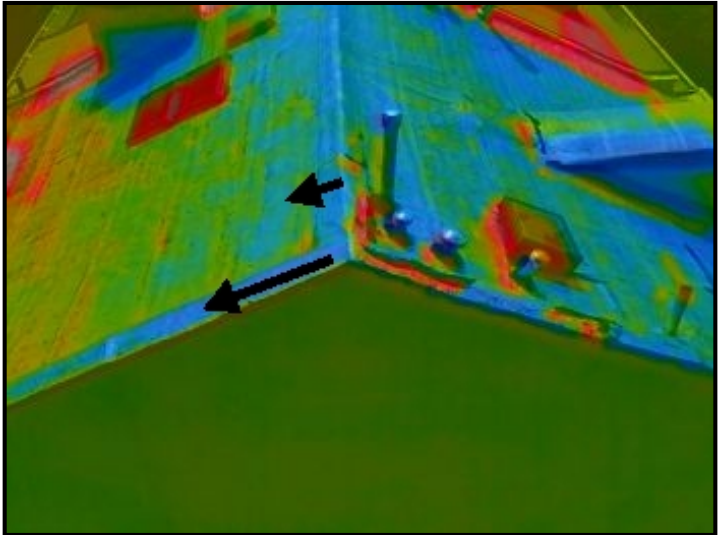
Water entering through roof membrane system/coping stone connection point, cascading down through the roof and depositing into the rear facade and internal wall area below.

Infrared imaging of water entering through roof membrane system/coping stone connection point, cascading down through the roof and depositing into the rear facade and internal wall area below.

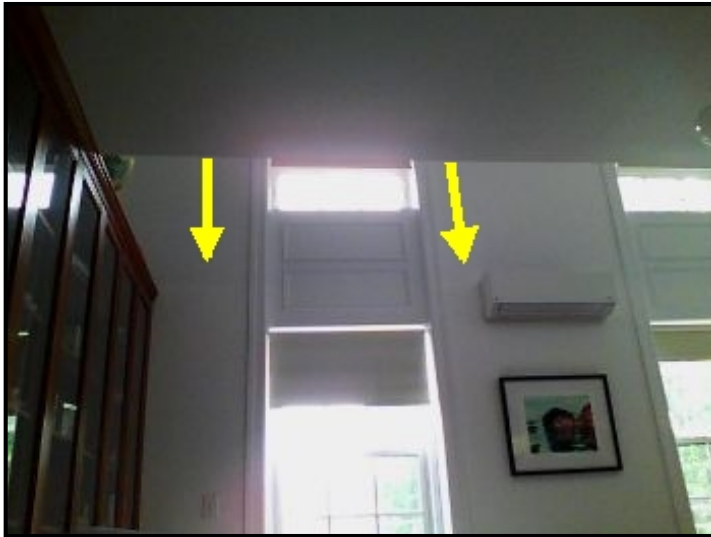
9. Unit 4 Living Room Ceiling/Wall Leak Source and Origin: Roof Membrane / Parapet Wall. Heavy wind-driven rain water is entering through the upper roof membrane system connection point to the parapet wall coping stone, seeping into the roof membrane system and cascading down along the roof pitch where it is consolidating at the edge of the roof behind the gutter system. Once within this corner area, water is cascading out through the edge of the roof, backflowing into the substrate and cascading down into the internal ceiling / wall area, not yet causing damage to the surrounding drywall system.

Water entry into wall area.

- a. Inspect upper roof membrane system for overall integrity due to significant moisture entry into the membrane system.
- b. If roof membrane is viable, install aluminum flashing cap over parapet wall system to prevent water entry into roof membrane connection point to coping stone.
- c. If roof membrane system is not viable, recommend full roof replacement.
- d. Seal entire side facade accordingly.

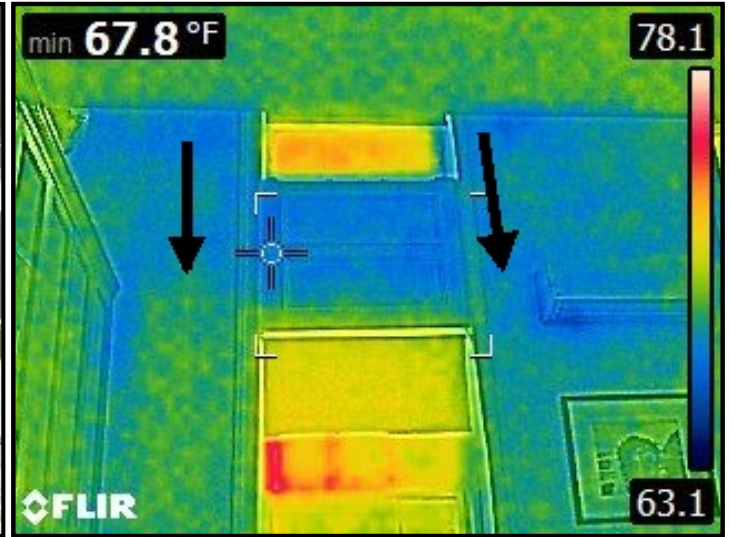
Infrared imaging of water entry into wall area.

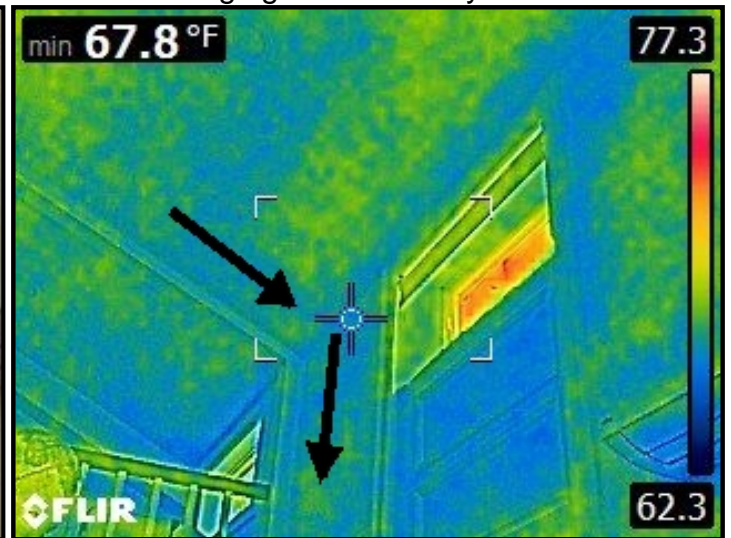
Water entry into ceiling/wall area.

Infrared imaging of water entry into ceiling/wall area.

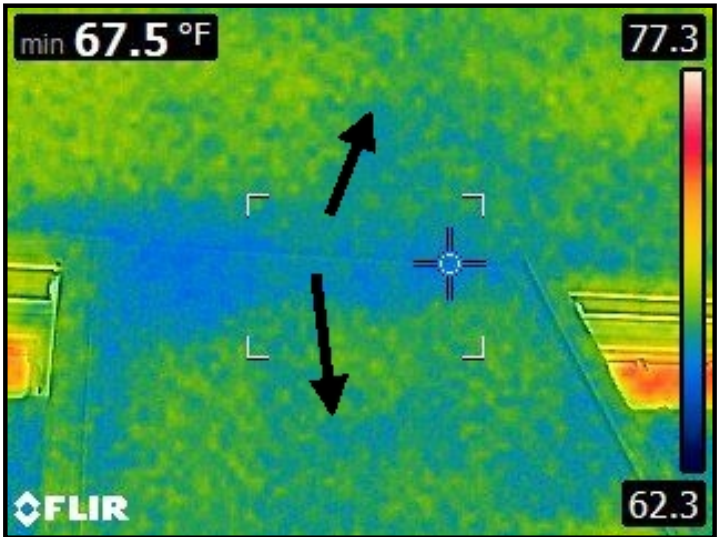
Water entry into ceiling/wall area.

Infrared imaging of water entry into ceiling/wall area.

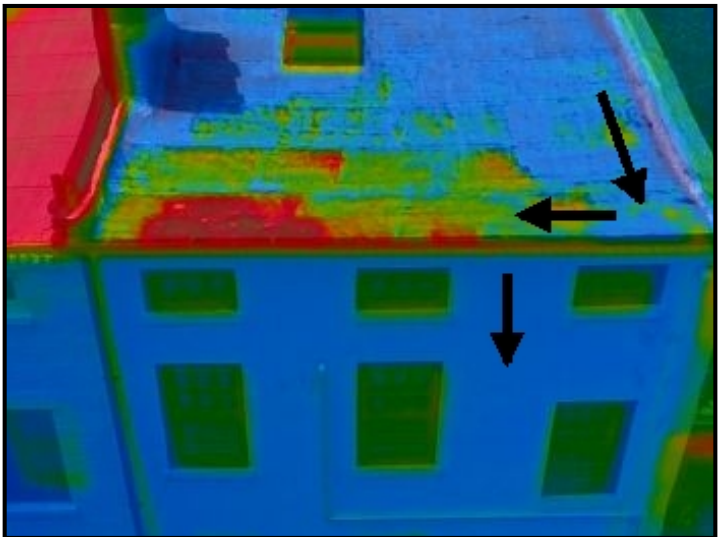
Water entering through the roof membrane system and cascading down into the rear facade.

Infrared imaging of water entering through the roof membrane system and cascading down into the rear facade.

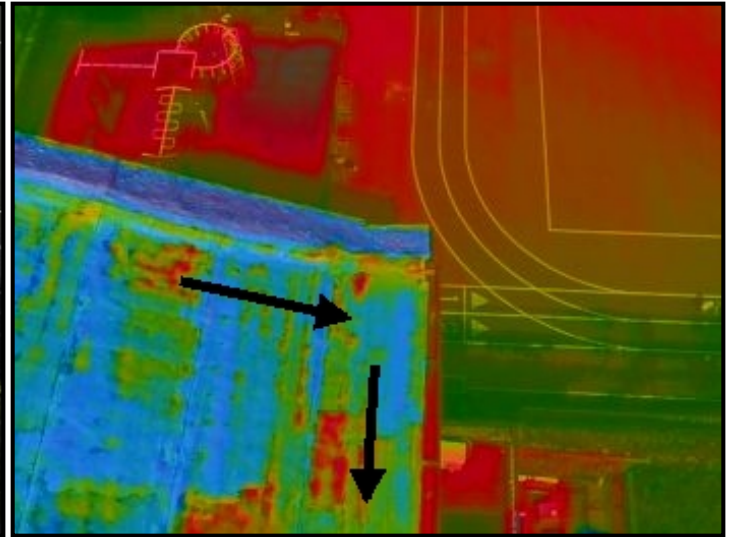
Water entering through roof membrane system connection point to the coping stone and cascading down into the rear facade.

Infrared imaging of water entering through roof membrane system connection point to the coping stone and cascading down into the rear facade.

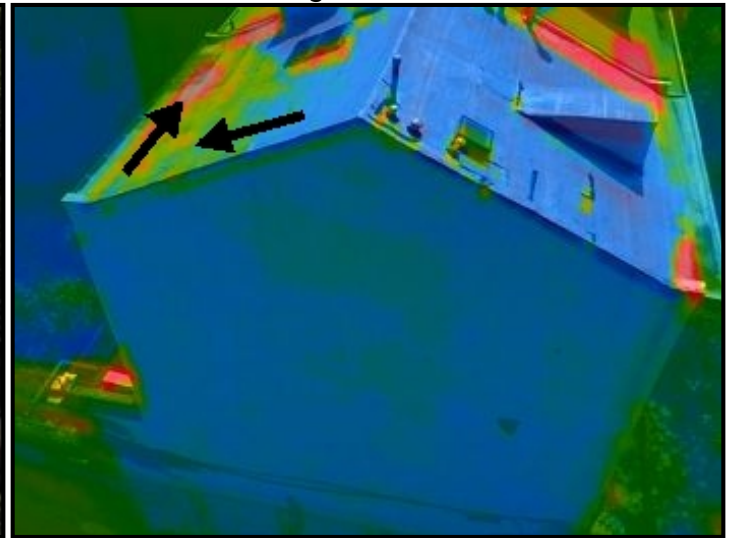
Water entering through roof membrane system connection point to the coping stone and cascading down into the rear facade.

Infrared imaging of water entering through roof membrane system connection point to the coping stone and cascading down into the rear facade.
