JP Diagnostics *Leak Detection Report*

Date of Inspection: 6/20/2022 Time: 0900 Size: Brick / Masonry

Full Building Infrared Audit (FB.IR.AUD)

2065 West 7th Street, 2nd Floor, Brooklyn, NY 11223

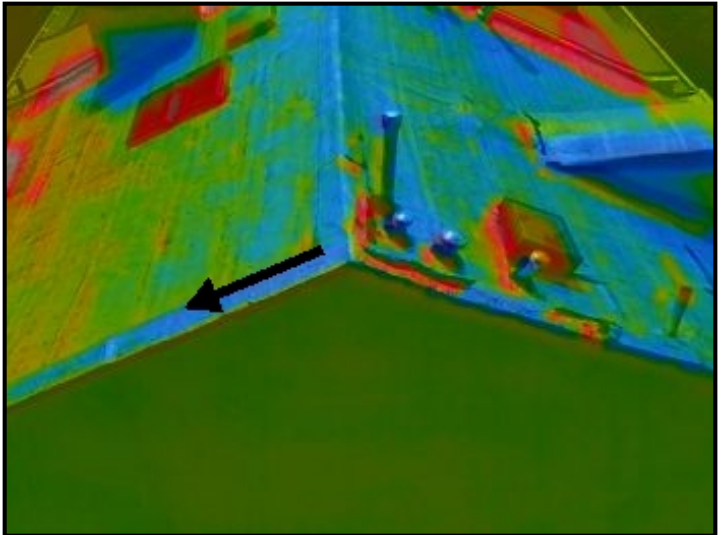
Water entering through roof membrane system connection point to the coping stone and cascading down into the rear facade.

Infrared imaging of water entering through roof membrane system connection point to the coping stone and cascading down into the rear facade.
