JP Diagnostics *Leak Detection Report*

Date of Inspection: 3/22/2022 Time: 1400 Size: Brick Commercial

Full Building Infrared Audit (FB.IR.AUD)

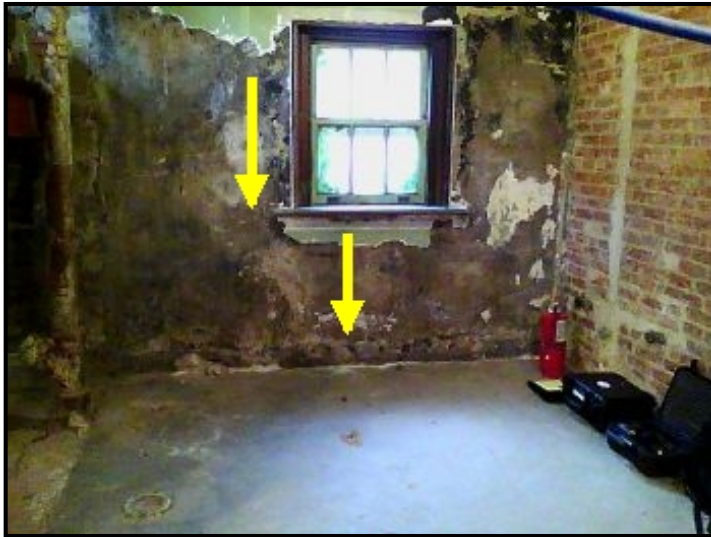
1. **Basement Wall/Window Leak#1 Source and Origin: Sidewalk/Facade Connection Point - Window Bay.** Heavy wind-driven rain water is entering through the sidewalk connection point to the facade as well as the open window port within the facade. Water is cascading down and depositing into the internal wall/window frame area below. Based on all data available, we believe there are also water leaks emanating from the window bay area below the grate, however, the metal grate interferes with the infrared imaging and cannot discern if water is, in fact entering. We recommend removal of the grate system and conducting followup scans within the window bay area.

Water entry into wall/window frame area.

- a. Install new window where plywood is installed.
- b. If window is not to be installed, close masonry structural opening as necessary.
- c. Waterproof sidewalk/facade connection point.
- d. Remove window bay grate.
- e. Conduct followup scans to confirm if window bay area is a secondary water entry point.

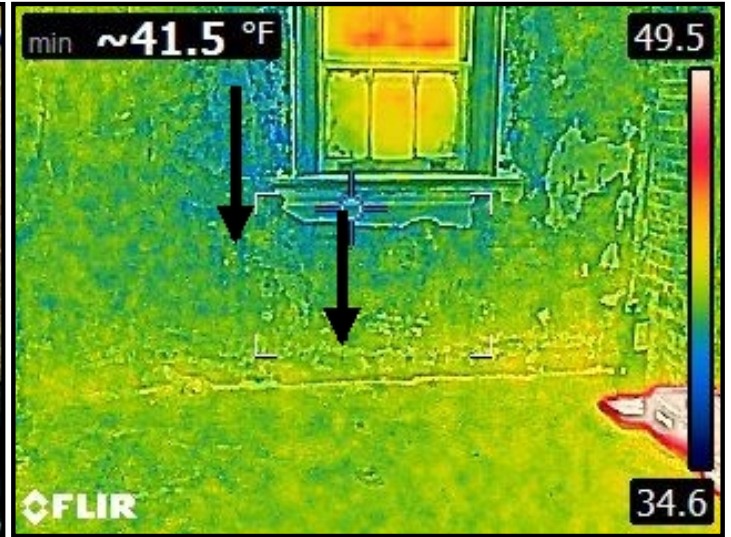
Infrared imaging of water entry into wall/window frame area.

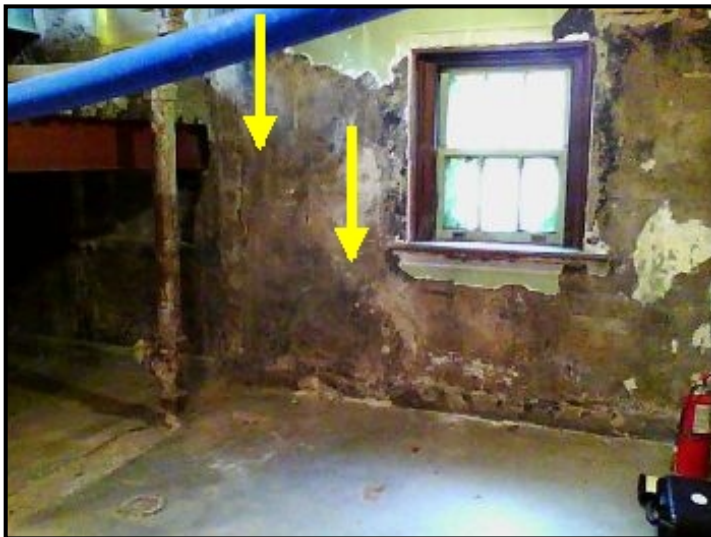
Water entry into wall/window frame area.

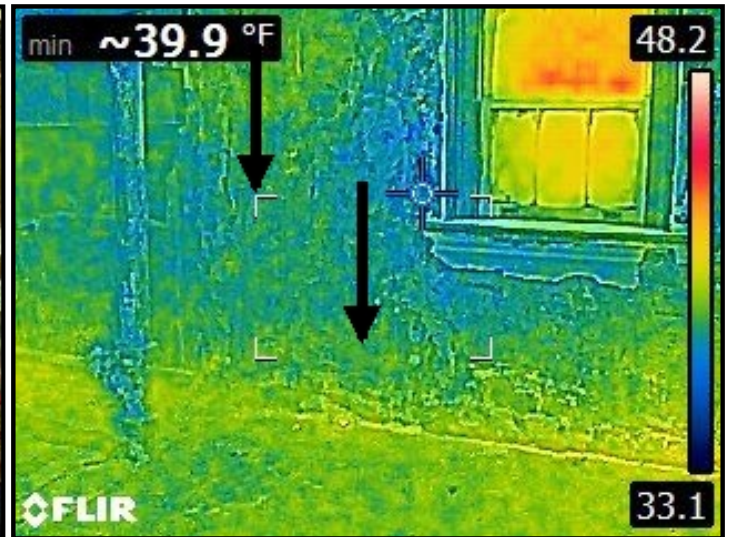
Infrared imaging of water entry into wall/window frame area.

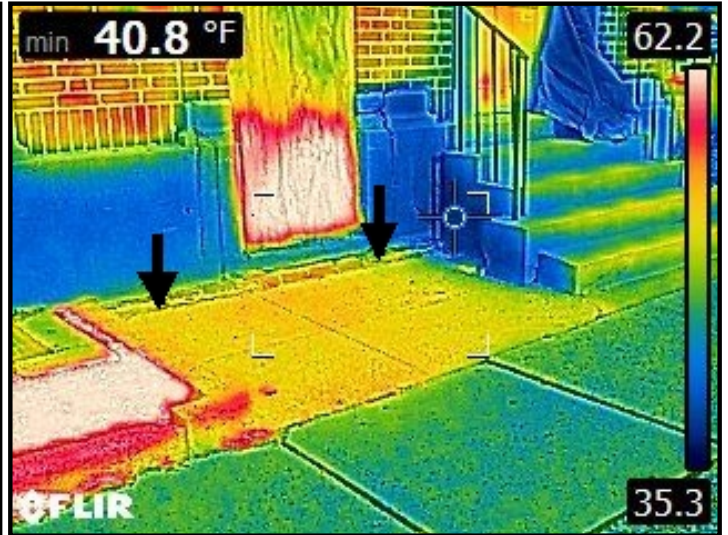
Infrared imaging of water entering through sidewalk connection point to facade and cascading down into the wall area below.

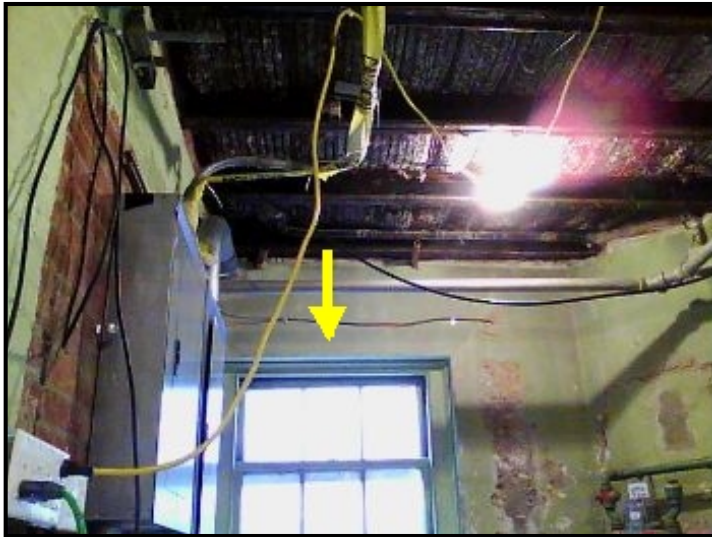
2. **Basement Wall/Window Leak#2 Source and Origin: Utility Connection Point to Brick Facade - Window Bay.** Heavy wind-driven rain water is entering through the utility connection points to the brick facade and cascading down into the internal wall/window frame area below. Based on all data available, we believe there are also water leaks emanating from the window bay area below the grate, however, the metal grate interferes with the infrared imaging and cannot discern if water is, in fact entering. We recommend removal of the grate system and conducting followup scans within the window bay area.

Water entry into wall/window frame area.

- a. Seal around utility connection points to brick facade.
- b. Seal brick facade with Silane Siloxane sx5000.
- c. Remove window bay grate.
- d. Conduct followup scans to confirm if window bay area is a secondary water entry point.

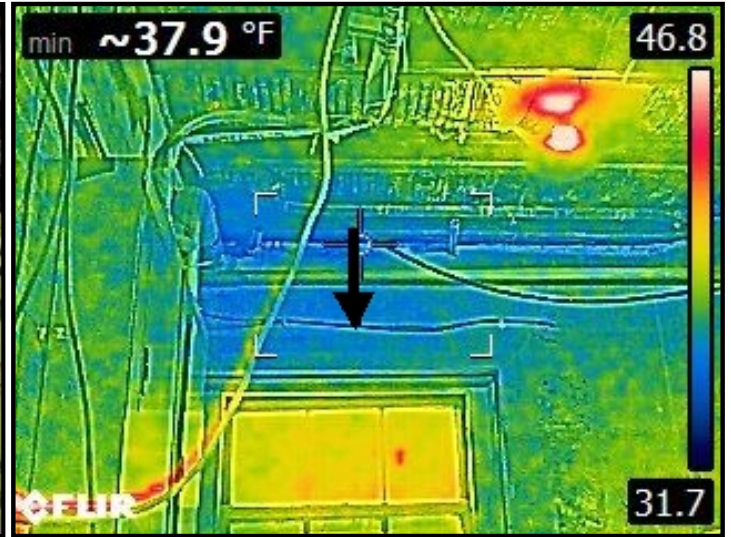
Infrared imaging of water entry into wall/window frame area.

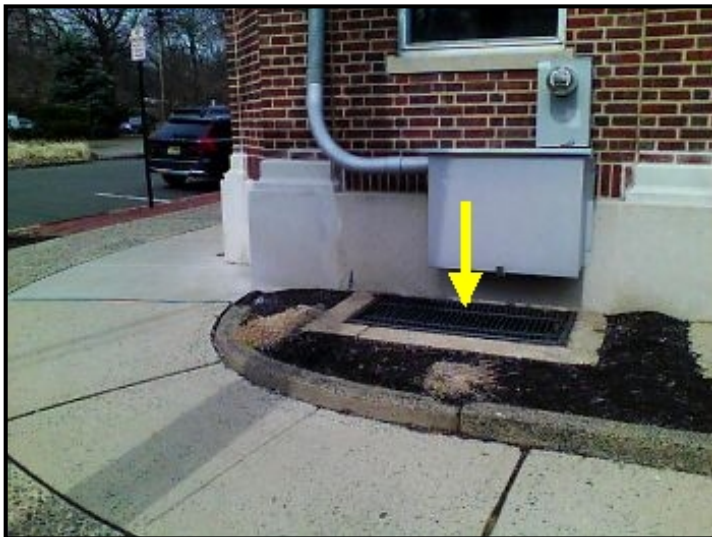
Water entering through utility connection point to brick facade and cascading down into the upper wall/window frame area below.

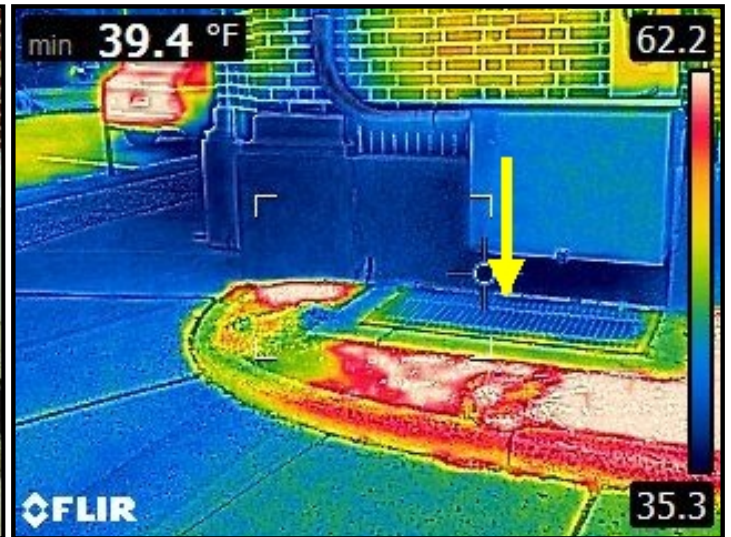
Infrared imaging of water entering through utility connection point to brick facade and cascading down into the upper wall/window frame area below.

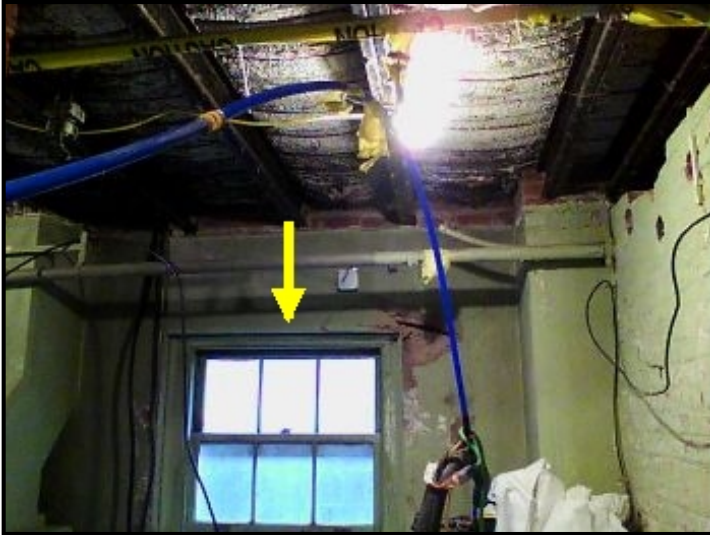
3. Basement Wall/Window Frame Leak#2 Source and Origin: Sidewalk/Facade Connection Point - Window Bay. Heavy rain water is entering through the sidewalk connection point to the facade and cascading down into the wall/window frame area below. Based on all data available, we believe there are also water leaks emanating from the window bay area below the grate, however, the metal grate interferes with the infrared imaging and cannot discern if water is, in fact entering. We recommend removal of the grate system and conducting followup scans within the window bay area.

Water entry into wall/window frame area.

- a. Excavate sidewalk area, as outlined.
- b. Waterproof area accordingly.
- c. Remove window bay grate.
- d. Conduct followup scans to confirm if window bay area is a secondary water entry point.

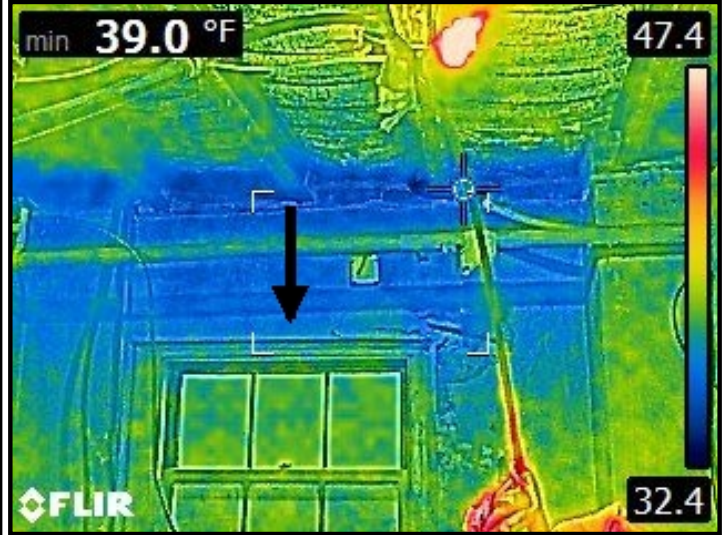
Infrared imaging of water entry into wall/window frame area.

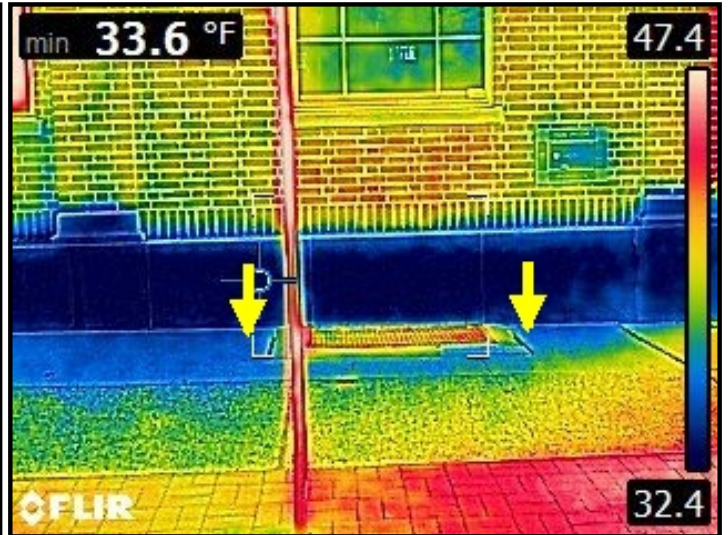
Infrared imaging of water entering through sidewalk connection point to brick facade and cascading down into the wall/window frame area below.

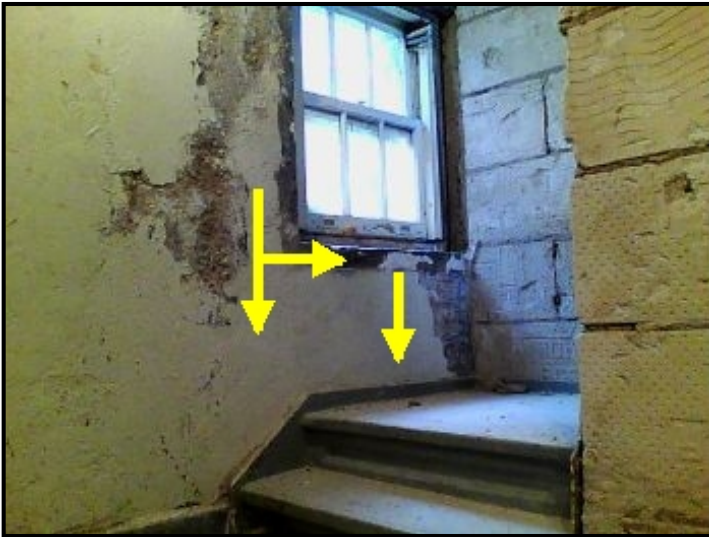
4. Basement Wall/Window Frame Leak#4 Source and Origin: Brick Facade - Window Bay. Heavy wind-driven rain water is entering through the brick facade, cascading down and depositing into the wall/window frame area below. Based on all data available, we believe there are also water leaks emanating from the window bay area below the grate, however, the metal grate interferes with the infrared imaging and cannot discern if water is, in fact entering. We recommend removal of the grate system and conducting followup scans within the window bay area.

Water entry into wall/window frame area.

- a. Seal brick facade with Silane Siloxane sx5000.
- b. Remove window bay grate.
- c. Conduct followup scans to confirm if window bay area is a secondary water entry point.

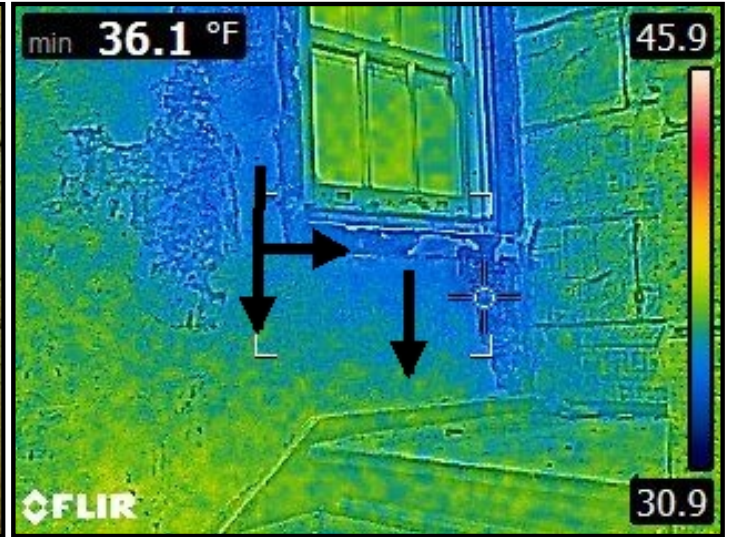
Infrared imaging of water entry into wall/window frame area.

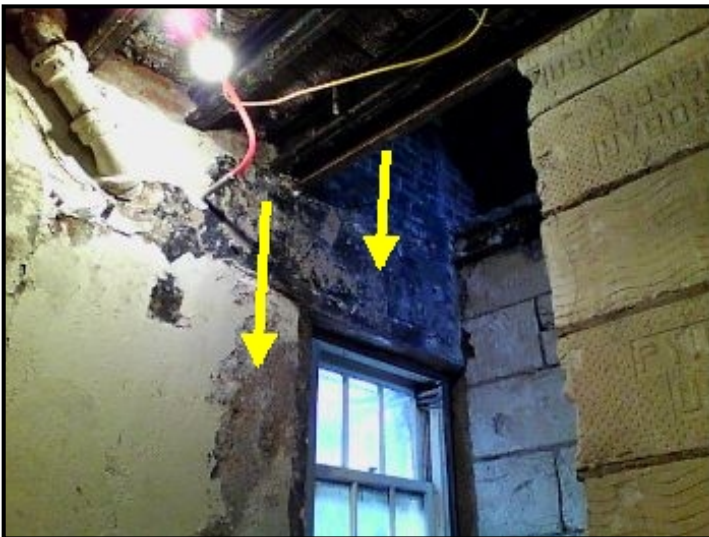
Water entry into wall/window frame area.

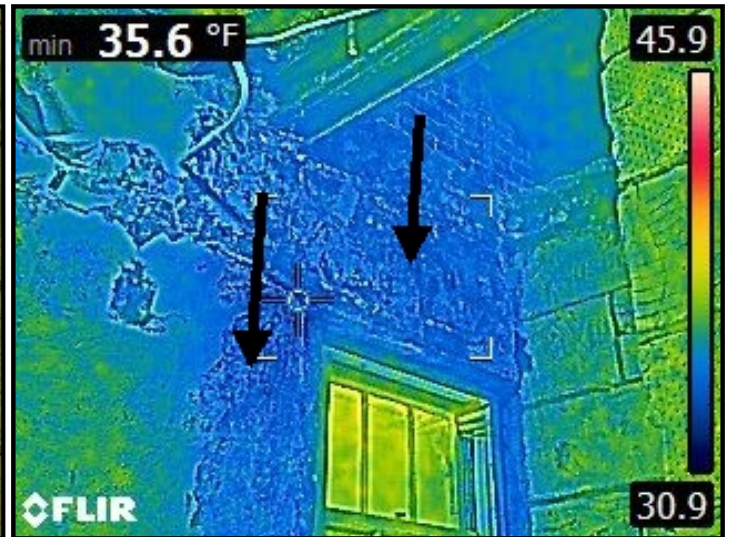
Infrared imaging of water entry into wall/window frame area.

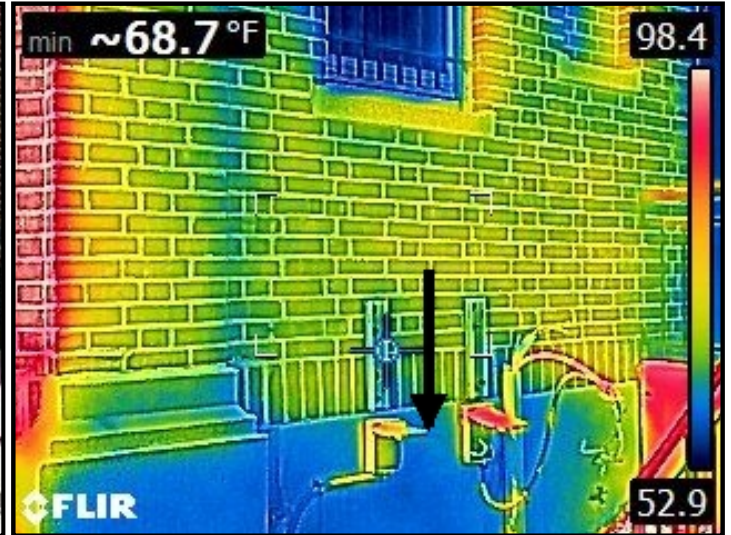
Infrared imaging of water entering through brick facade and cascading down into wall/window frame area below.

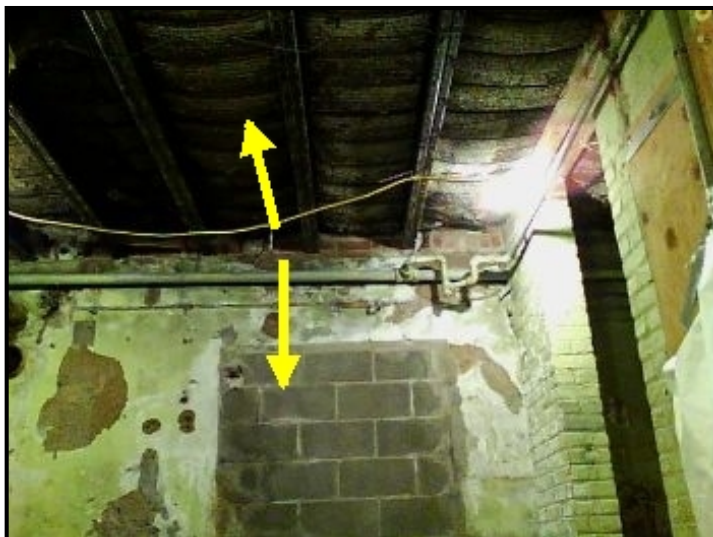
5. Basement Wall Leak#5 Source and Origin: Brick Facade. Heavy wind-driven rain water is entering through the upper brick facade, cascading down and depositing into the internal wall area below. Water entry is minor and, at this time, the area is not actively dripping. It appears the water entering is seeping into the masonry wall and not yet causing damage to the surrounding area. It is unclear whether the subterranean foundation wall area is a concern as the moisture signature tracked to the upper facade. However, after the brick system is sealed, we recommend monitoring the internal area for possible foundation leaks.

Water entry into wall area.

- a. Seal brick facade with Silane Siloxane sx5000 to prevent further water entry.
- b. Monitor internal area for further water entry.

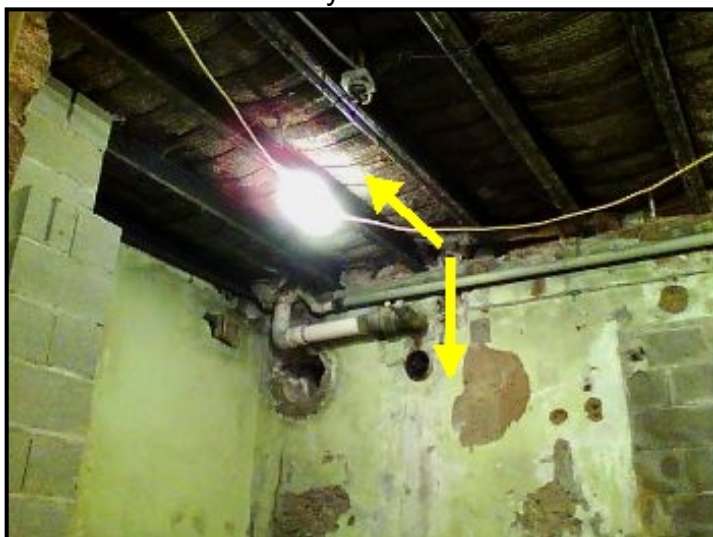
Water entry into wall area.

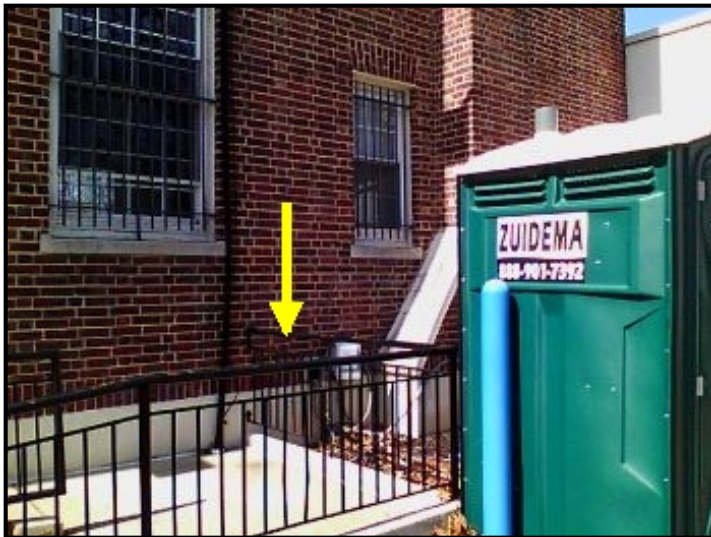
Water entering through brick facade and cascading down into the wall area below.

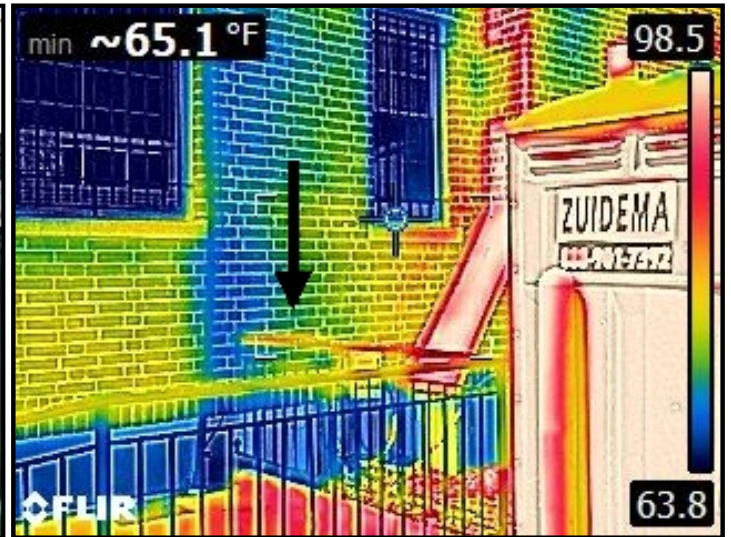
Infrared imaging of water entering through brick facade and cascading down into the wall area below.

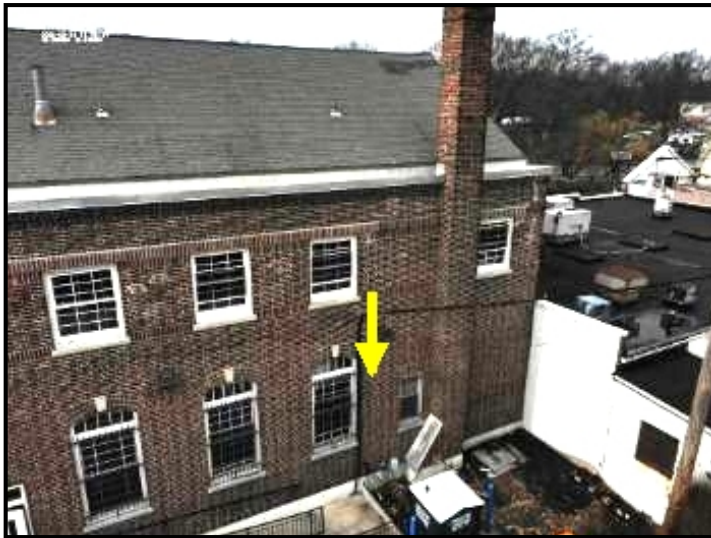
Water entering through brick facade and cascading down into the wall area below.

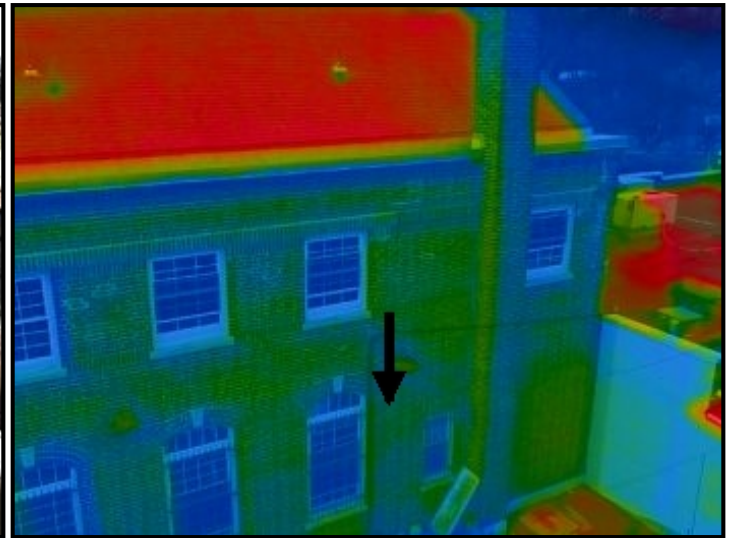
Infrared imaging of water entering through brick facade and cascading down into the wall area below.

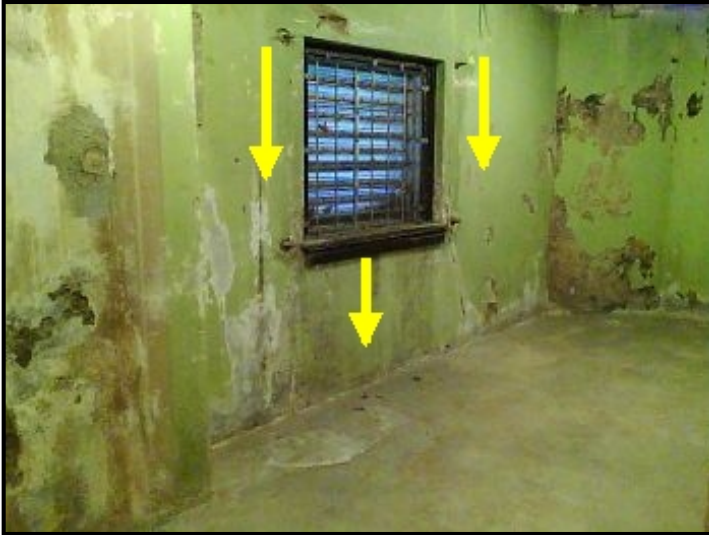
6. Basement Wall/Window Leak#6 Source and Origin: Sidewalk/Facade Connection Point - Window Bay. Heavy rain water is entering through the sidewalk connection point to the facade and cascading down into the wall/window frame area below. Based on all data available, we believe there are also water leaks emanating from the window bay area below the grate, however, the metal

Water entry into wall/window frame area.

- a. Excavate sidewalk area, as outlined.
- b. Waterproof area accordingly.
- c. Remove window bay grate.
- d. Conduct followup scans to confirm if window bay area is a secondary water entry point.

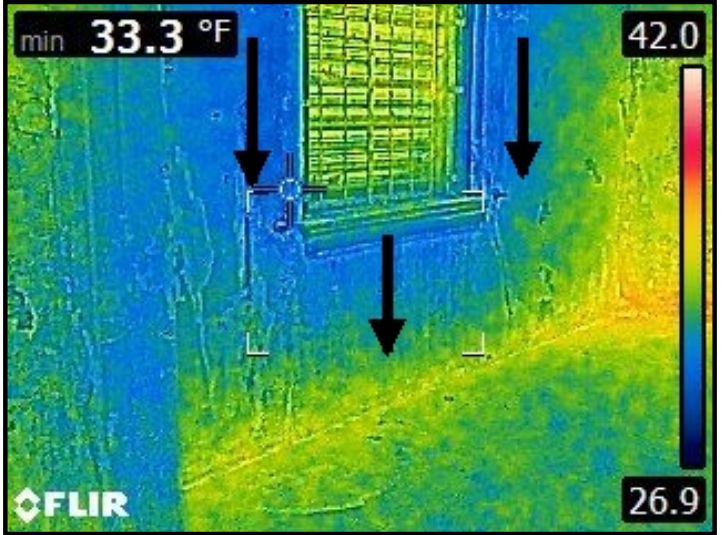
Infrared imaging of water entry into wall/window frame area.

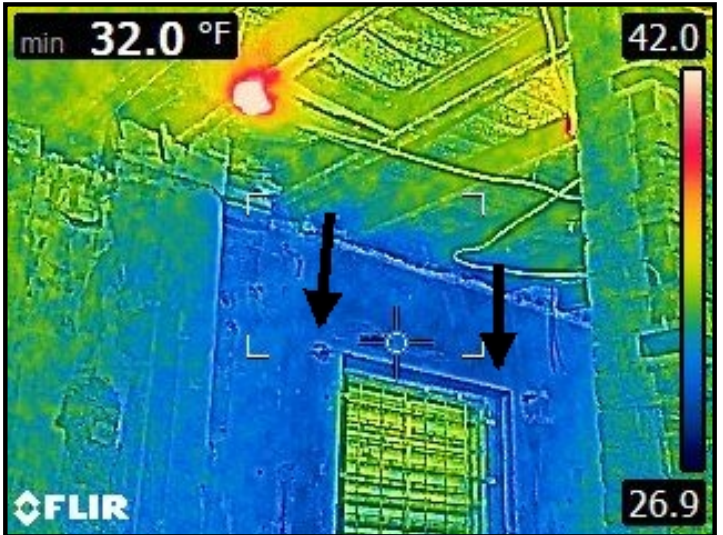
Infrared imaging of water entry into wall/window frame area.

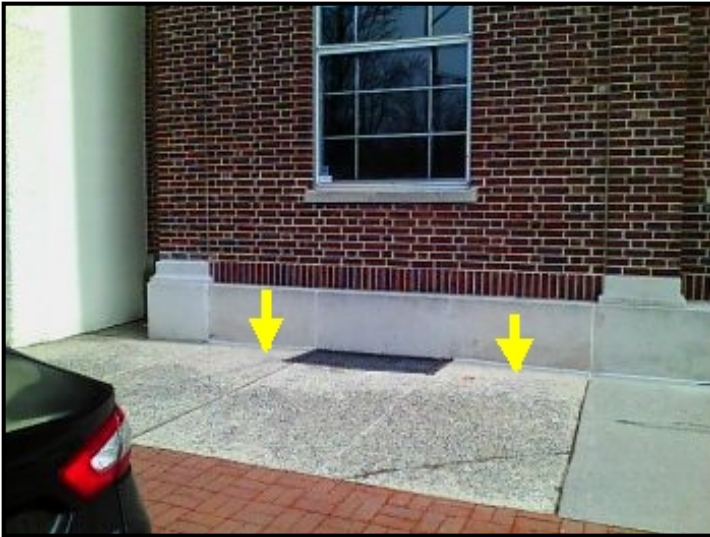
Water entering through sidewalk/brick facade connection point and cascading down into the wall/window frame area below.

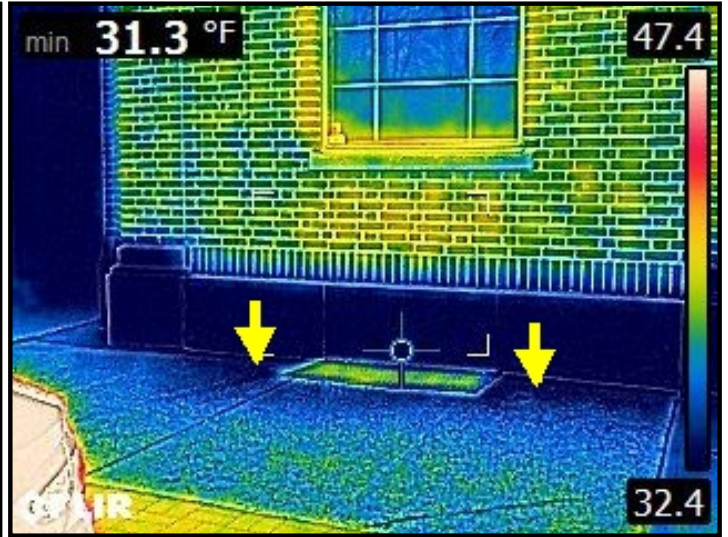
Infrared imaging of water entering through sidewalk/brick facade connection point and cascading down into the wall/window frame area below.

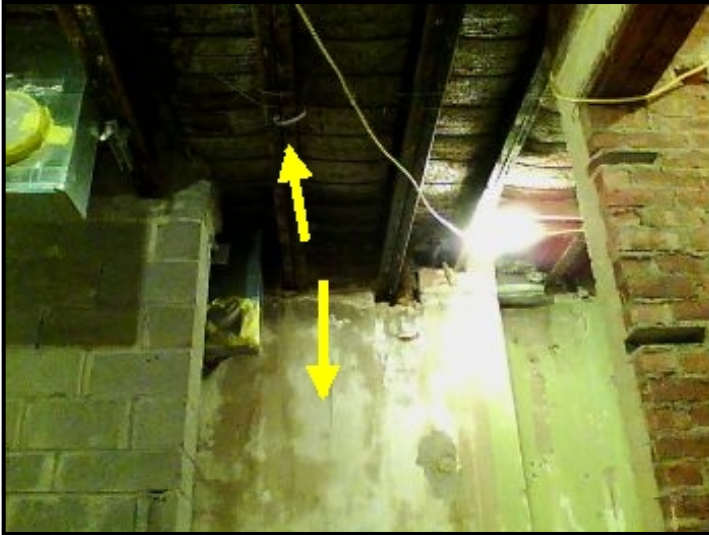
7. Basement Wall/Ceiling Leak#7 Source and Origin: Front Access Stairs/Stoop. Heavy rain water is entering through the front stairs/stoop area, specifically through the degraded tile grout joints, cascading down and depositing into the ceiling/wall area below. Water entry is widespread and severe, entering throughout the entire stoop structure all the way to its connection point to the front access door baseplate. All tile covering the stoop must be removed and the structure properly waterproofed.

Water entry into wall/ceiling area.

- a. Excavate all tile from front stairs/stoop structure.
- b. Waterproof area accordingly.
- c. Replace tile as necessary.

NOTE: Pay special attention to properly waterproofing/flashing stoop surface to front access door baseplate. Door frame may need to be removed entirely in order for this to be done properly.

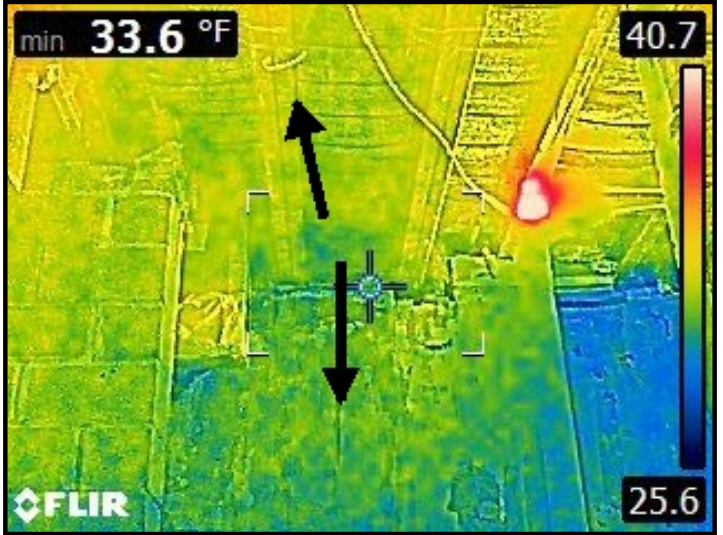
Infrared imaging of water entry into wall/ceiling area.

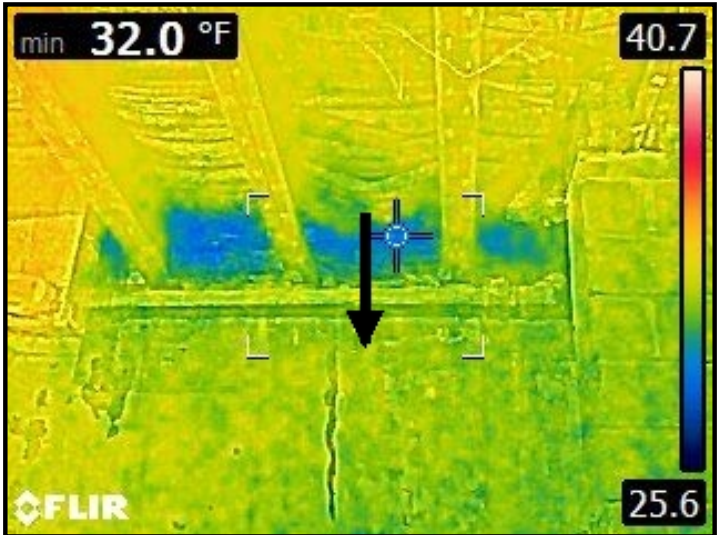
Infrared imaging of water entry into wall/ceiling area.

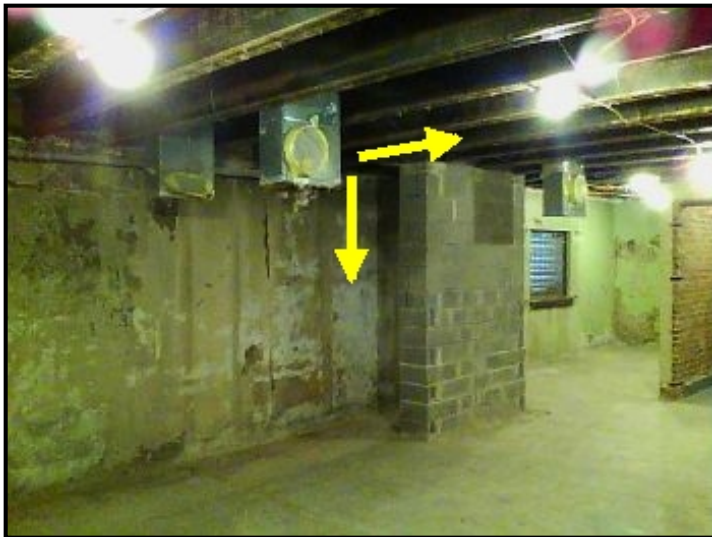
Water entry into wall/ceiling area.

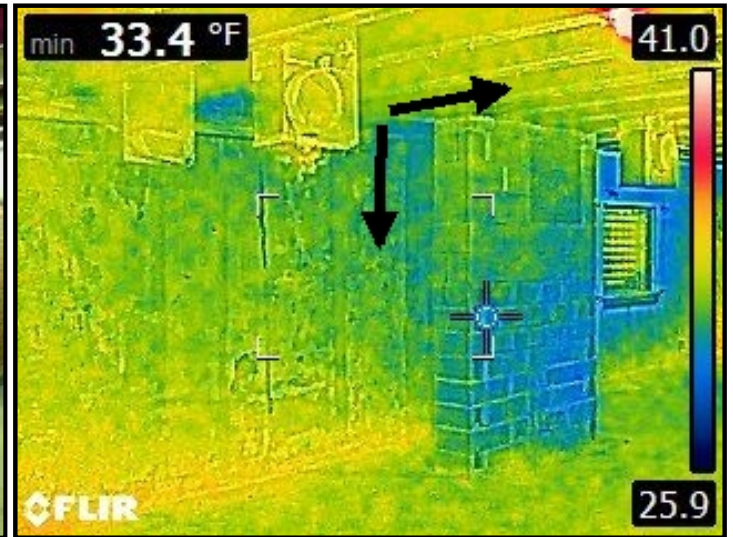
Infrared imaging of water entry into wall/ceiling area.

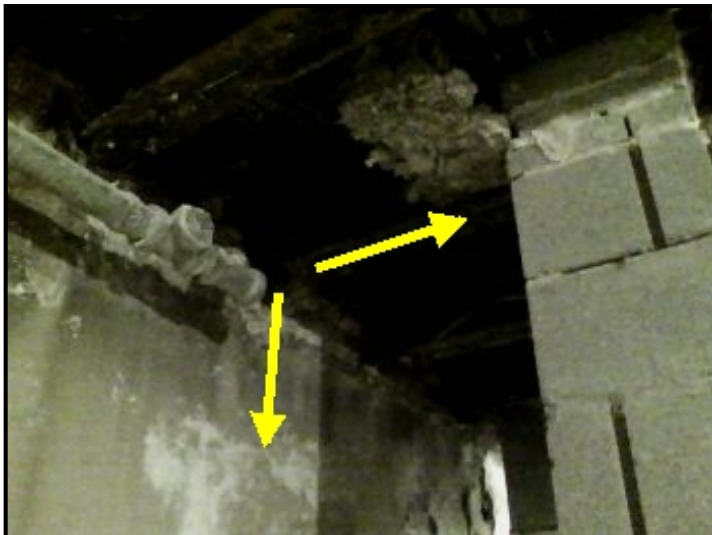
Water entry into wall/ceiling area.

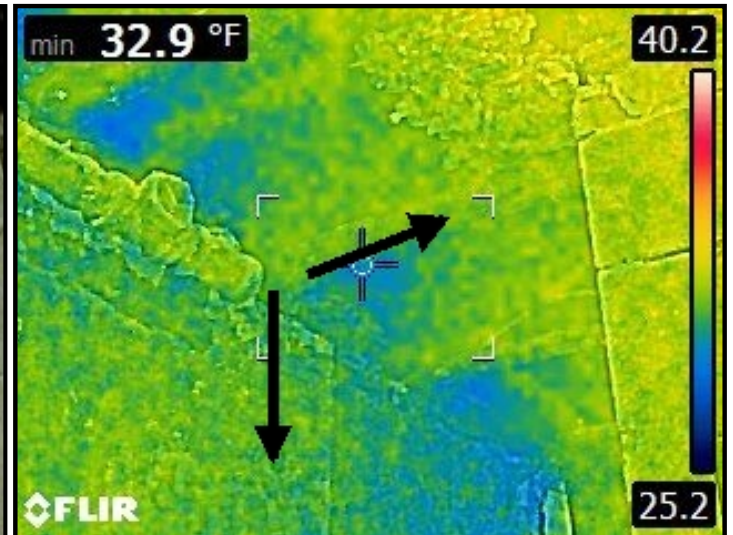
Infrared imaging of water entry into wall/ceiling area.

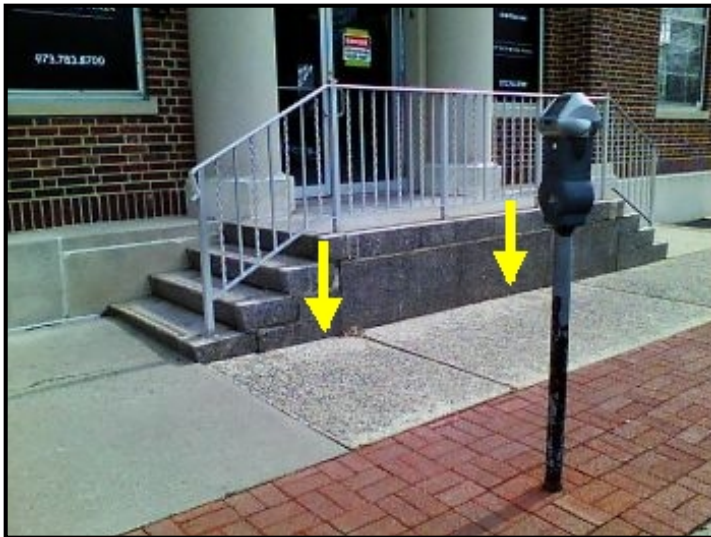
Widespread and severe water entry through the front access stairs/stoop and cascading down into the ceiling/wall area below.

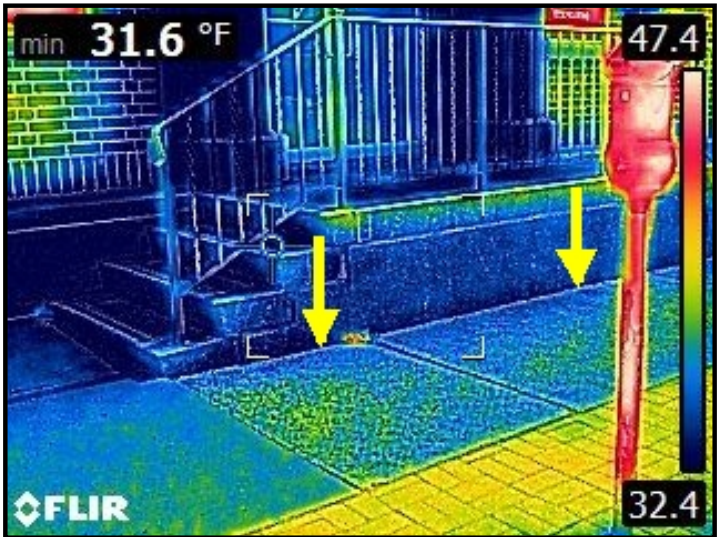
Infrared imaging of widespread and severe water entry through the front access stairs/stoop and cascading down into the ceiling/wall area below.

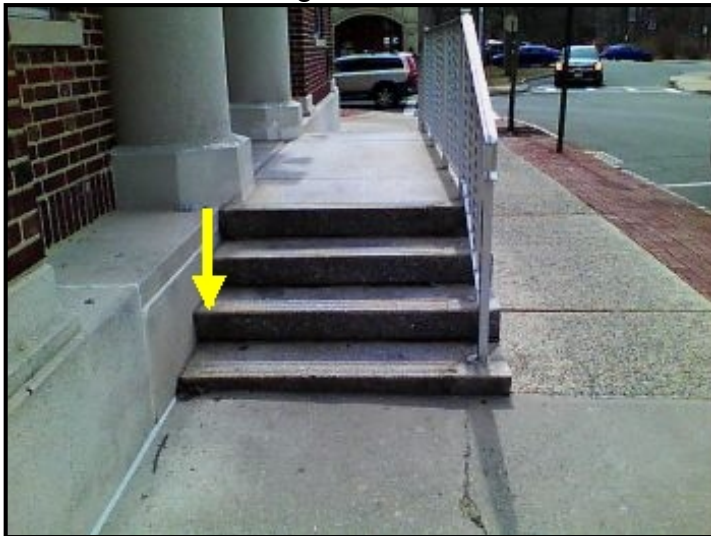
Widespread and severe water entry through the front access stairs/stoop and cascading down into the ceiling/wall area below.

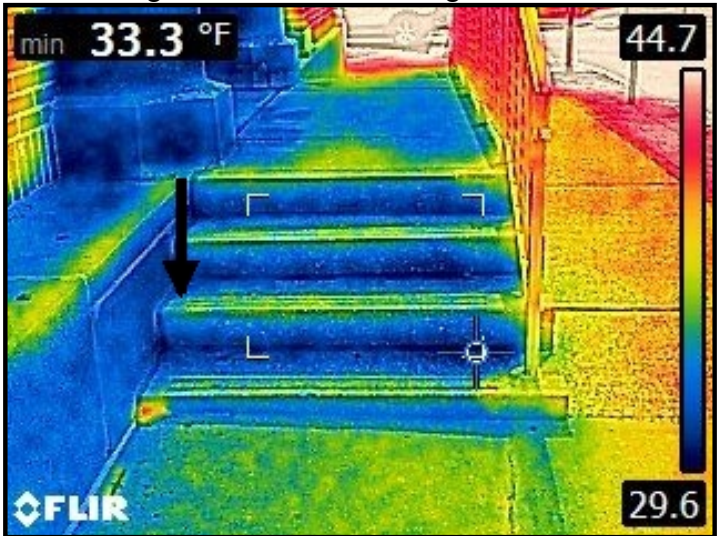
Infrared imaging of widespread and severe water entry through the front access stairs/stoop and cascading down into the ceiling/wall area below.

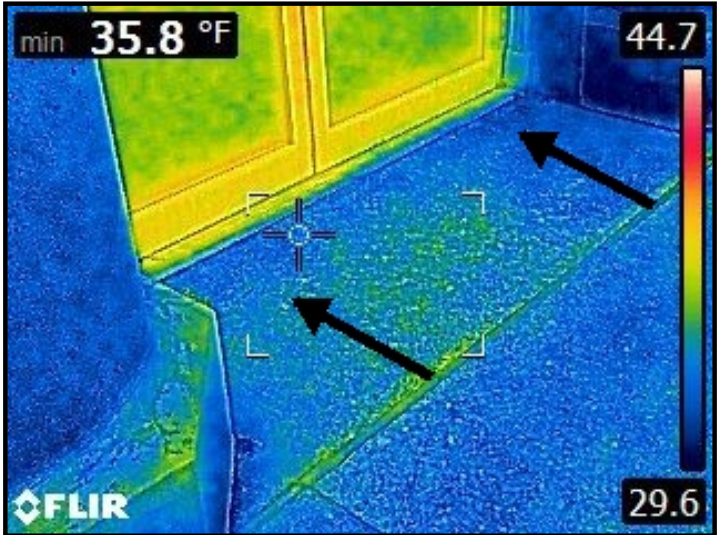
Infrared imaging of widespread and severe water entry through the front access stairs/stoop and cascading down into the ceiling/wall area below.

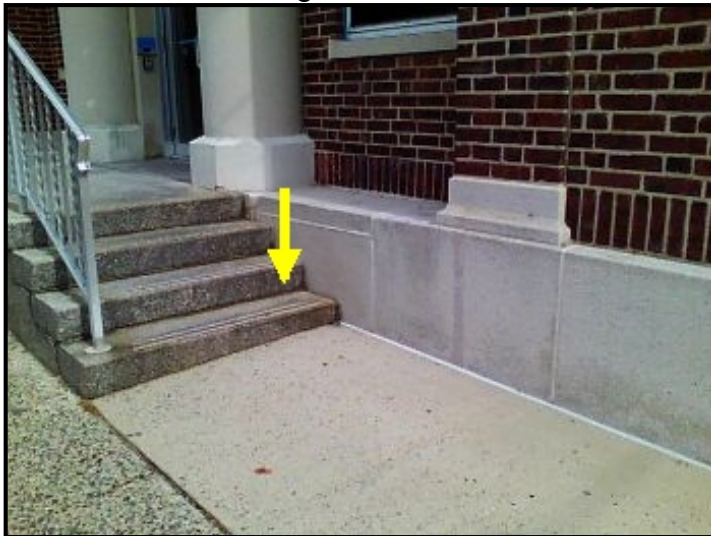
Widespread and severe water entry through the front access stairs/stoop and cascading down into the ceiling/wall area below.

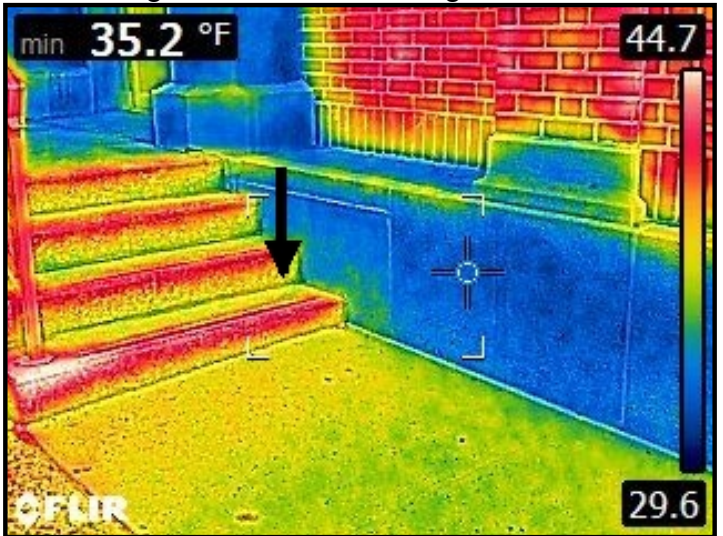
Infrared imaging of widespread and severe water entry through the front access stairs/stoop and cascading down into the ceiling/wall area below.

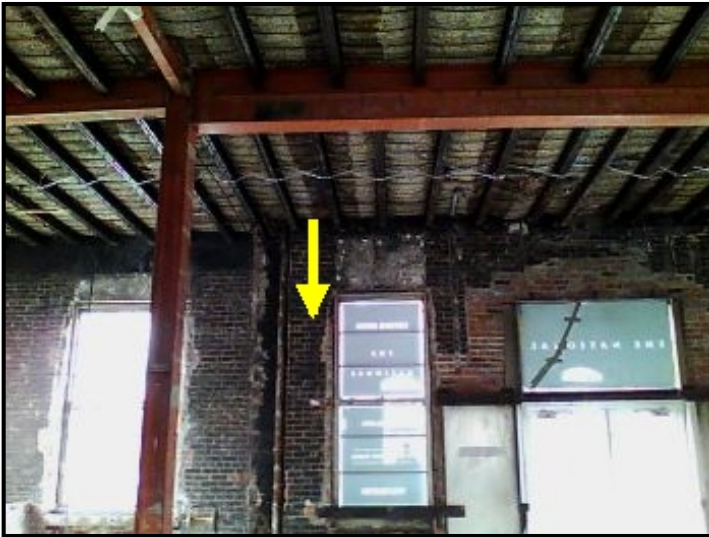
8. First Floor Upper Wall Leak Source and Origin: Upper Brick Facade Behind Front Pillar - Further Testing Required. Heavy wind-driven rain water is entering through the front brick facade, cascading down and depositing into the internal wall area below. Water entry is minor and is not yet causing active dripping within the area.

Water entry into upper wall area.

- a. Conduct followup scans to confirm findings.
- b. Waterproof brick facade with Silane Siloxane sx5000.
- c. Monitor internal area for further water entry.

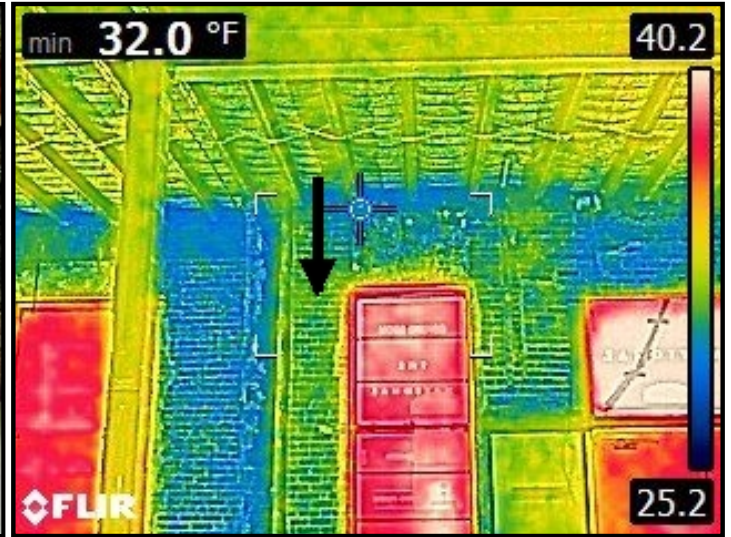
Infrared imaging of water entry into upper wall area.

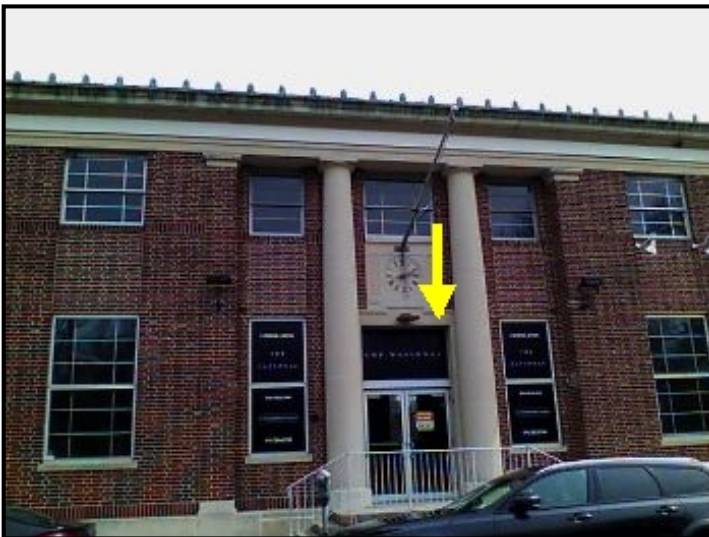
Water entering through upper brick facade behind pillar and cascading down into the internal wall area below.

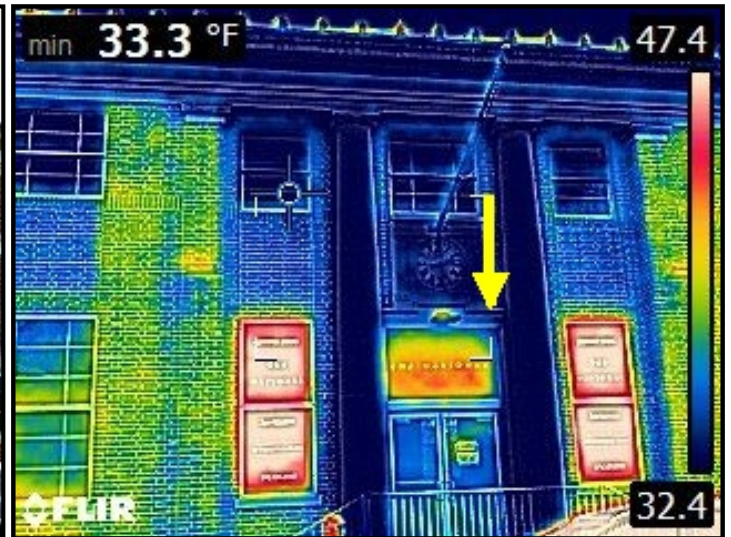
Infrared imaging of water entering through upper brick facade behind pillar and cascading down into the internal wall area below.

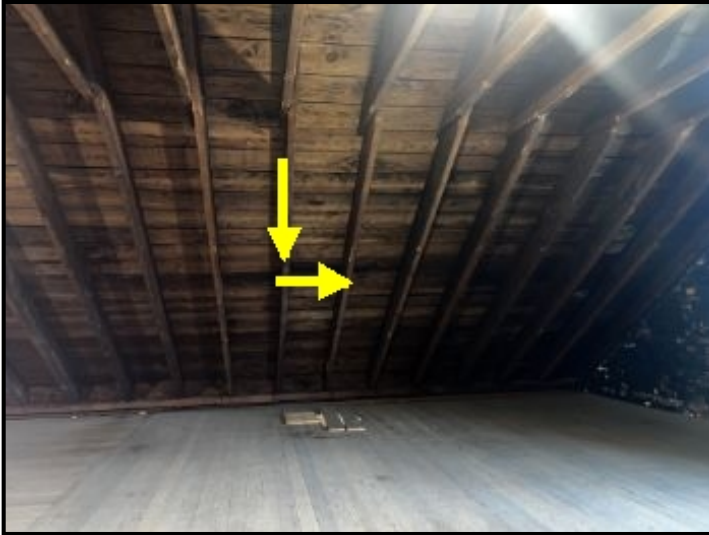
9. Attic Ceiling Leak#1 Source and Origin: Roof Shingle System. Heavy rain water is entering through the roof shingles at roof peak, cascading down and depositing into the roof substrate/attic ceiling area. The exact cause of water entry is not well understood. Accordingly to high definition drone photography there does not appear to be defects within the roof shingles, however, infrared analysis indicates water entry within the area. We recommend inspecting the roof shingles, especially at roof peak area, and repairing/replacing accordingly.

Water entry into attic ceiling.

- a. Inspect roof shingles especially at roof peak.
- b. Repair/replace accordingly.

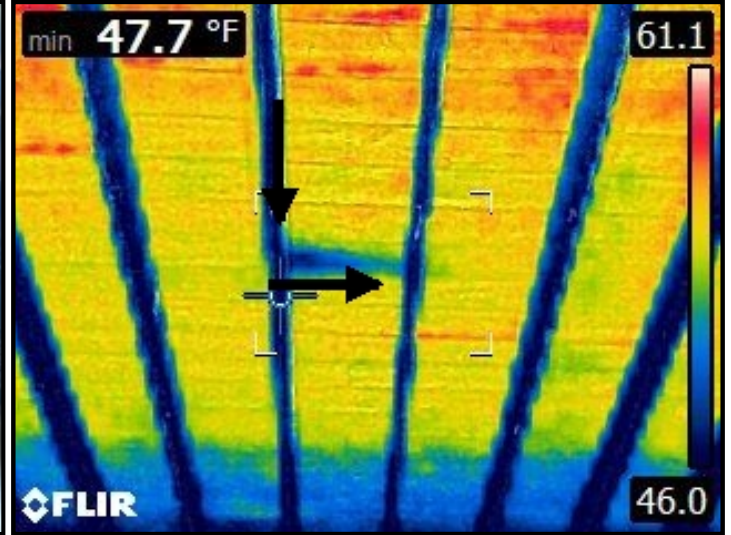
Infrared imaging of water entry into attic ceiling.

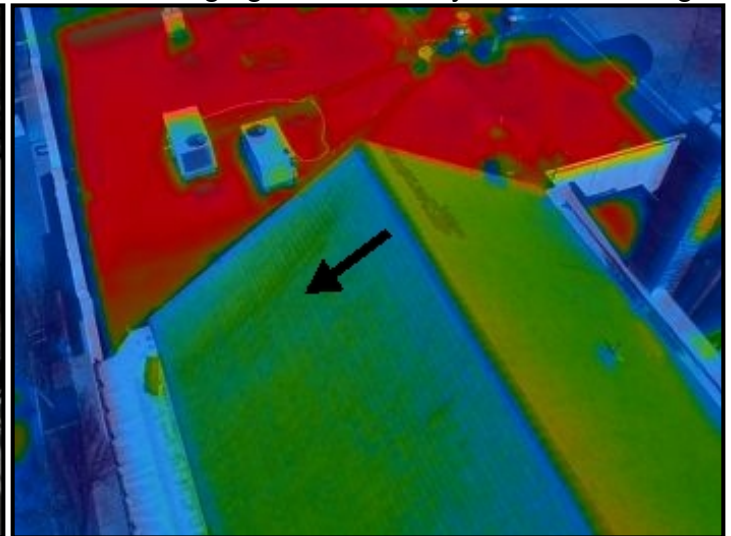
Infrared imaging of water entering through roof peak shingles and cascading down into the attic ceiling area below.

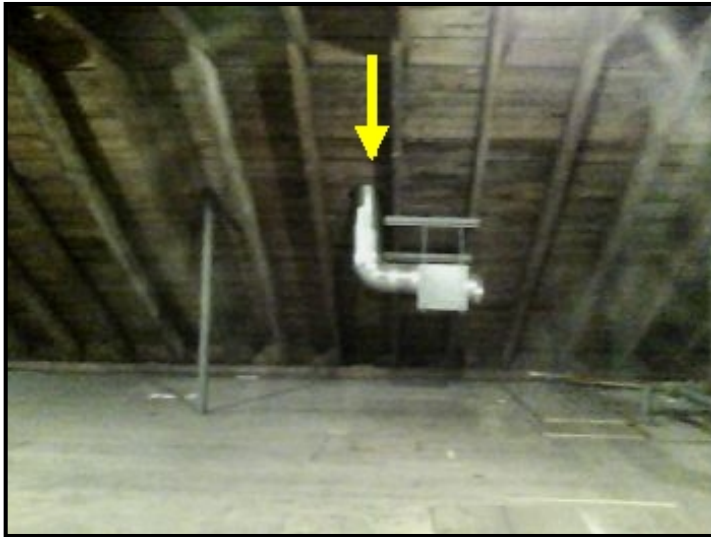
10. Attic Ceiling Leak#2 Source and Origin: Roof Shingle System. Heavy rain water is entering through the roof shingle system, specifically around two displaced roof shingles, as shown in the following images. Water is entering through the roof shingle system, cascading down and depositing into the roof substrate around the vent system entry point.

Water entry into attic ceiling around vent line.

- a. Inspect roof shingle system.
- b. Replace displaced roof shingles.
- c. Inspect around vent line entry point into shingle system and waterproof area as necessary.

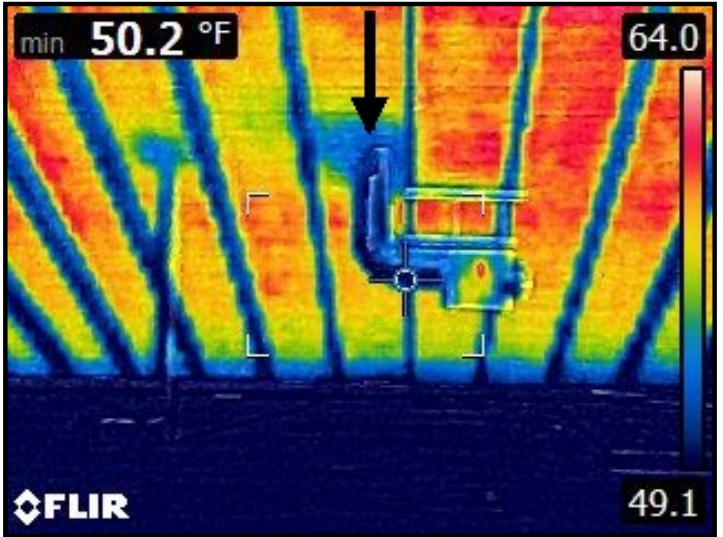
Infrared imaging of water entry into attic ceiling around vent line.
