JP Diagnostics *Leak Detection Report*

Date of Inspection: 3/22/2022 Time: 1400 Size: Brick Commercial

Full Building Infrared Audit (FB.IR.AUD)

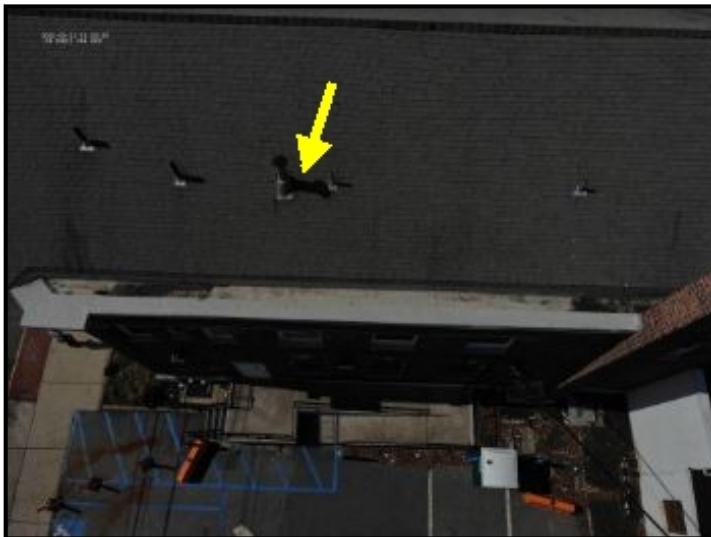
Water entering through shingle roof system, cascading down and depositing around the roof vent/internal ceiling area below.

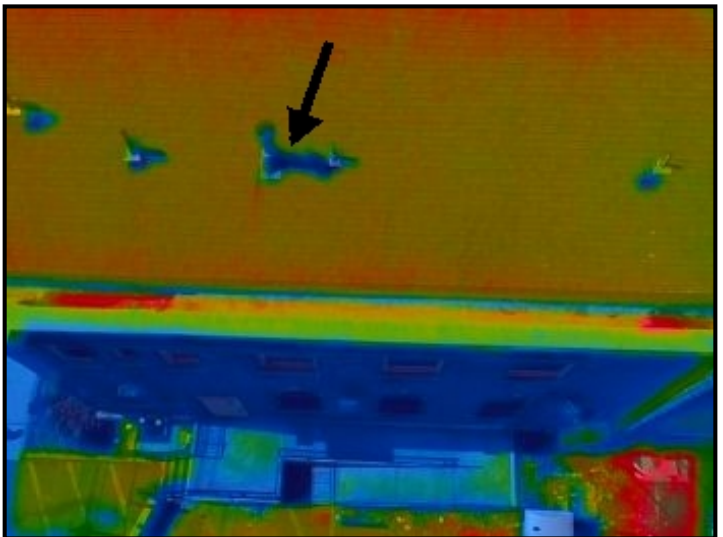
Infrared imaging of water entering through shingle roof system, cascading down and depositing around the roof vent/internal ceiling area below. (Limited Infrared Data)
