JP Diagnostics Leak Detection Report

Inspection prepared for: .

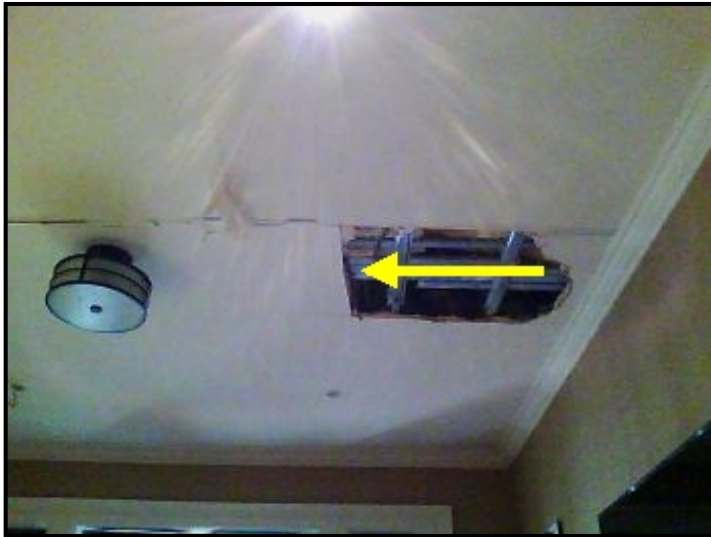
Water entry into ceiling area.

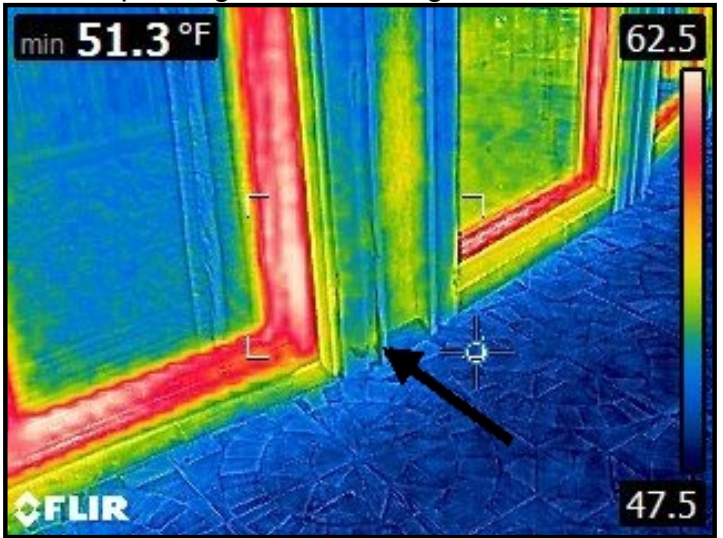
Infrared imaging of water entering through terrace tile and door baseplate, cascading down and depositing into the ceiling areas below.

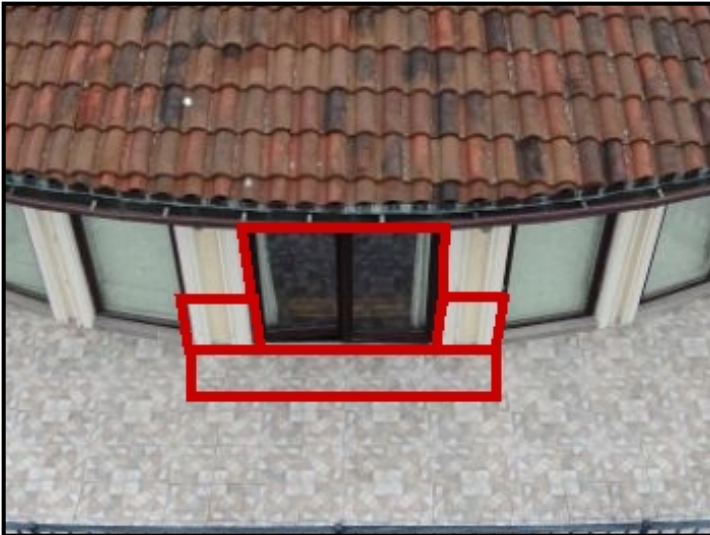
Repair Point: Excavate tile around door baseplate and EIFS facade. Remove door frame entirely. Waterproof and flash area accordingly.

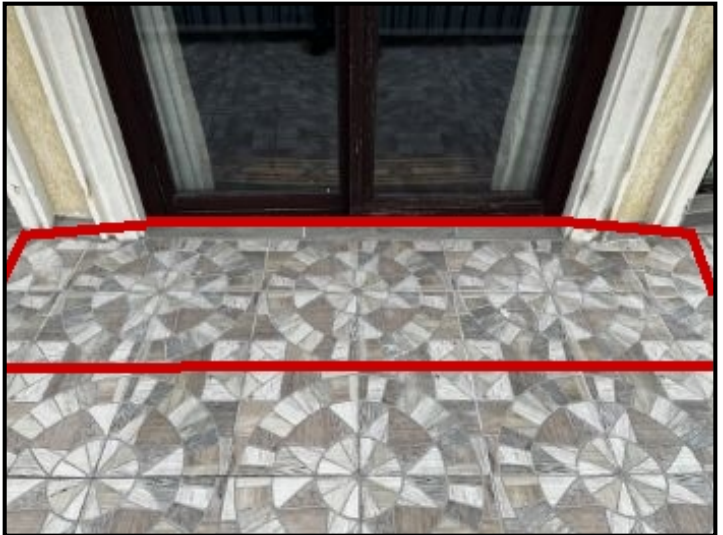
Repair Point: Excavate tile around door baseplate and EIFS facade. Remove door frame entirely. Waterproof and flash area accordingly.

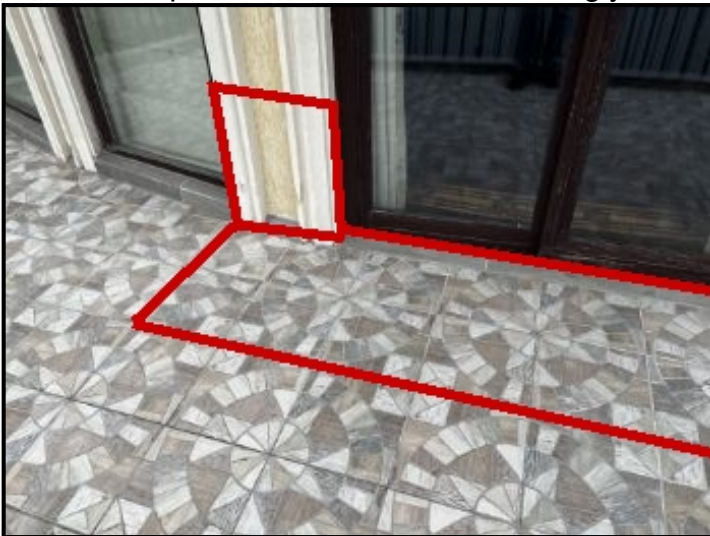
Repair Point: Excavate tile around door baseplate and EIFS facade. Remove door frame entirely. Waterproof and flash area accordingly.

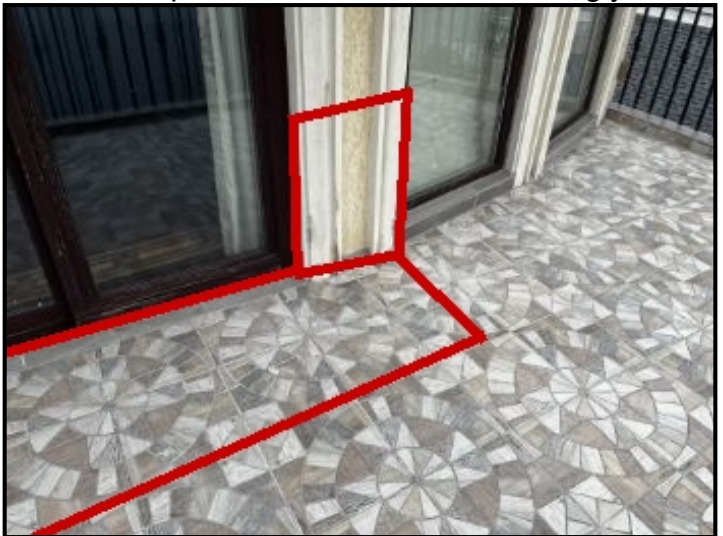
Repair Point: Excavate tile around door baseplate and EIFS facade. Remove door frame entirely. Waterproof and flash area accordingly.

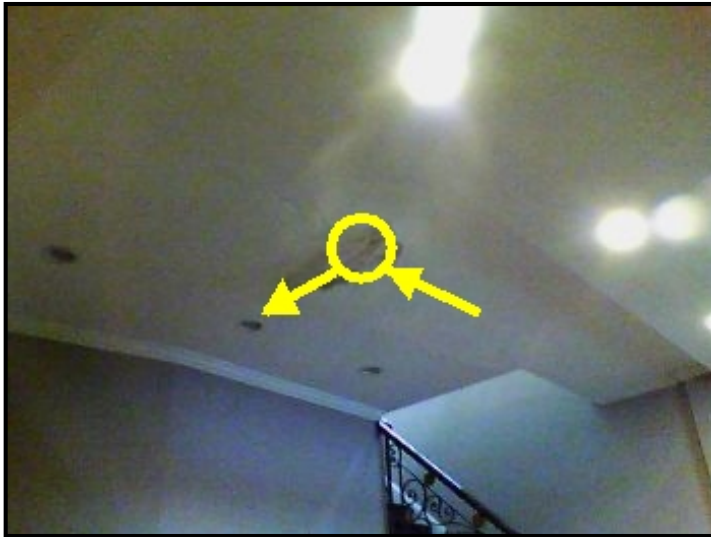
Water entry into ceiling area.

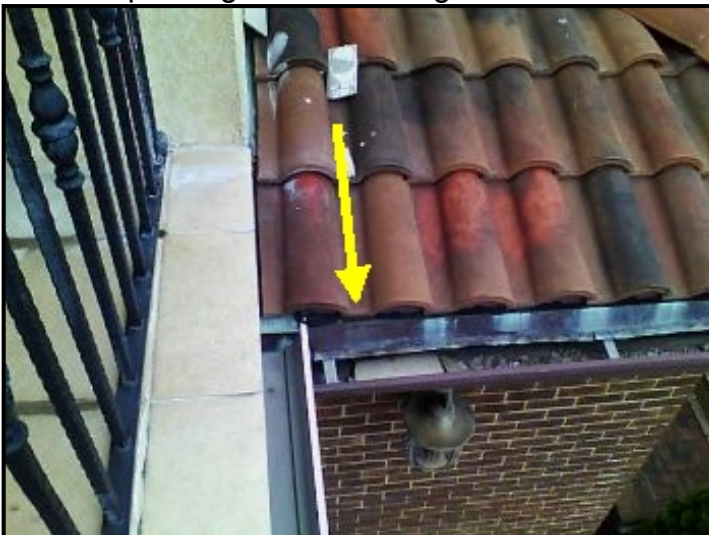
Water entering through broken spanish roof tile, cascading down and depositing into the brick facade eventually entering into the ceiling area below.

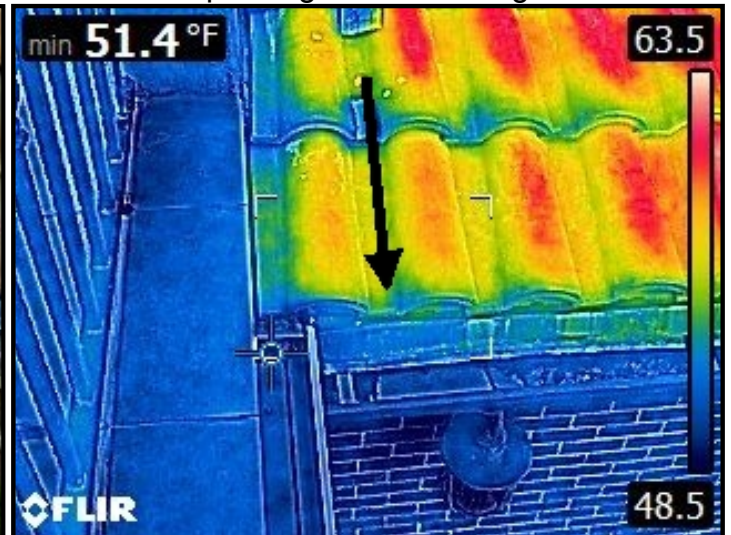
Infrared imaging of water entering through broken spanish roof tile, cascading down and depositing into the brick facade eventually entering into the ceiling area below.

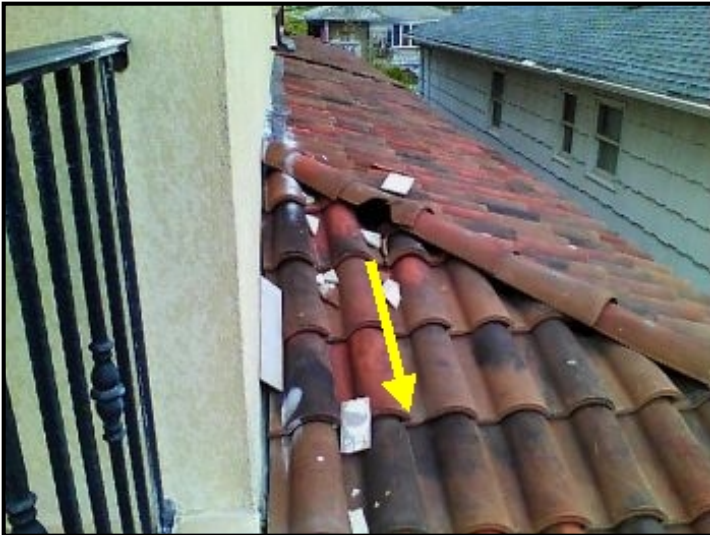
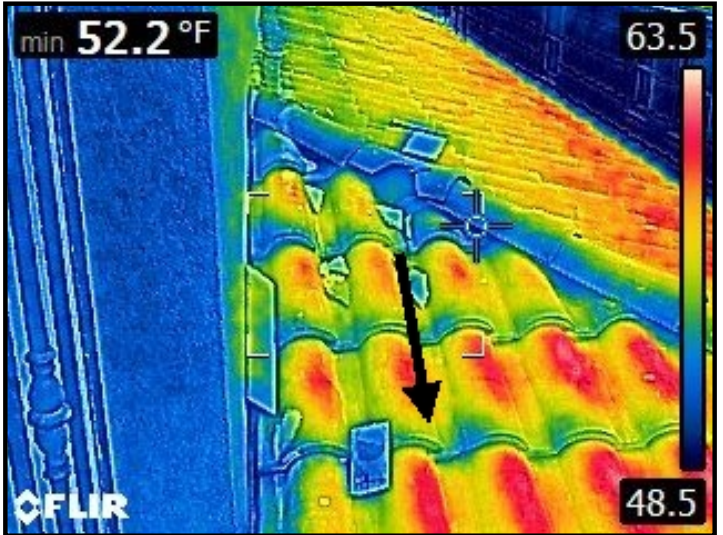
Water entering through broken spanish roof tile, cascading down and depositing into the brick facade eventually entering into the ceiling area below.

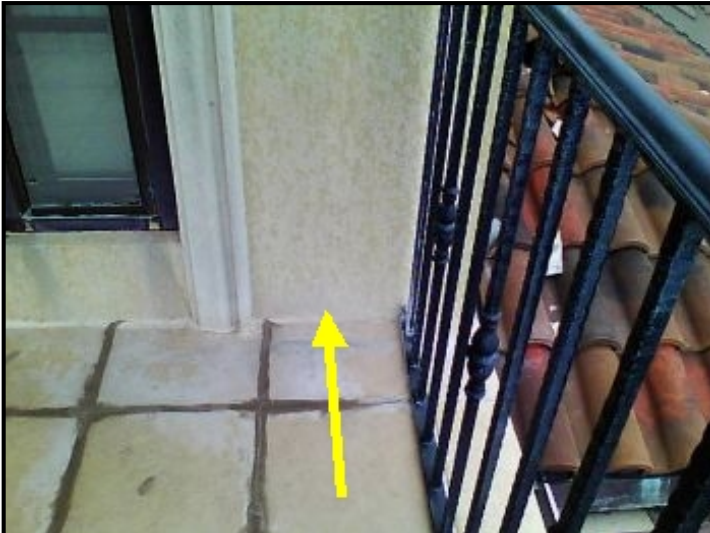
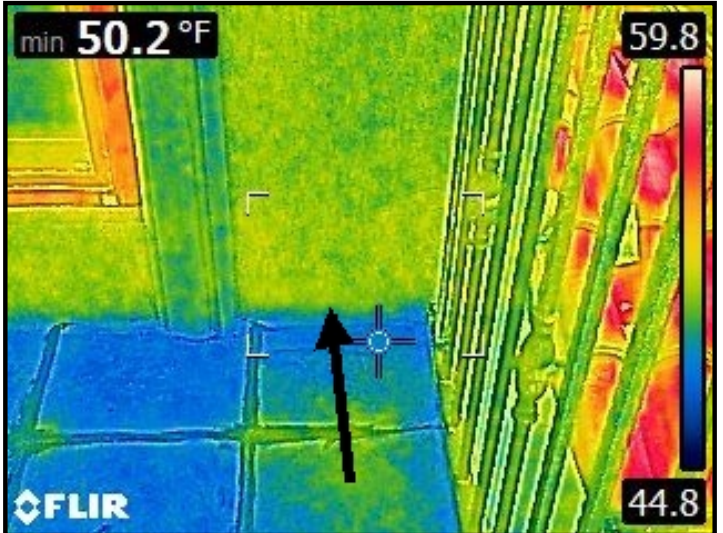
Water entering through terrace tile floor and EIFS facade, backflowing into the substrate and cascading down into the ceiling area below.

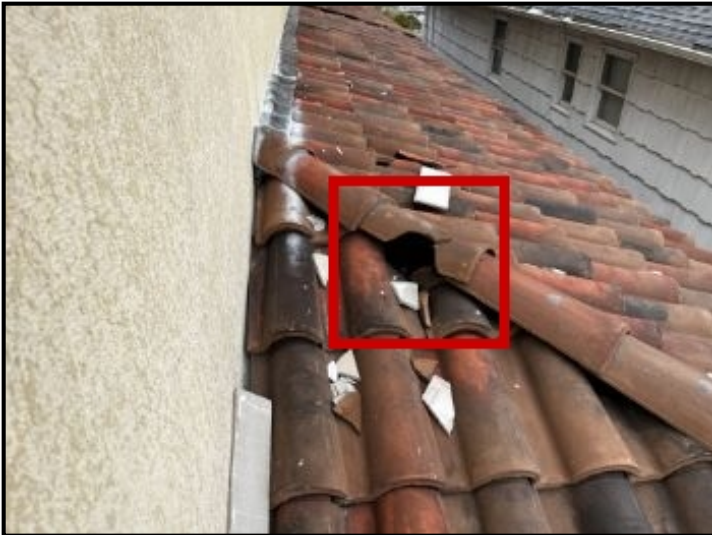
Repair Point: Replace spanish roof tile system.

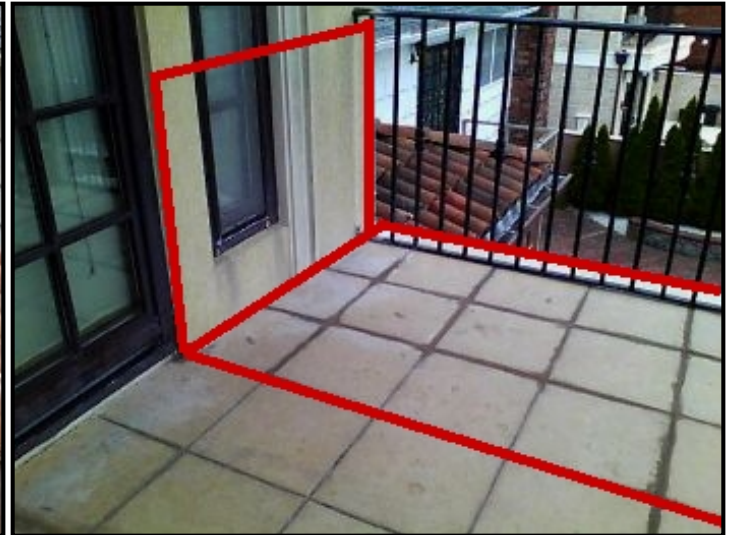
Repair Point: Remove railing. Excavate tile floor area. Excavate EIFS facade. Waterproof and flash area accordingly.

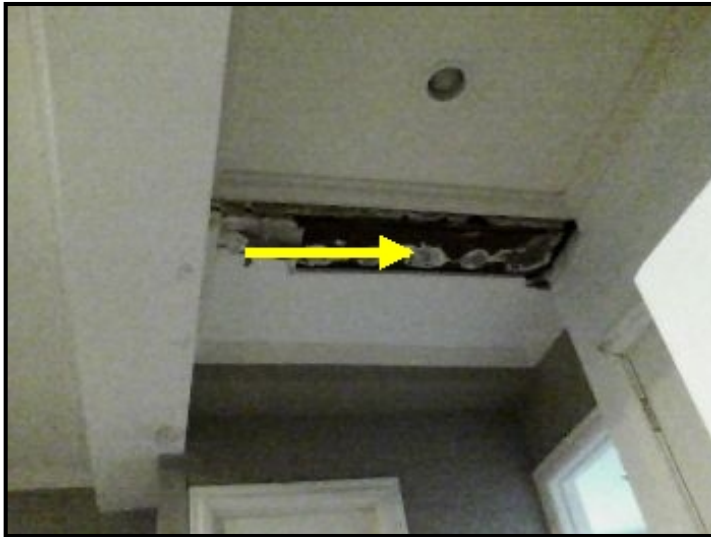
Water entry into ceiling area.

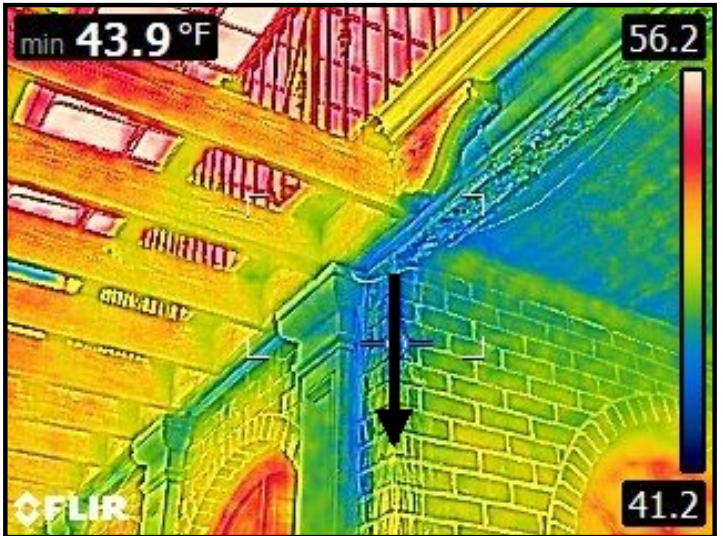
Infrared imaging of severe water entry into brick facade and cascading down into the ceiling area below.

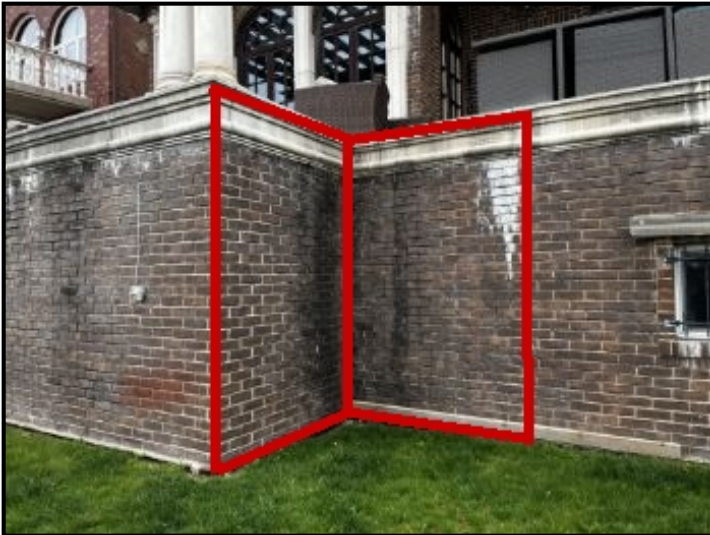
Repair Point: Excavate corner brick. Waterproof area accordingly. If excavation is not viable, repoint brick facade and seal with RD Elastoflex or Silane Siloxane sx5000.

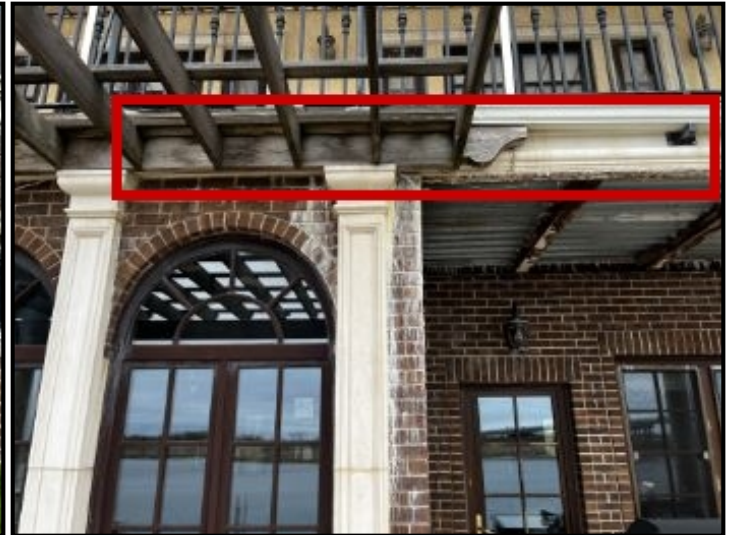
Repair Point: Remove wood pavilion from facade. Remove gutter system. Waterproof area accordingly.

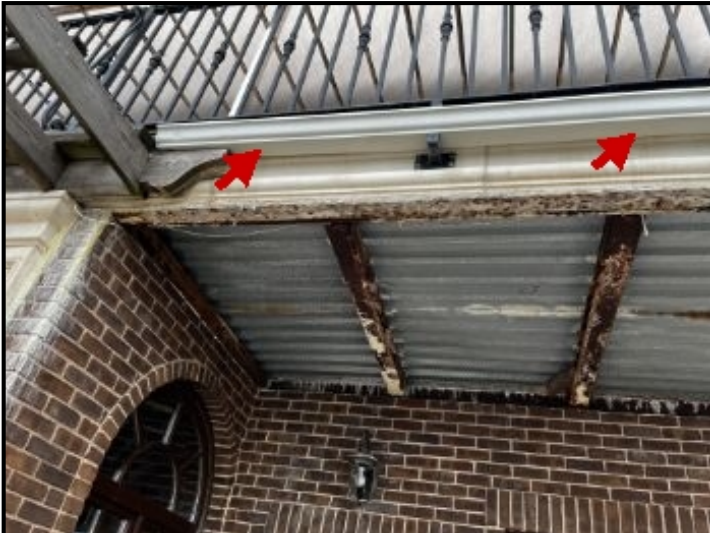
Repair Point: Remove wood pavilion from facade. Remove gutter system. Waterproof area accordingly.

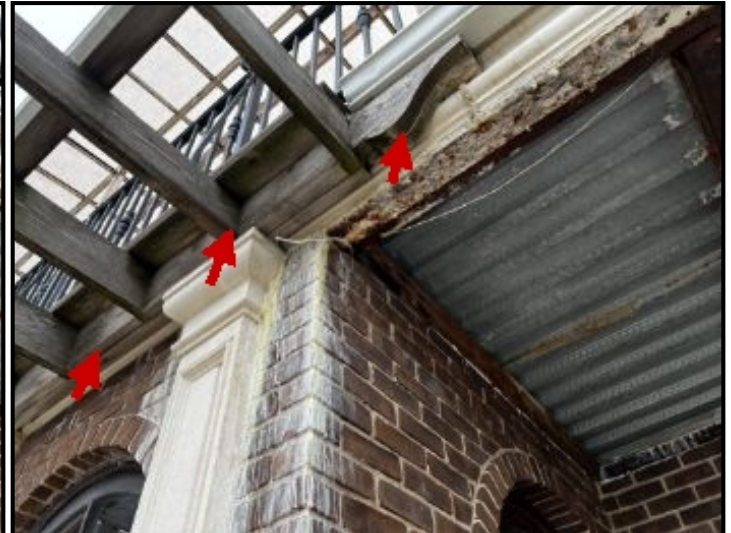
Repair Point: Remove wood pavilion from facade. Remove gutter system. Waterproof area accordingly.

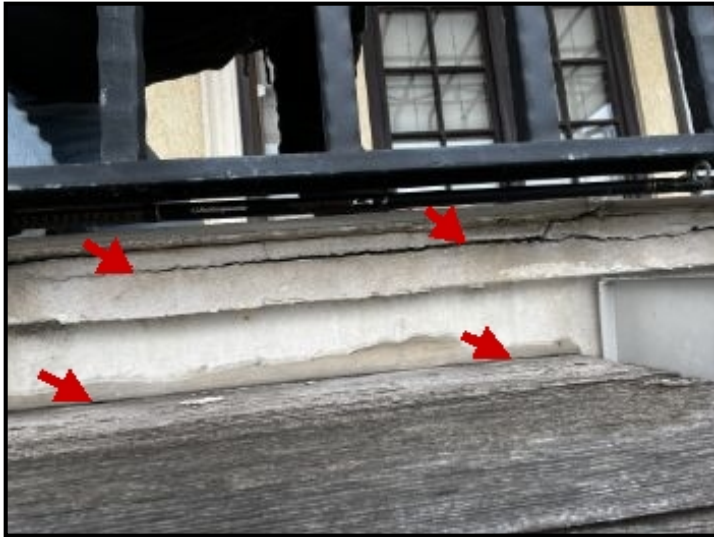
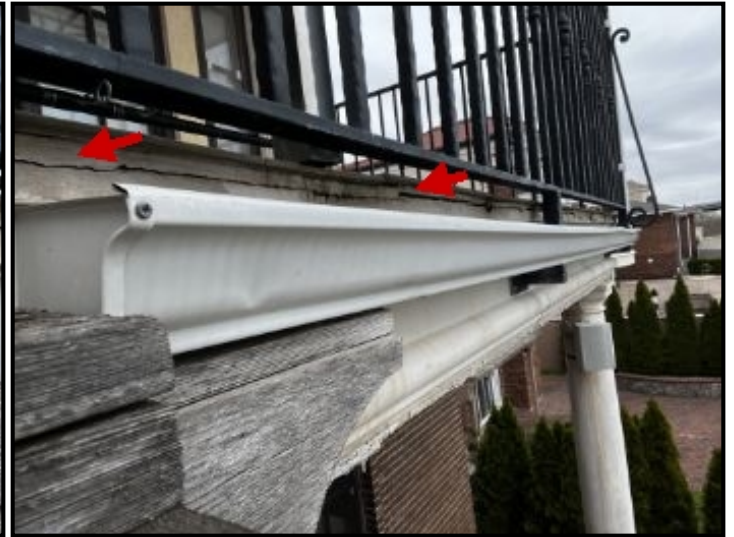
Repair Point: Remove wood pavilion from facade.
Remove gutter system. Waterproof area accordingly.
