JP Diagnostics LLC

Infrared Leak Detection Report

Date of Inspection: 10/17/2024 Time: 1200 Size: Residential

Ten-Leak Source and Origin (10L.SO)

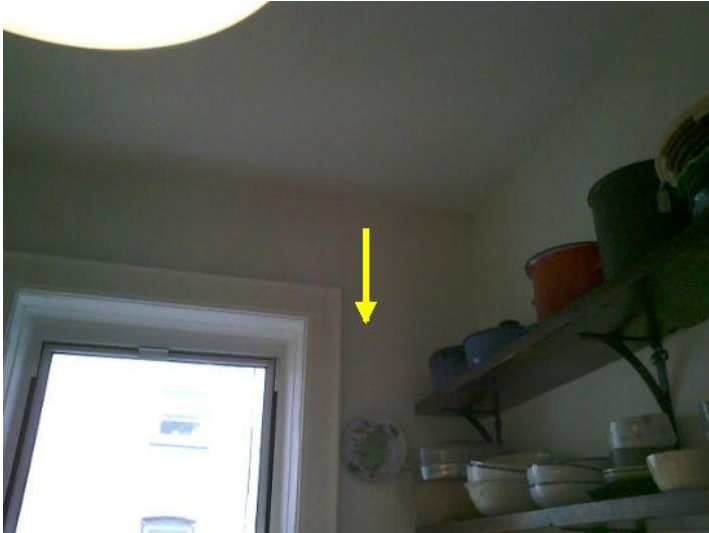
1. Water Leak Source / Origin: Window Sill / Parapet Wall Coping Stone

Water entry into wall area.

Repair Point: Conduct followup infrared scans to confirm findings. Remove coping stone. Waterproof parapet wall.

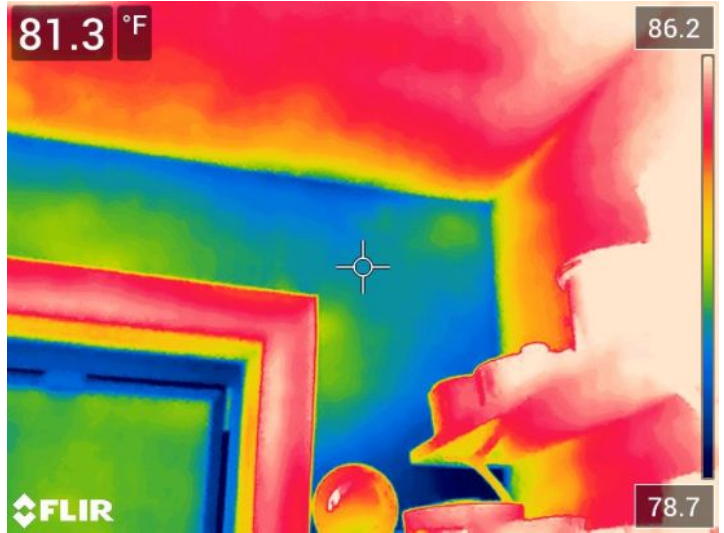
Infrared imaging of water entry into wall area.

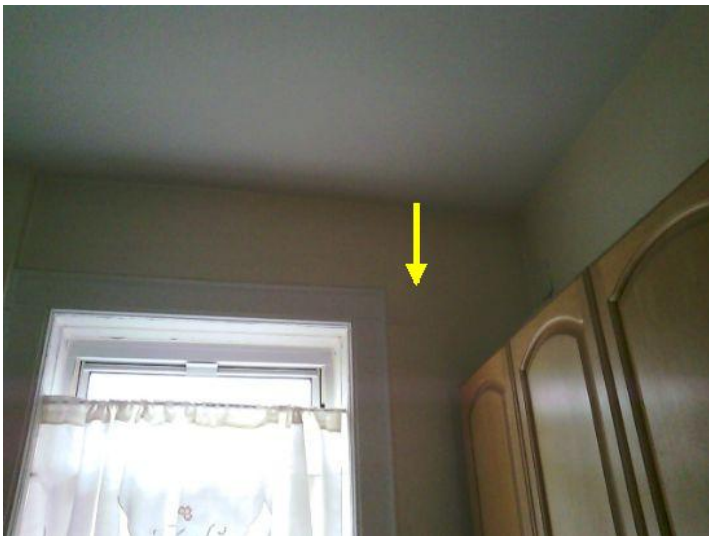
Water entry into wall area.

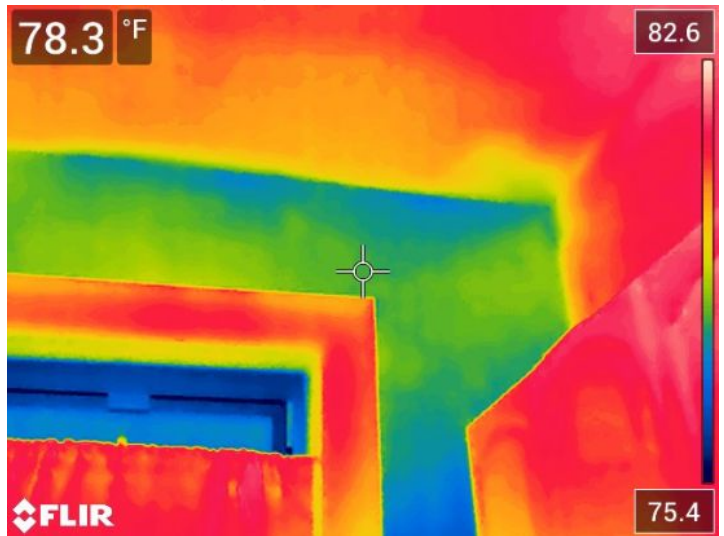
Infrared imaging of water entry into wall area.

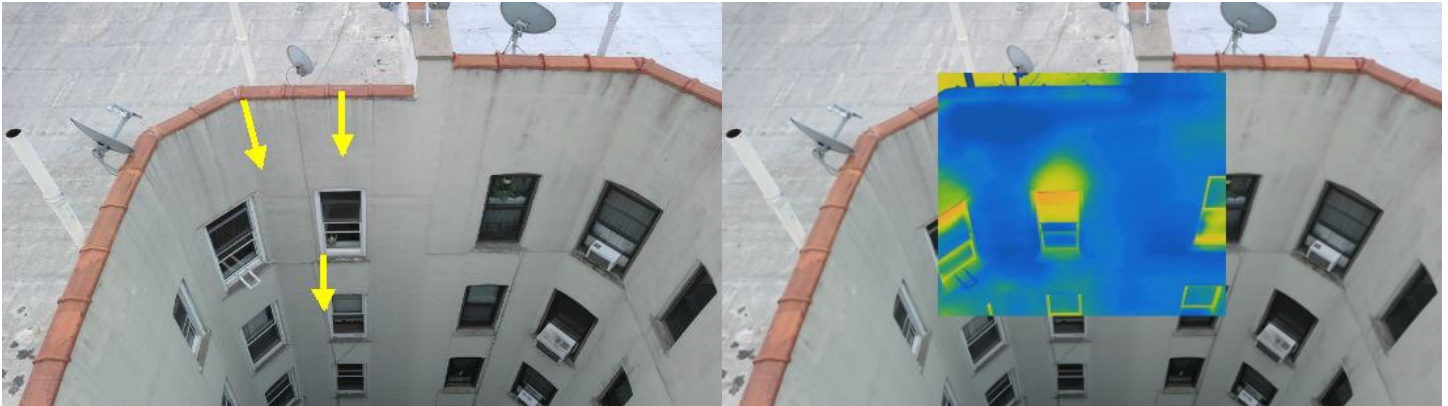
- **Source & Origin:** **Window Sill / Parapet Wall Coping Stone.**
 - **Description:** Heavy wind-driven rain water is entering through the top floor window sill and parapet wall coping stone joints, back flowing into the substrate and cascading down into the wall areas below.
 - **Repairs / Scope of Work:**
 - a. Remove parapet wall coping stones, as outlined.
 - b. Waterproof parapet wall topside.
 - c. Waterproof window sill.
 - d. Reinstall coping stones.
-

Water entering through the parapet wall coping stone and cascading down into the wall areas below.

Infrared imaging of water entering through the parapet wall coping stone and cascading down into the wall areas below.

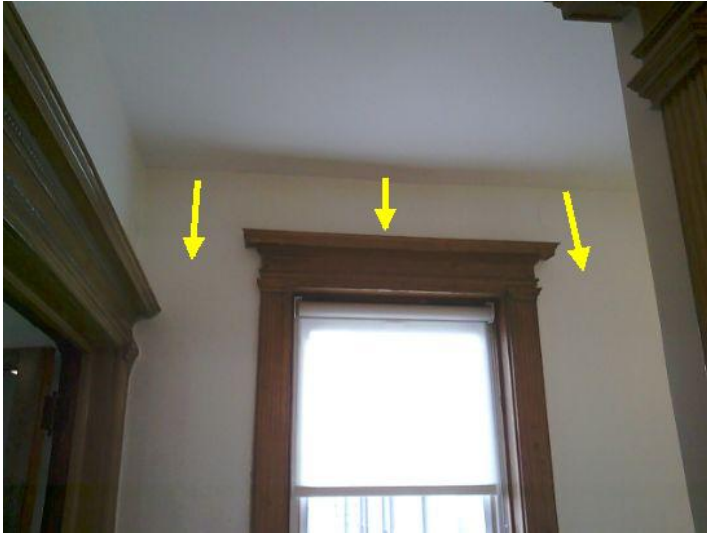
1. Water Leak Source / Origin: Window Sill / Parapet Wall Coping Stone

Water entry into wall / window frame area.

Repair Point: Waterproof window sills. Remove coping stone. Waterproof parapet wall.

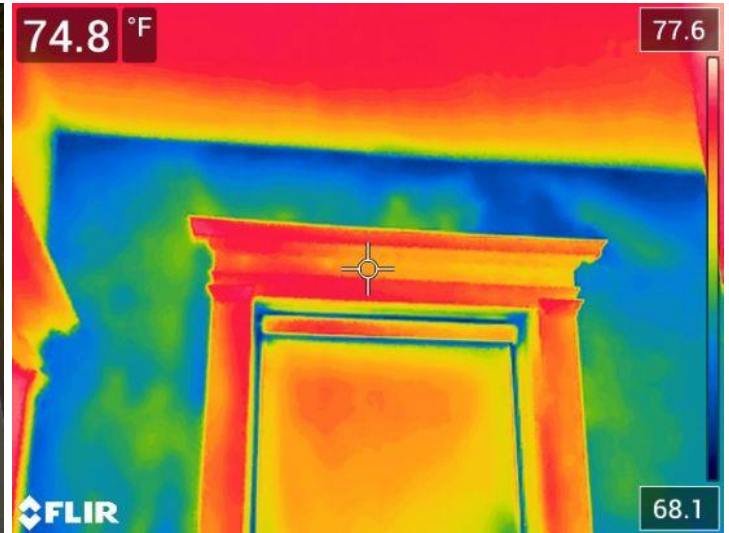
Infrared imaging of water entry into wall / window frame area.

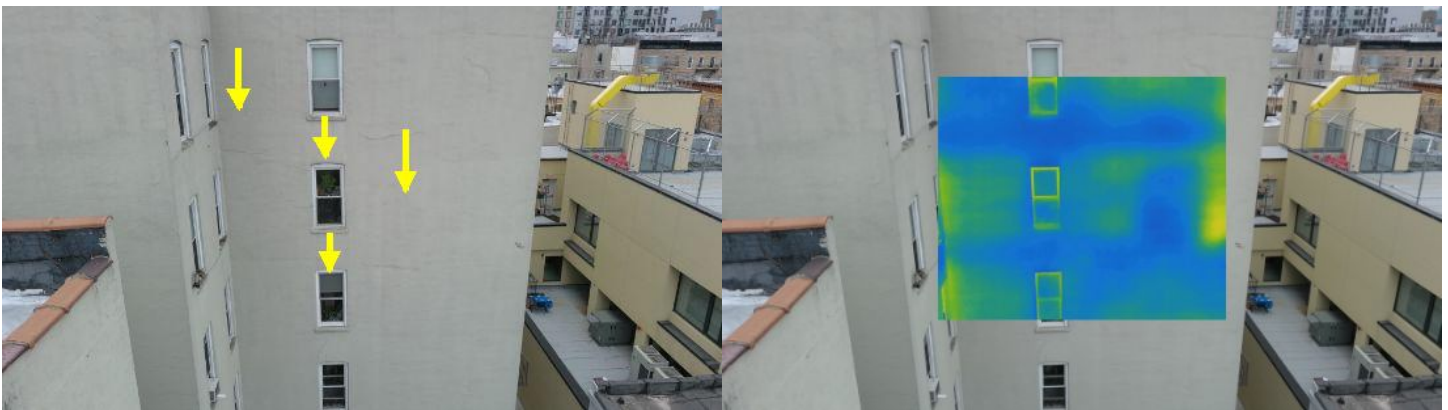
- **Source & Origin:** **Window Sills / Parapet Wall Coping Stone.**
 - **Description:** Heavy wind-driven rain water is entering through the upper floors window sills and parapet wall coping stone joints, back flowing into the substrate and cascading down into the wall areas below.
 - **Repairs / Scope of Work:**
 - e. Remove parapet wall coping stones, as outlined.
 - f. Waterproof parapet wall topside.
 - g. Waterproof window sills.
 - h. Reinstall coping stones.
-

Water entering through the window sills and parapet wall coping stone, cascading down and depositing into the wall / window areas below.

Infrared imaging of water entering through the window sills and parapet wall coping stone, cascading down and depositing into the wall / window areas below.

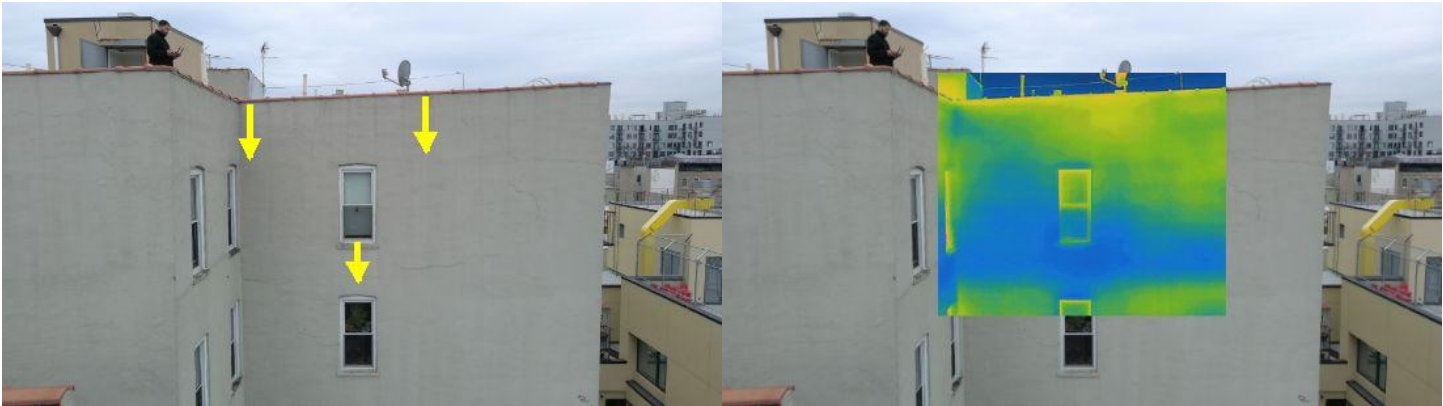
Water entering through the window sills and parapet wall coping stone, cascading down and depositing into the wall / window areas below.

Infrared imaging of water entering through the window sills and parapet wall coping stone, cascading down and depositing into the wall / window areas below.

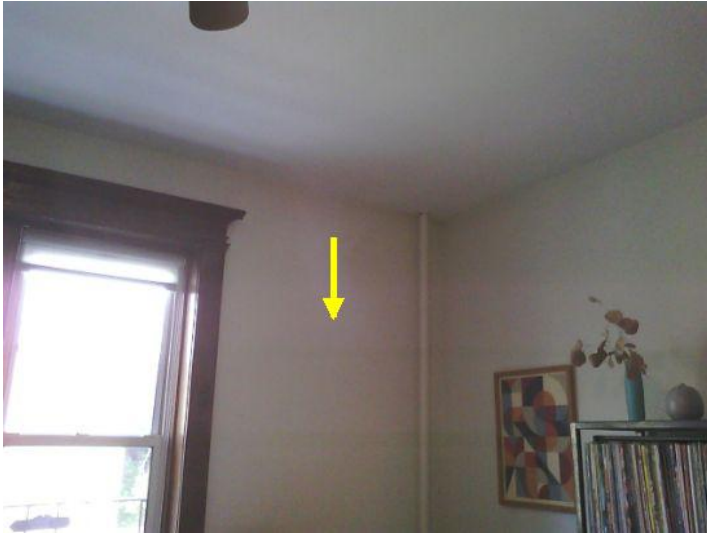
1. Water Leak Source / Origin: Facade / Parapet Wall Coping Stone

Water entry into wall area.

Repair Point: Remove coping stone from parapet wall. Waterproof parapet wall. Waterproof rear facade.

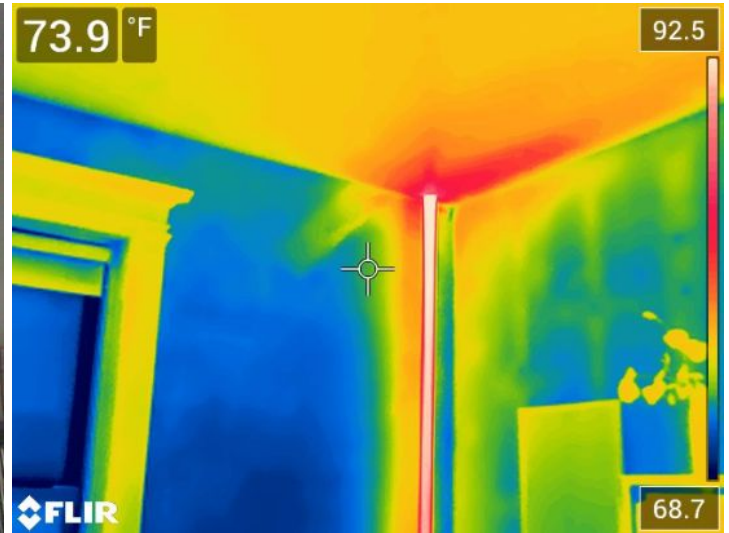
Infrared imaging of water entry into wall area.

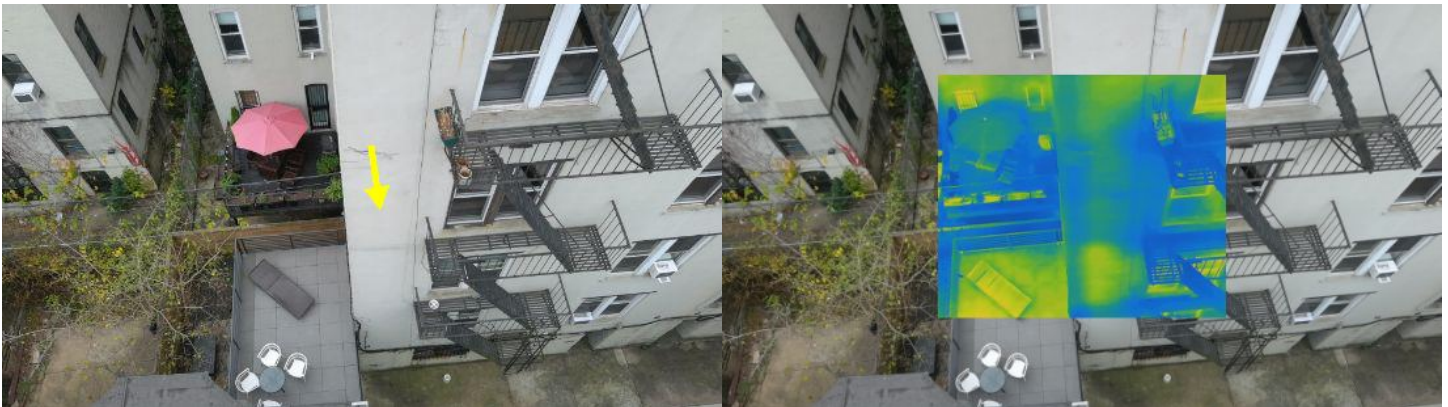
- **Source & Origin:** **Rear Facade / Parapet Wall Coping Stone.**
 - **Description:** Heavy wind-driven rain water is entering through large structural cracks within the rear facade as well as through the parapet wall coping stones, back flowing into the substrate and cascading down into the wall area below.
 - **Repairs / Scope of Work:**
 - i. Remove deteriorated sealant and masonry from rear facade.
 - j. Remove parapet wall coping stones.
 - k. Waterproof rear facade.
 - l. Waterproof parapet wall topside.
 - m. Reinstall coping stone.
-

Water entering through the rear facade and parapet wall coping stone, cascading down and depositing into the wall areas below.

Infrared imaging of water entering through the rear facade and parapet wall coping stone, cascading down and depositing into the wall areas below.

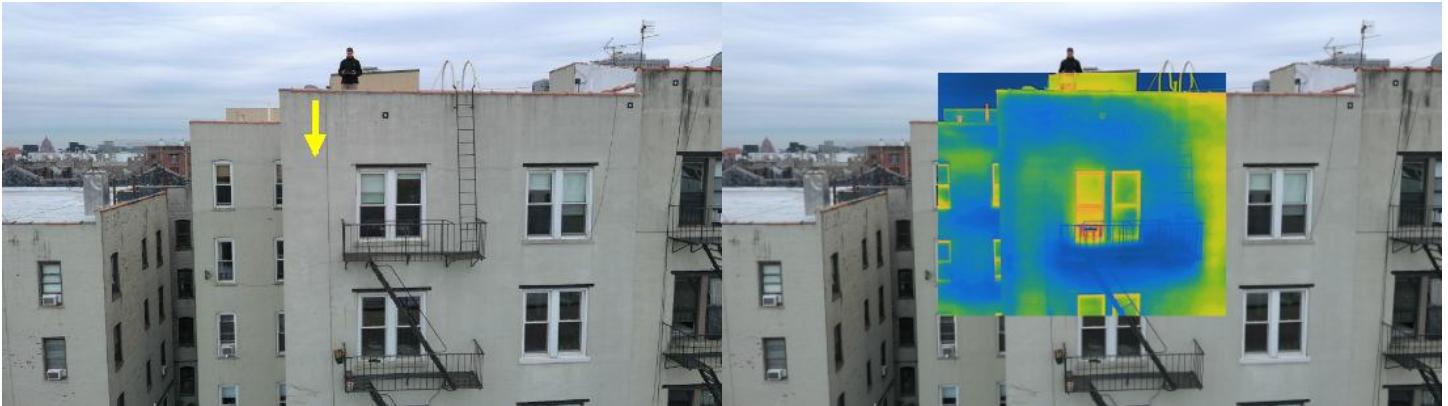
Water entering through the rear facade and parapet wall coping stone, cascading down and depositing into the wall areas below.

Infrared imaging of water entering through the rear facade and parapet wall coping stone, cascading down and depositing into the wall areas below.

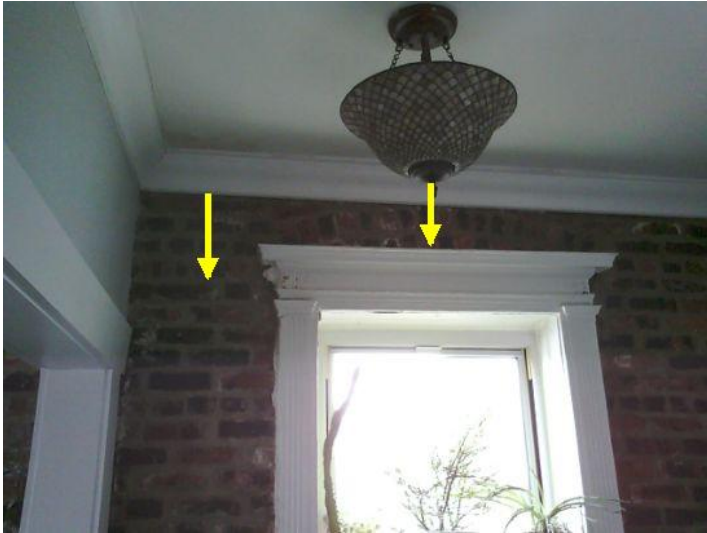
1. Water Leak Source / Origin: Parapet Wall Coping Stone

Water entry into wall / window frame area.

Repair Point: Remove parapet wall coping stones. Waterproof parapet wall.

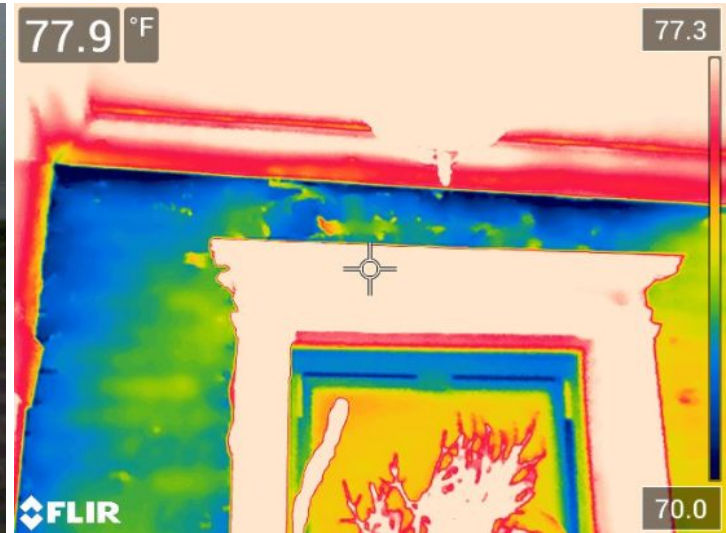
Infrared imaging of water entry into wall / window frame area.

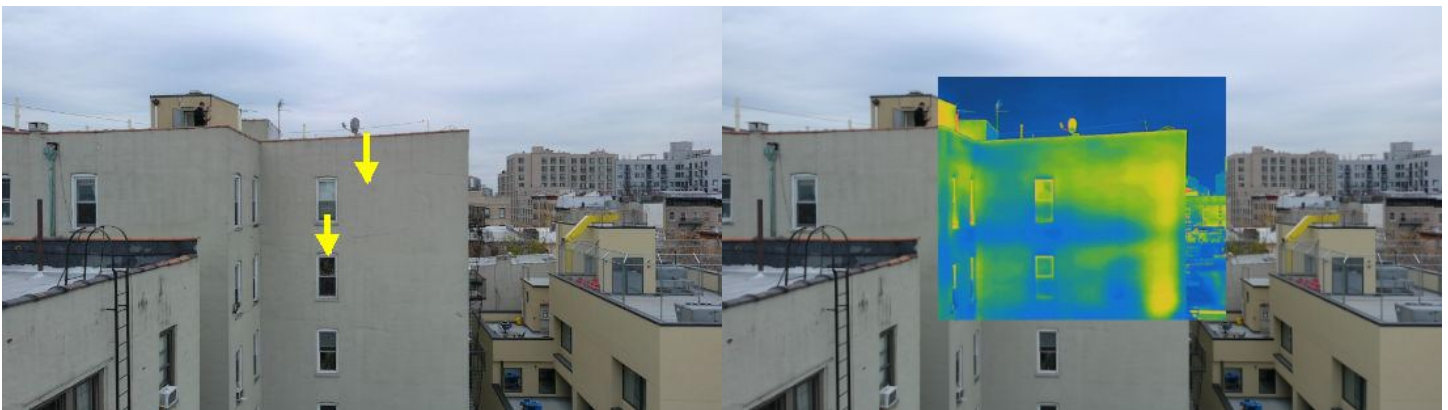
- **Source & Origin:** **Window Sill / Parapet Wall Coping Stone.**
 - **Description:** Heavy wind-driven rain water is entering through the top floor window sill and parapet wall coping stone joints, back flowing into the substrate and cascading down into the wall areas below.
 - **Repairs / Scope of Work:**
 - n. Remove parapet wall coping stones, as outlined.
 - o. Waterproof parapet wall topside.
 - p. Waterproof window sill.
 - q. Reinstall coping stones.
-

Water entering through parapet wall coping stones and cascading down into the wall / window frame areas below.

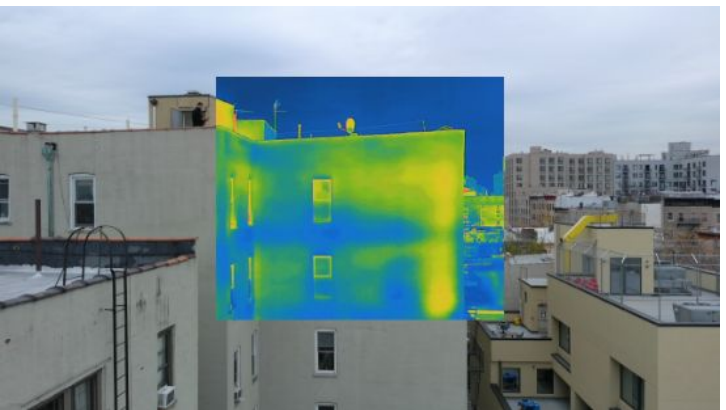
Infrared imaging of water entering through parapet wall coping stones and cascading down into the wall / window frame areas below.

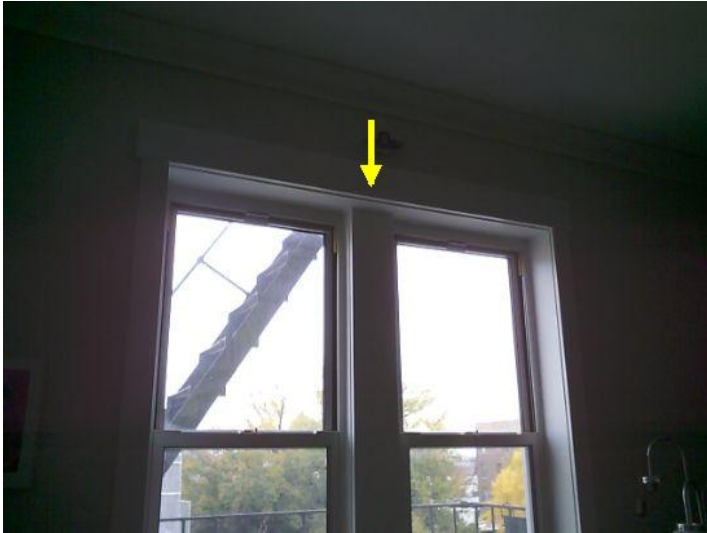
1. Water Leak Source / Origin: Facade / Parapet Wall Coping Stone

Water entry into wall / window frame area.

Repair Point: Remove parapet wall coping stones. Waterproof parapet wall. Waterproof rear facade.

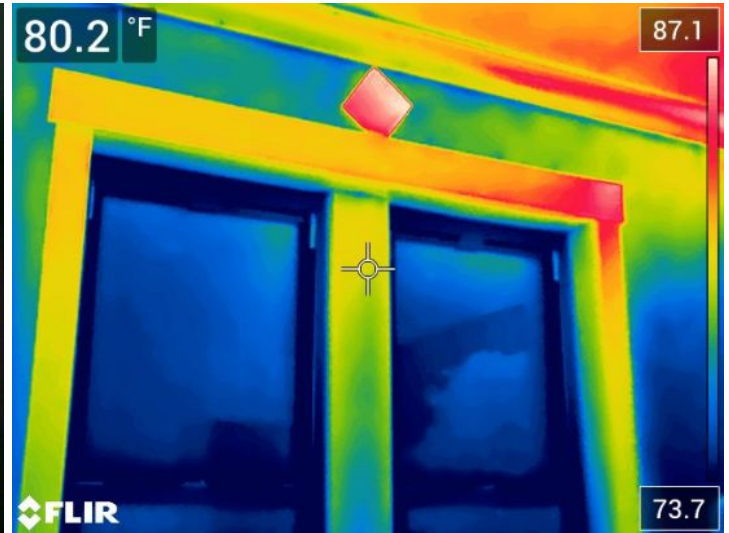
Infrared imaging of water entry into wall / window frame area.

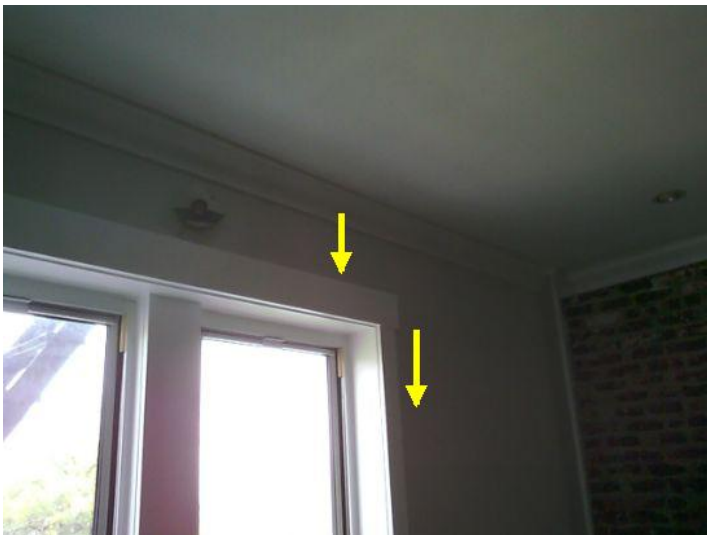
Water entry into wall / window frame area.

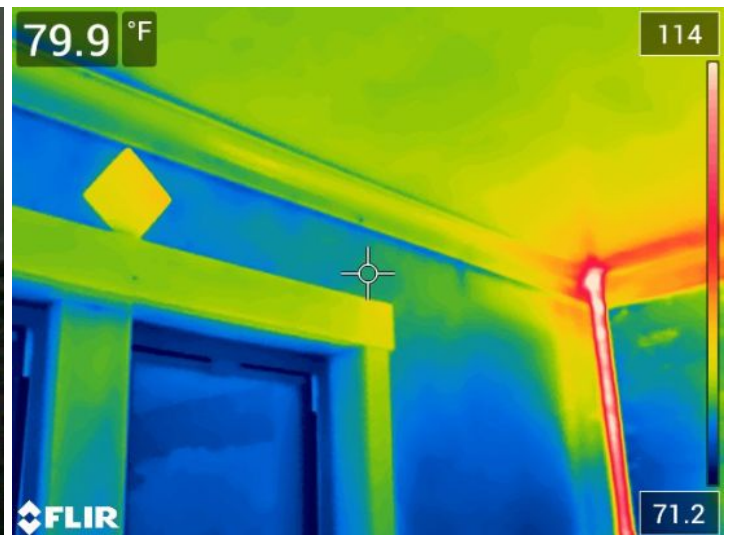
Infrared imaging of water entry into wall / window frame area.

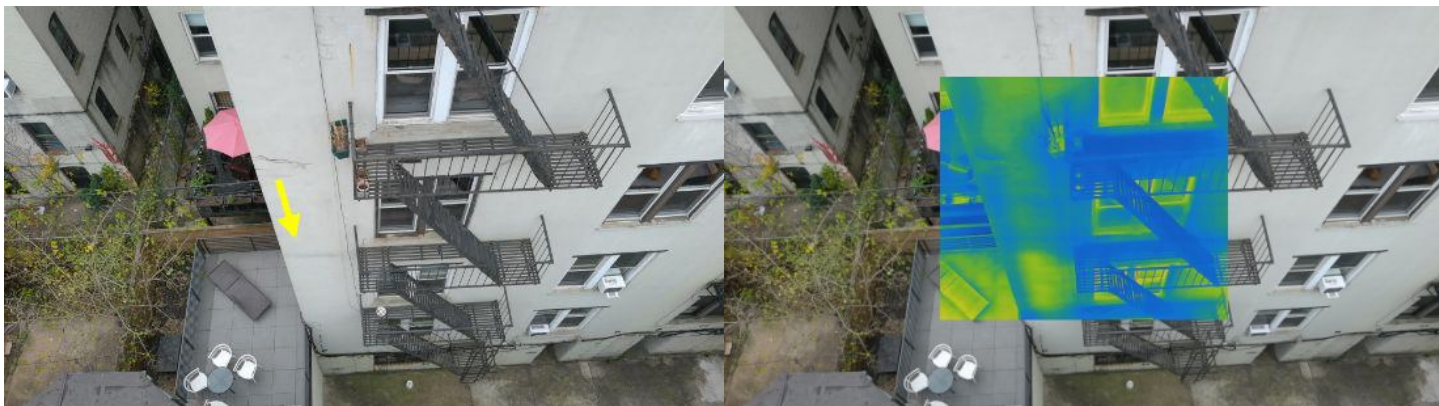
- **Source & Origin:** **Rear Facade / Parapet Wall Coping Stone.**
- **Description:** Heavy wind-driven rain water is entering through large structural cracks within the rear facade as well as through the parapet wall coping stones, back flowing into the substrate and cascading down into the wall area below.
- **Repairs / Scope of Work:**
 - r. Remove deteriorated sealant and masonry from rear facade.
 - s. Remove parapet wall coping stones.
 - t. Waterproof rear facade.

Water entering through the rear facade and parapet wall coping stone, cascading down and depositing into the wall / window frame areas below.

Infrared imaging of water entering through the rear facade and parapet wall coping stone, cascading down and depositing into the wall / window frame areas below.

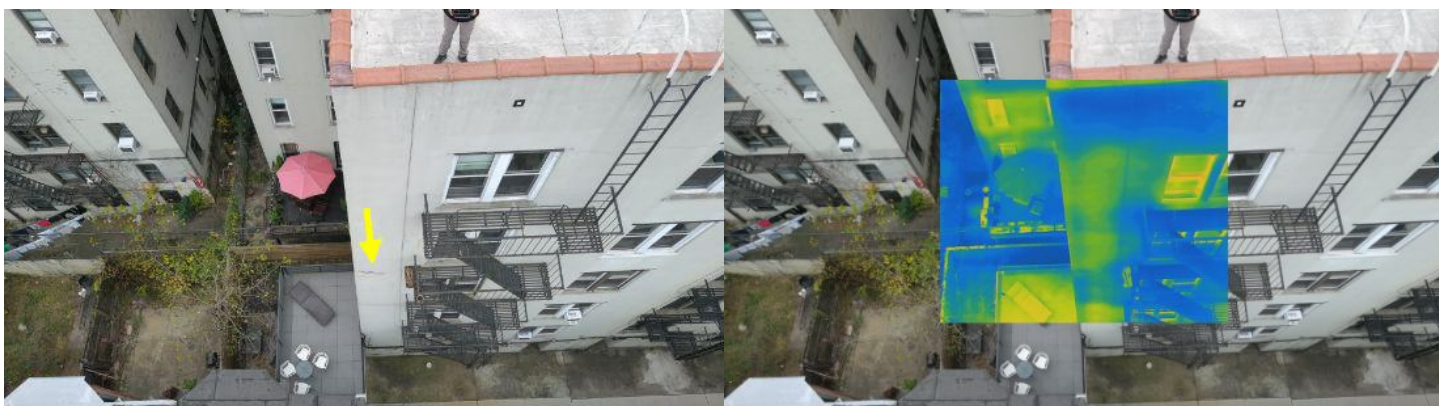
Water entering through the rear facade and parapet wall coping stone, cascading down and depositing into the wall / window frame areas below.

Infrared imaging of water entering through the rear facade and parapet wall coping stone, cascading down and depositing into the wall / window frame areas below.

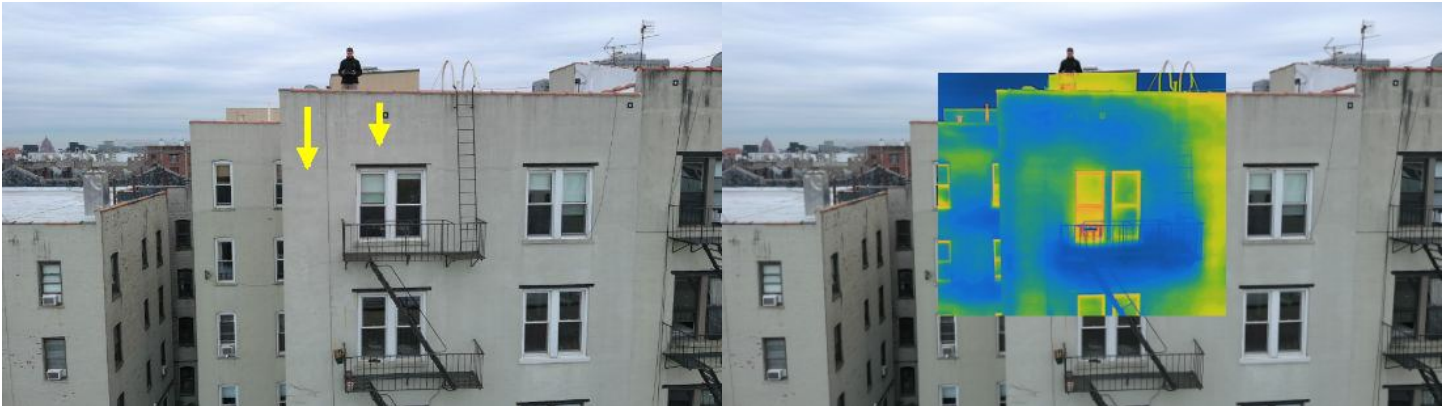
Water entering through the rear facade and parapet wall coping stone, cascading down and depositing into the wall / window frame areas below.

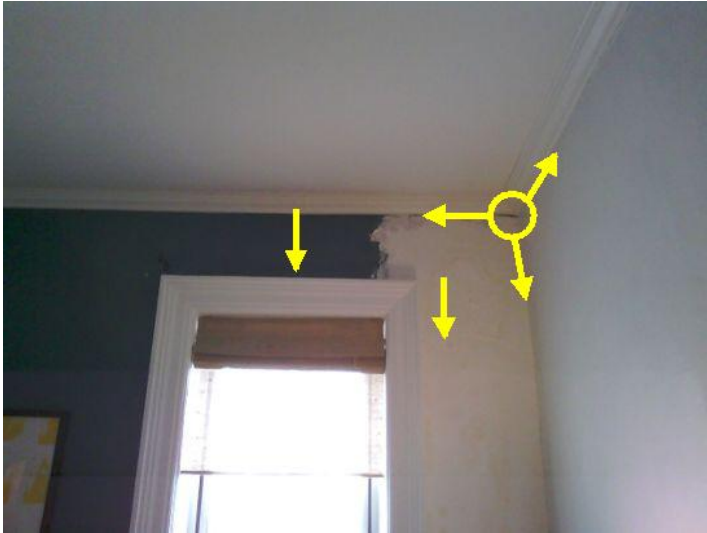
1. Water Leak Source / Origin: Parapet Wall Coping Stone

Water entry into wall / window frame area.

Repair Point: Remove coping stones. Waterproof parapet wall.

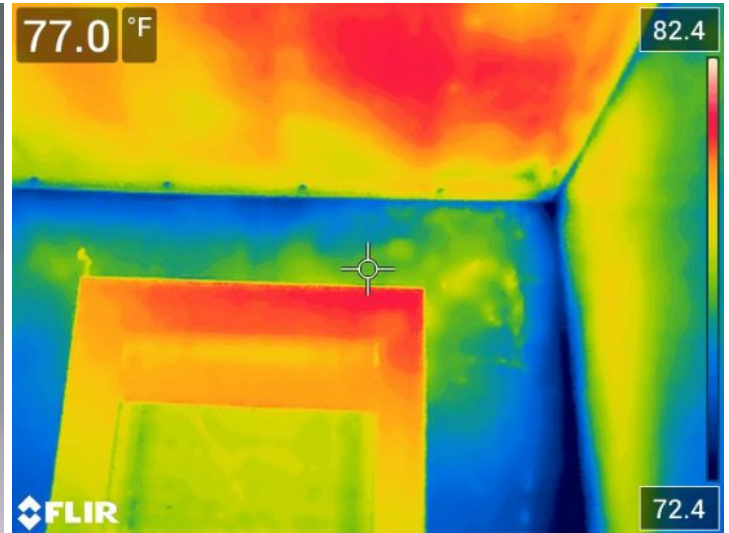
Infrared imaging of water entry into wall / window frame area.

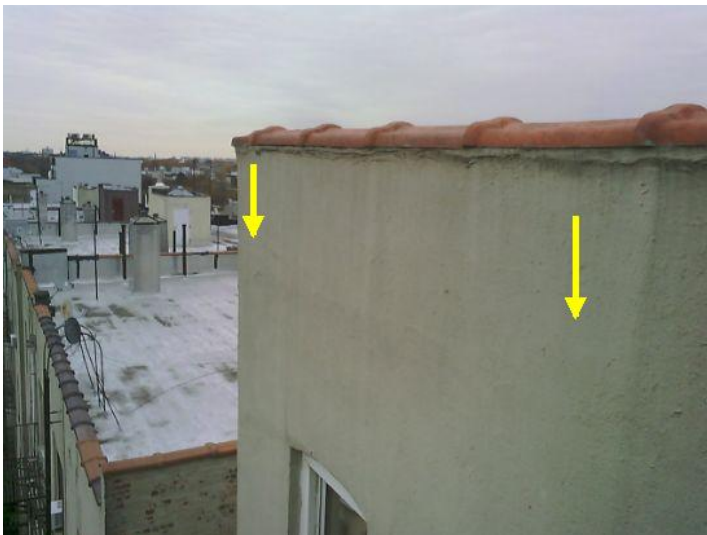
- **Source & Origin:** **Parapet Wall Coping Stone.**
 - **Description:** Heavy rain water is entering through the parapet wall coping stone, back flowing into the substrate and cascading down into the wall area below.
 - **Repairs / Scope of Work:**
 - w. Remove coping stones from parapet wall.
 - x. Waterproof parapet wall topside.
 - y. Reinstall coping stones.
-

Water entering through the parapet wall coping stone and cascading down into the internal wall areas below.

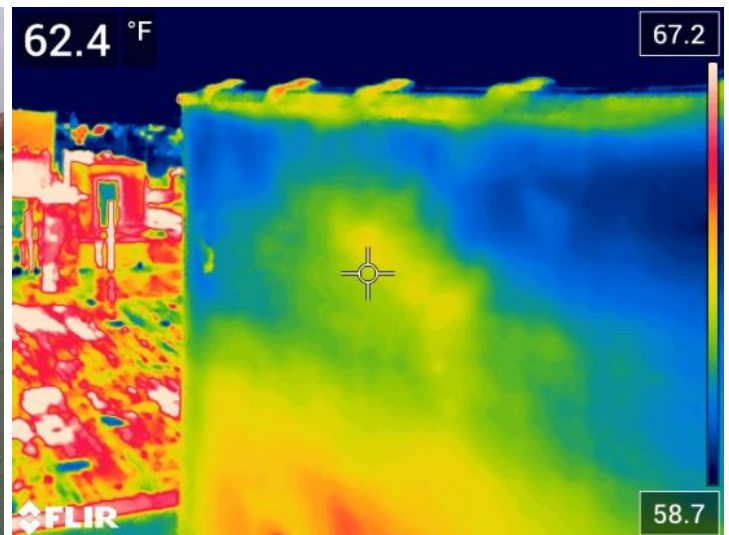
Infrared imaging of water entering through the parapet wall coping stone and cascading down into the internal wall areas below.

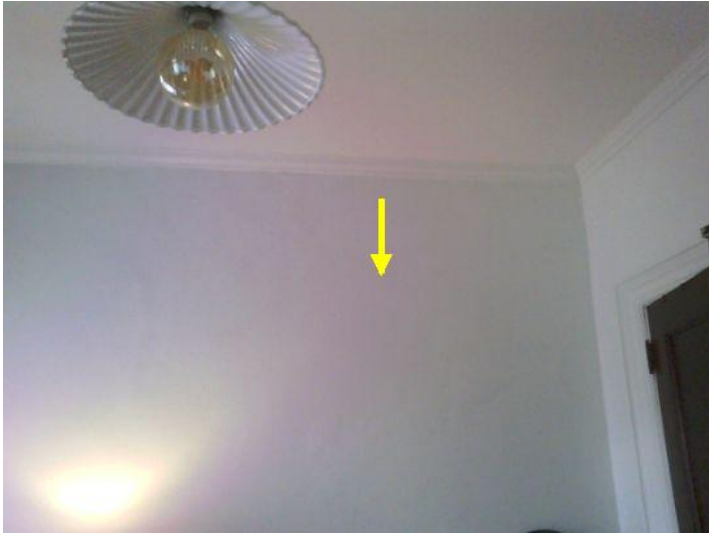
1. Water Leak Source / Origin: Facade / Parapet Wall Coping Stone

Water entry into wall area.

Repair Point: Remove coping stones from parapet wall. Waterproof side facade. Waterproof parapet wall.

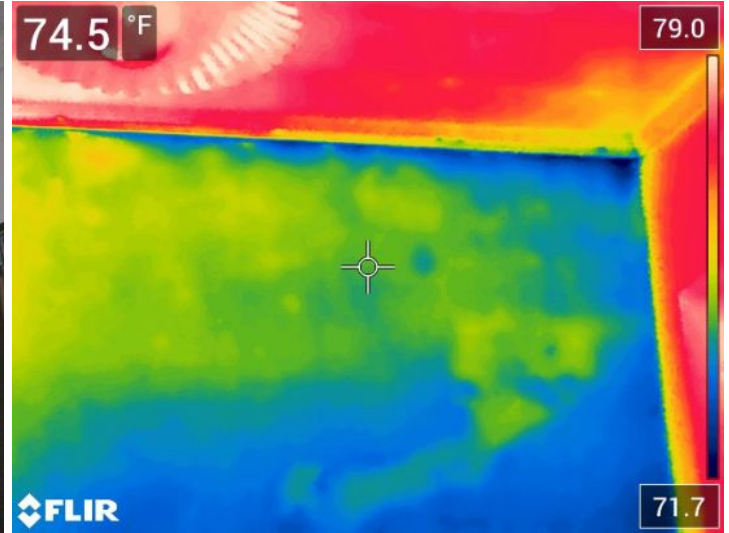
Infrared imaging of water entry into wall area.

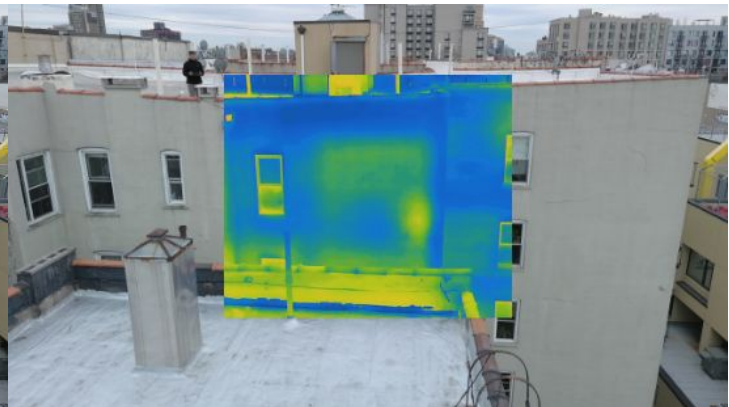
- **Source & Origin:** **Side Facade / Parapet Wall Coping Stone.**
 - **Description:** Heavy wind-driven rain water is entering through the structural cracks within the side facade as well as the parapet wall coping stones, back flowing into the substrate and cascading down into the wall area below.
 - **Repairs / Scope of Work:**
 - z. Remove coping stones from parapet wall.
 - aa. Waterproof parapet wall topside.
 - bb. Repair structural cracks in side facade.
 - cc. Waterproof side facade.
-

Water entering through side facade and parapet wall coping stone, cascading down and depositing into the wall areas below.

Infrared imaging of water entering through side facade and parapet wall coping stone, cascading down and depositing into the wall areas below.

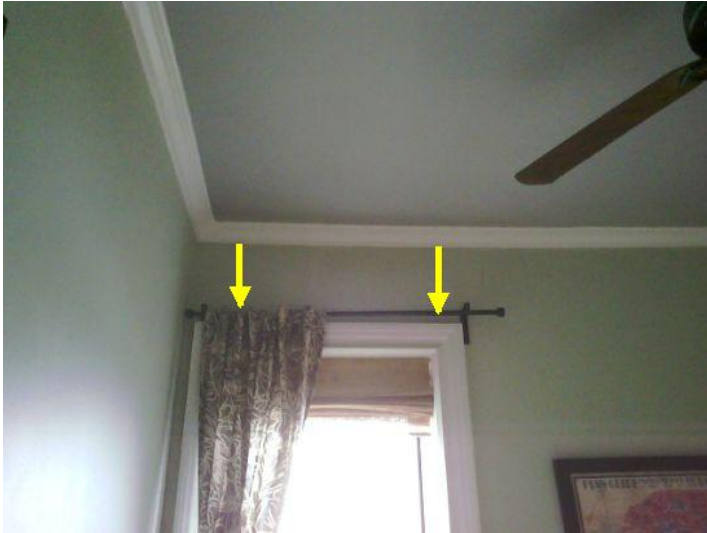
1. Water Leak Source / Origin: Facade / Parapet Wall Coping Stone

Water entry into wall / window frame area.

Repair Point: Remove coping stones from parapet wall. Waterproof side facade. Waterproof parapet wall.

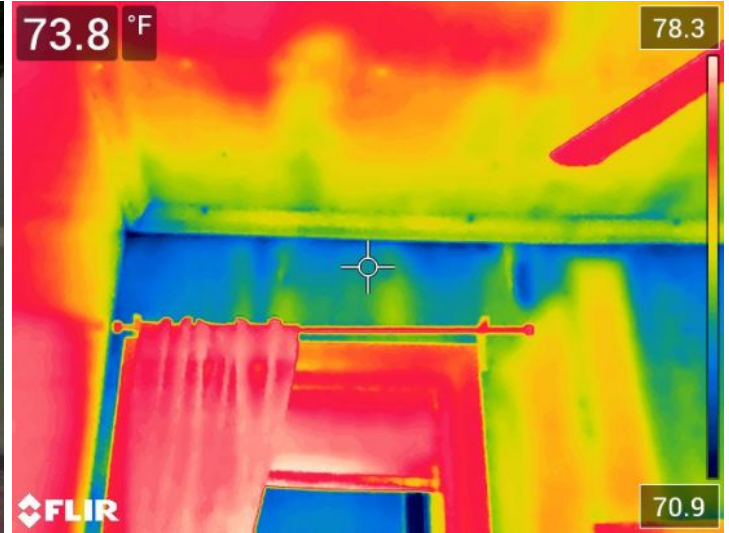
Infrared imaging of water entry into wall / window frame area.

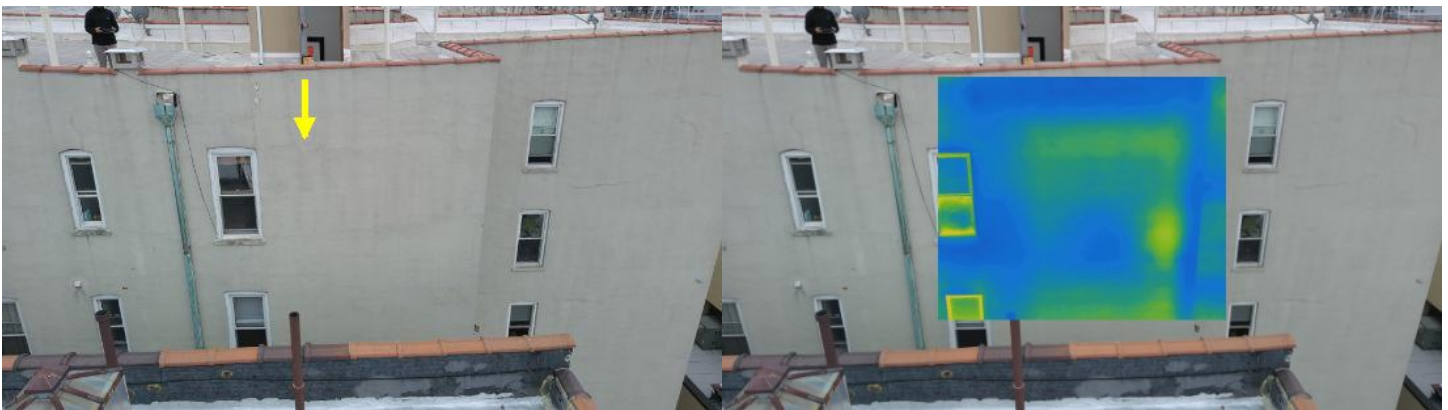
- **Source & Origin:** **Side Facade / Parapet Wall Coping Stone.**
- **Description:** Heavy wind-driven rain water is entering through the structural cracks within the side facade as well as the parapet wall coping stones, back flowing into the substrate and cascading down into the wall area below.
- **Repairs / Scope of Work:**

Water entering through side facade and parapet wall coping stone, cascading down and depositing into the wall areas below.

Infrared imaging of water entering through side facade and parapet wall coping stone, cascading down and depositing into the wall areas below.

- dd. Remove coping stones from parapet wall.
 - ee. Waterproof parapet wall topside.
 - ff. Repair structural cracks in side facade.
 - gg. Waterproof side facade.
-

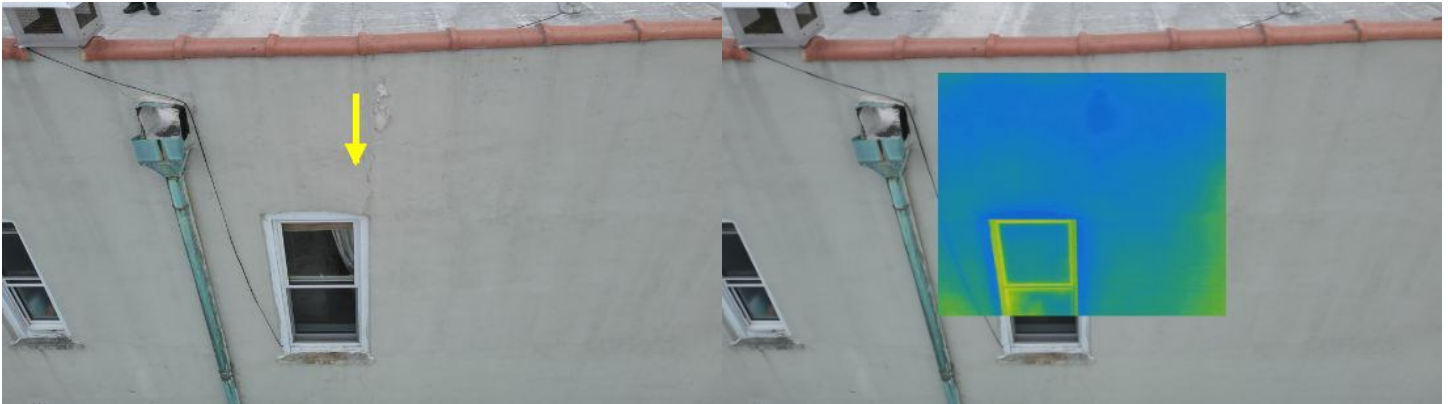
Water entering through side facade and parapet wall coping stone, cascading down and depositing into the wall areas below.

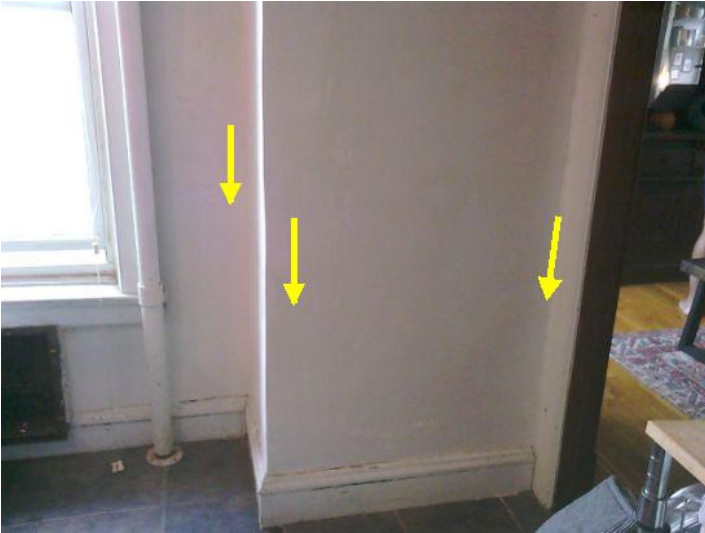
- **Source & Origin:** **Boiler Condensate / Chimney Cap / Chimney and Parapet Wall Structure.**
 - **Description:** During boiler operation, hot gases from boiler discharge are becoming blocked within the chimney stack causing the air to condense creating high levels of condensation within the chimney system, Water is also entering through the chimney structure especially where the parapet walls connect and cascading down into the wall areas below.
 - **Repairs / Scope of Work:**
 - hh. Contact boiler technician to examine boiler and insure proper operation of system.
 - ii. Remove current chimney cap and replace with proper cap which is properly fitted to the chimney structure.
 - jj. Waterproof chimney structure.
-

1. Water Leak Source / Origin: Chimney Frame and Cap

Water entry into wall area due to a combination of condensate buildup from the boiler exhaust discharge as well as water entry through the chimney walls and connecting parapets, cascading down and depositing into the wall areas below.

Repair Point: Remove chimney cap and install a proper cap to allow for unimpeded flow of boiler exhaust. Waterproof chimney structure as well as connecting parapet walls.

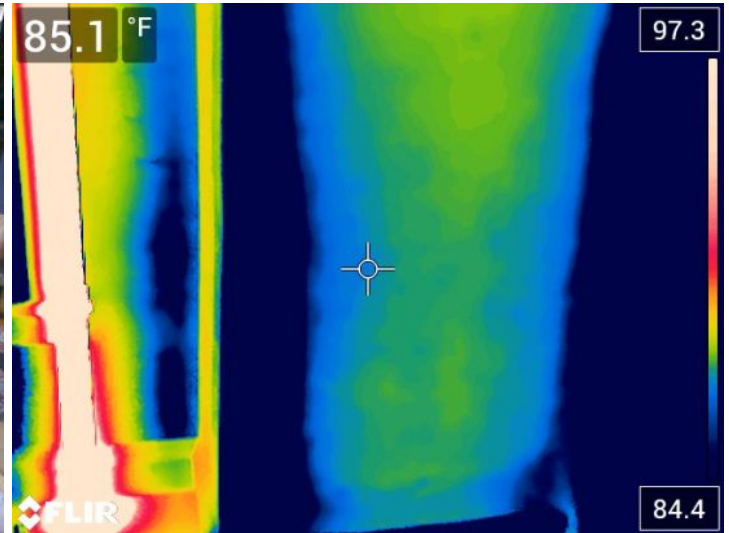
Infrared imaging of water entry into wall area due to a combination of condensate buildup from the boiler exhaust discharge as well as water entry through the chimney walls and connecting parapets, cascading down and depositing into the wall areas below.

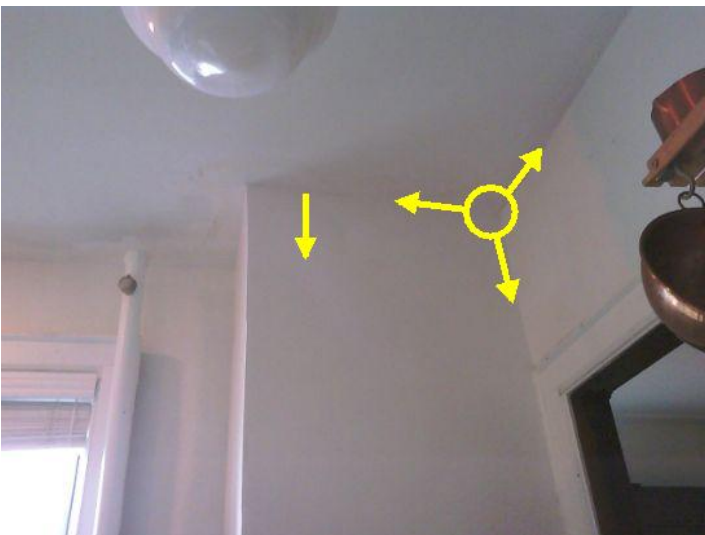
Water entry into wall area due to a combination of condensate buildup from the boiler exhaust discharge as well as water entry through the chimney walls and connecting parapets, cascading down and depositing into the wall areas below.

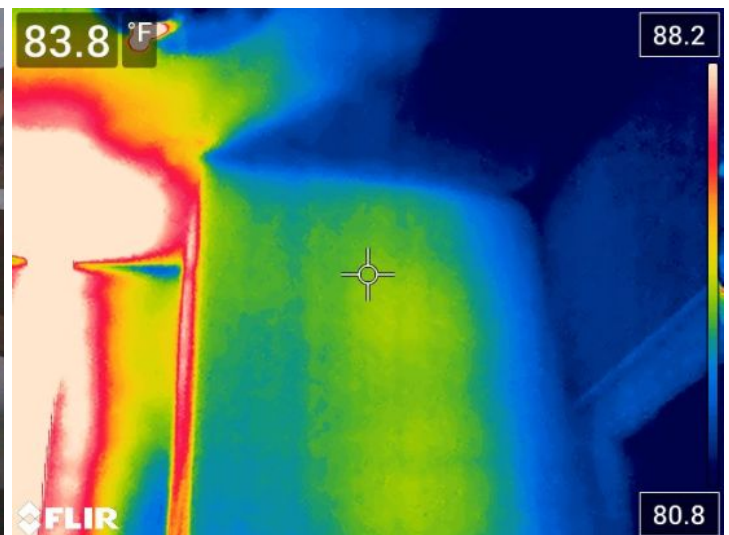
Infrared imaging of water entry into wall area due to a combination of condensate buildup from the boiler exhaust discharge as well as water entry through the chimney walls and connecting parapets, cascading down and depositing into the wall areas below.

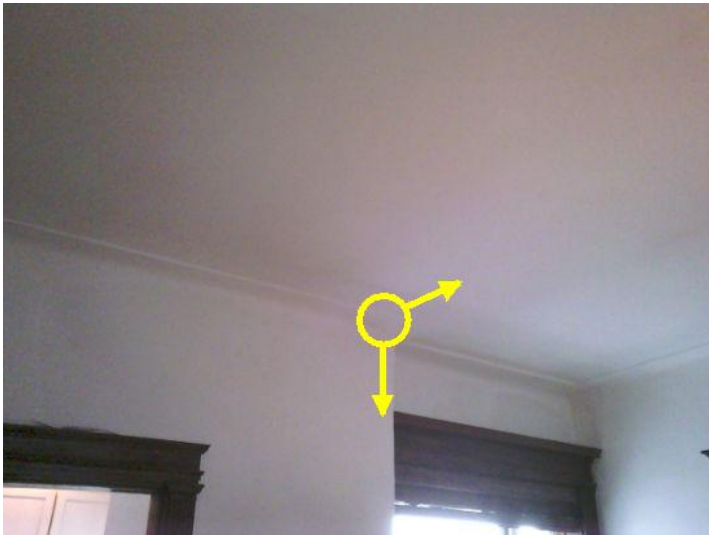
Water entry into wall area due to a combination of condensate buildup from the boiler exhaust discharge as well as water entry through the chimney walls and connecting parapets, cascading down and depositing into the wall areas below.

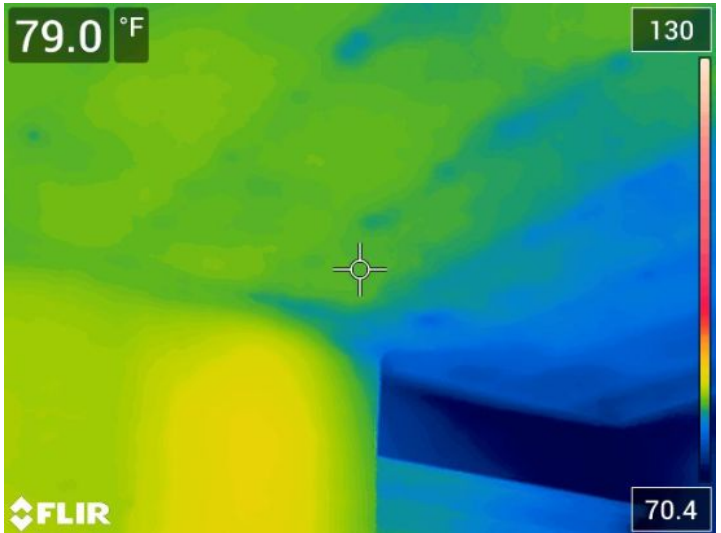
Infrared imaging of water entry into wall area due to a combination of condensate buildup from the boiler exhaust discharge as well as water entry through the chimney walls and connecting parapets, cascading down and depositing into the wall areas below.

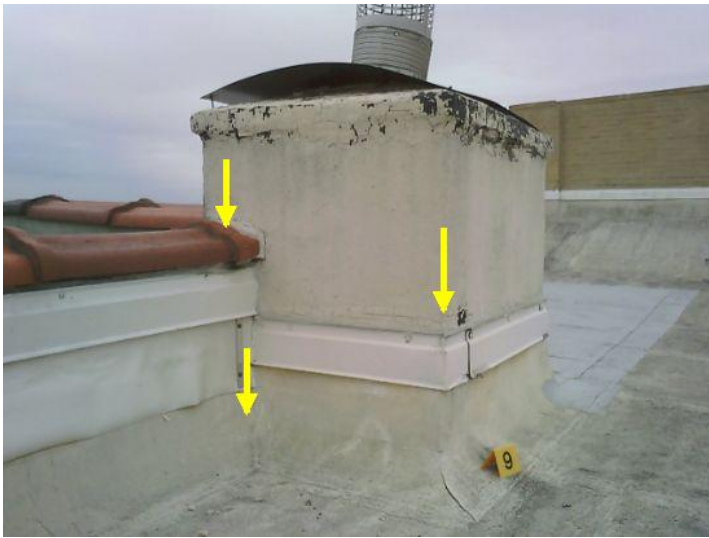
Water entering through the chimney structure as well as connecting parapet walls, cascading down and depositing into the wall areas below.

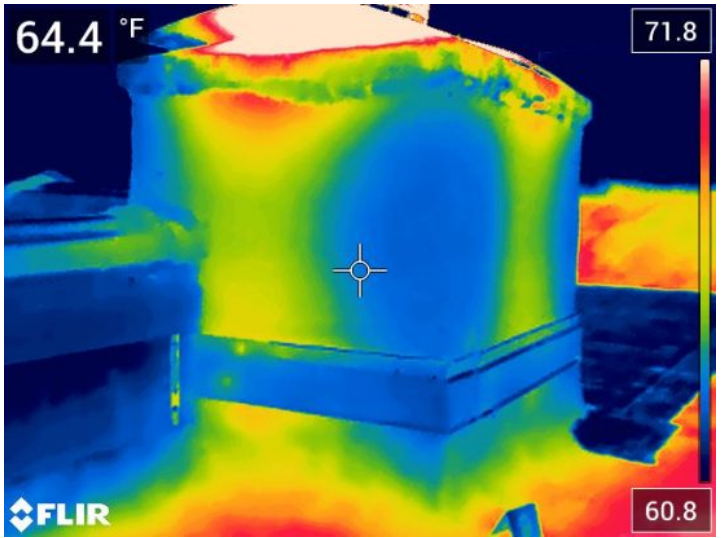
Infrared imaging of water entering through the chimney structure as well as connecting parapet walls, cascading down and depositing into the wall areas below.

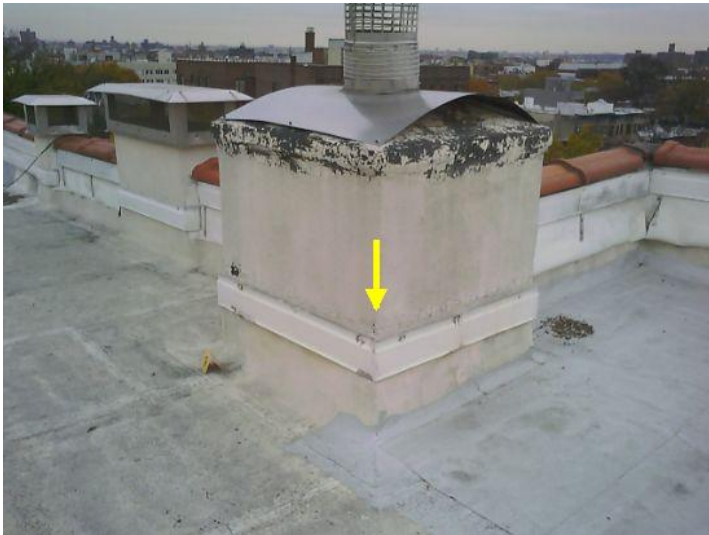
Water entering through the chimney structure as well as connecting parapet walls, cascading down and depositing into the wall areas below.

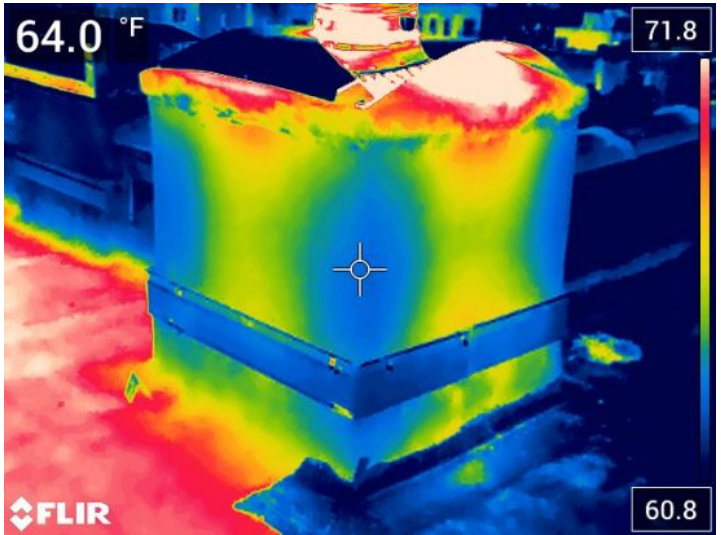
Infrared imaging of water entering through the chimney structure as well as connecting parapet walls, cascading down and depositing into the wall areas below.
