JP Diagnostics LLC

Infrared Leak Detection Report

Date of Inspection: 10/17/2024 Time: 1200 Size: Residential

Ten-Leak Source and Origin (10L.SO)

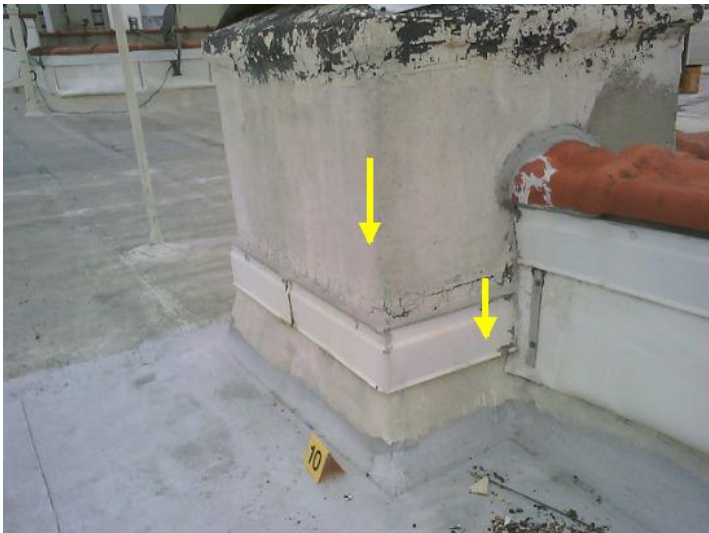
Water entering through the chimney structure as well as connecting parapet walls, cascading down and depositing into the wall areas below.

Repair Point: Remove chimney cap and install a proper cap to allow for unimpeded flow of boiler exhaust. Waterproof chimney structure as well as connecting parapet walls.

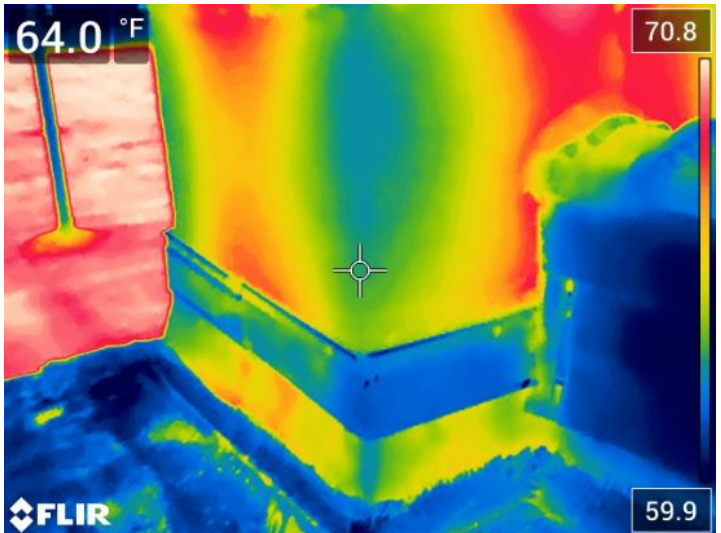
Infrared imaging of water entering through the chimney structure as well as connecting parapet walls, cascading down and depositing into the wall areas below.

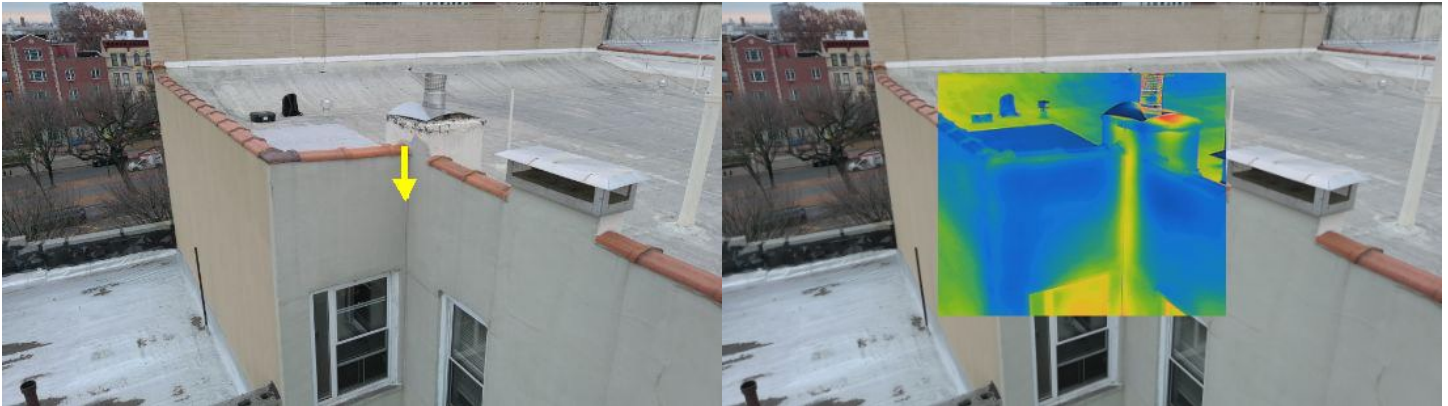
Water entering through the chimney structure as well as connecting parapet walls, cascading down and depositing into the wall areas below.

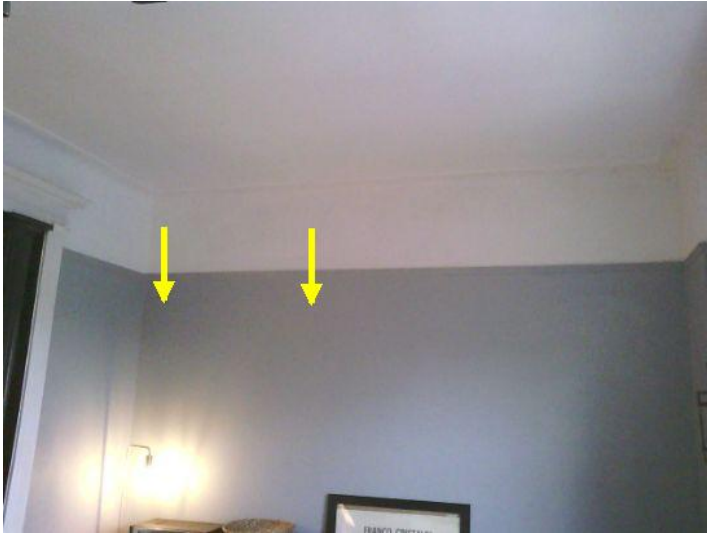
- **Source & Origin:** **Parapet Wall Coping Stone.**
 - **Description:** Heavy rain water is entering through the parapet wall coping stone joints, back flowing into the substrate and cascading down into the wall area below.
 - **Repairs / Scope of Work:**
 - kk. Remove coping stones from parapet wall.
 - ll. Waterproof parapet wall topside.
 - mm. Reinstall coping stones.
-

1. Water Leak Source / Origin: Parapet Coping Stone

Water entry into wall area.

Repair Point: Remove parapet wall coping stones. Waterproof parapet wall.....

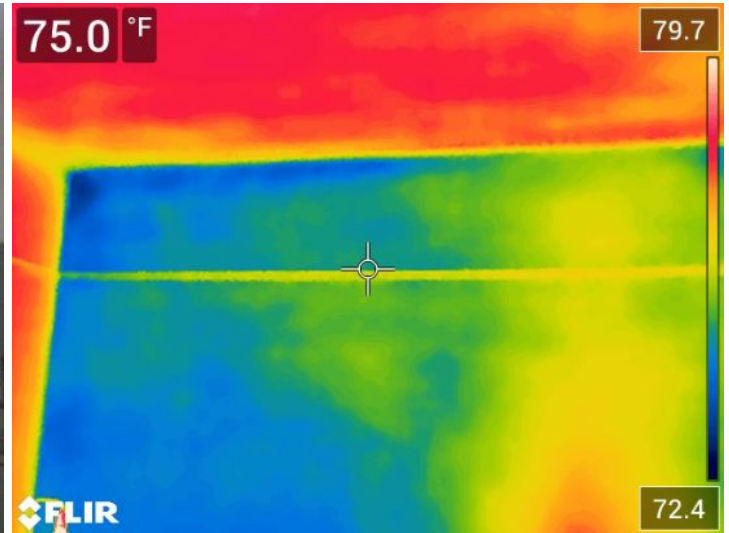
Infrared imaging of water entry into wall area.

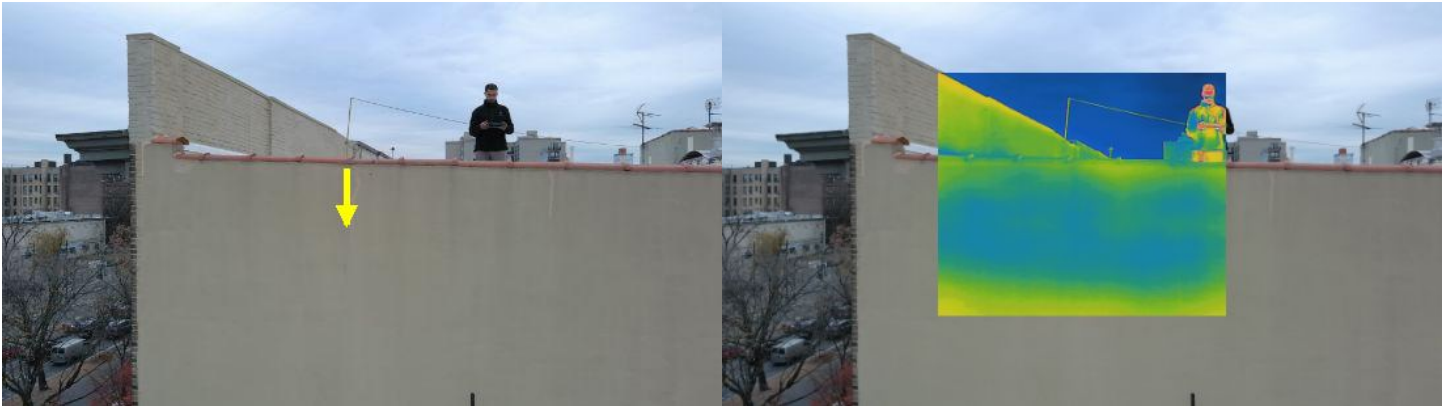
Infrared imaging of water entering through the parapet wall coping stones and cascading down into the wall areas below.

Water entering through the parapet wall coping stones and cascading down into the wall areas below.
