Infrared Leak Detection Report

Inspection prepared for:
Date of Inspection: 6/11/2024 Time: 0900 Size: Commercial
Weather: Clear - Warm/68df
Seven-Leak Source and Origin (7L.SO)

Inspector: Jarrod Parslow

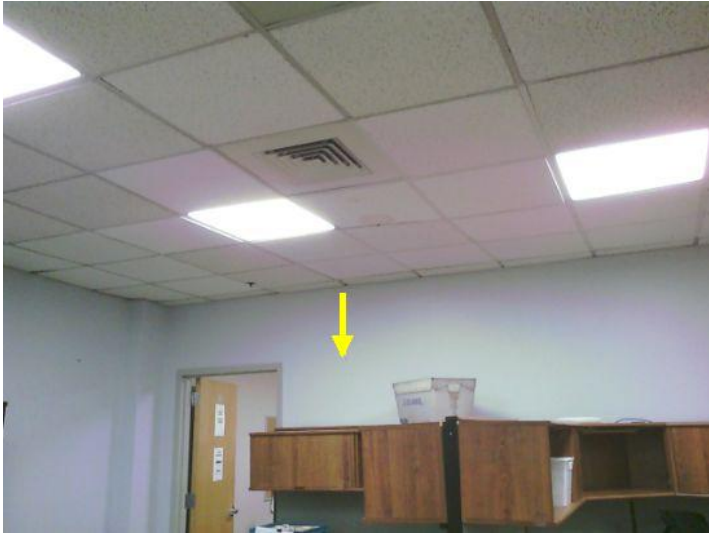
Water entry into wall area.

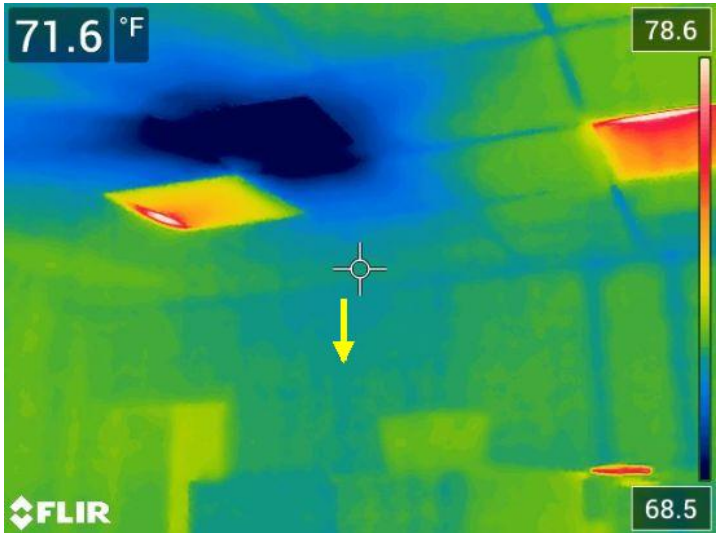
Infrared imaging of water entry into wall area.

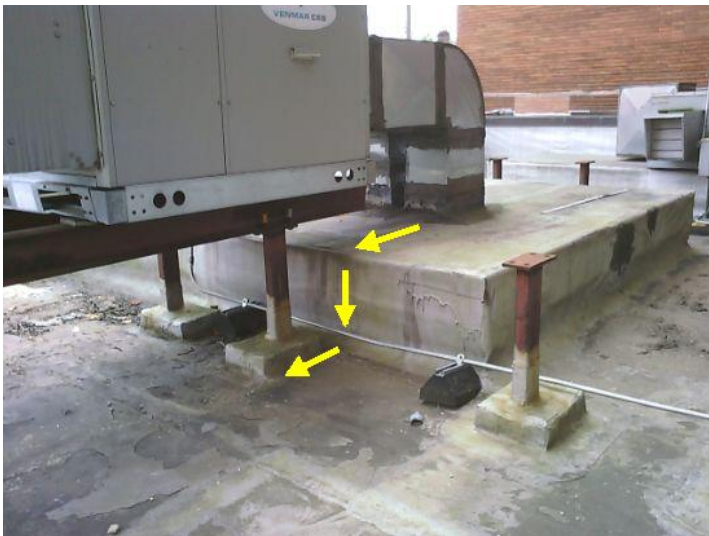
- **Source & Origin:** HVAC Duct / Roof Membrane.
 - **Description:** Heavy rain water is entering through the HVAC duct entry point into the roof membrane system and cascading down into the wall areas below.
 - **Repairs / Scope of Work:**
 - a. Waterproof around duct entry point into the roof membrane.
 - b. Clear all debris from the surrounding membrane system.
 - c. Waterproof outlined area of membrane with a liquid roof flashing such as Polyglass 1C.
-

Water entering through HVAC duct entry point into the roof membrane system and cascading down into the wall areas below.

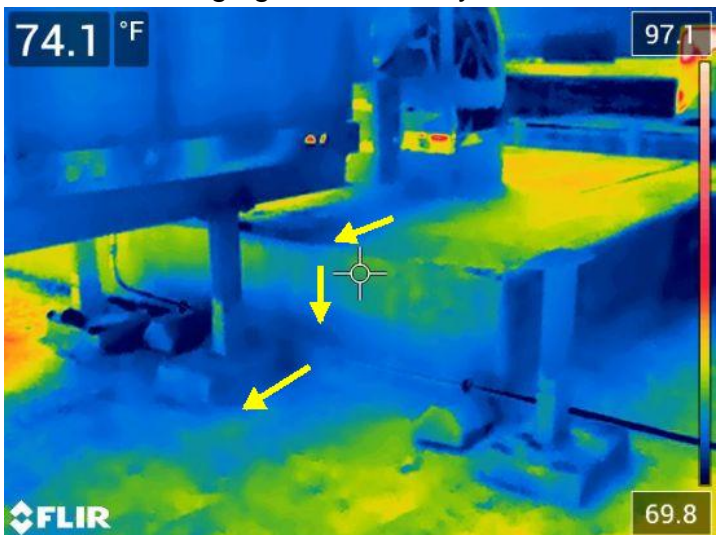
Infrared imaging of water entering through HVAC duct entry point into the roof membrane system and cascading down into the wall areas below.

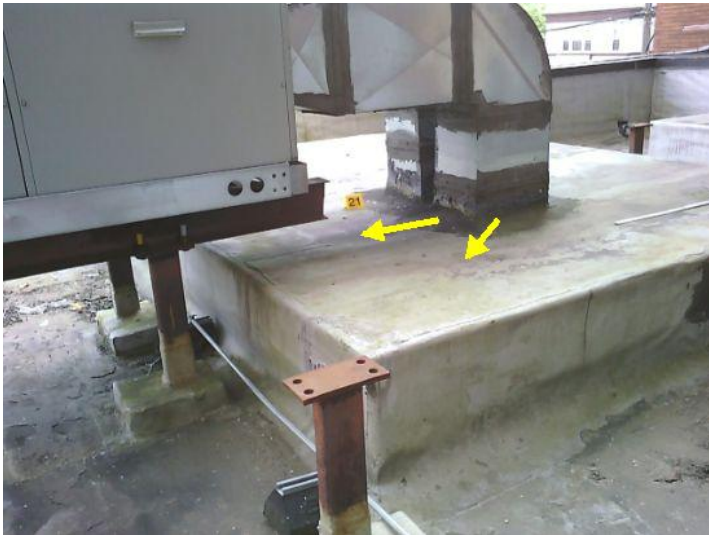
Water entering through HVAC duct entry point into the roof membrane system and cascading down into the wall areas below.

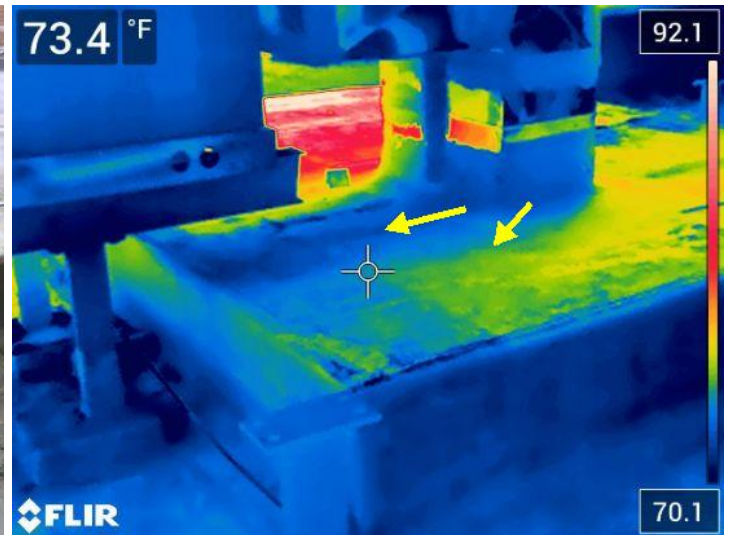
Infrared imaging of water entering through HVAC duct entry point into the roof membrane system and cascading down into the wall areas below.

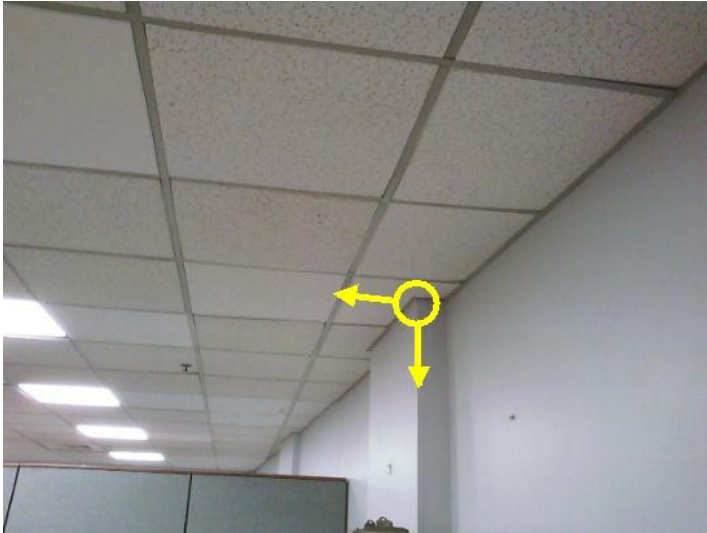
Water entry into wall area.

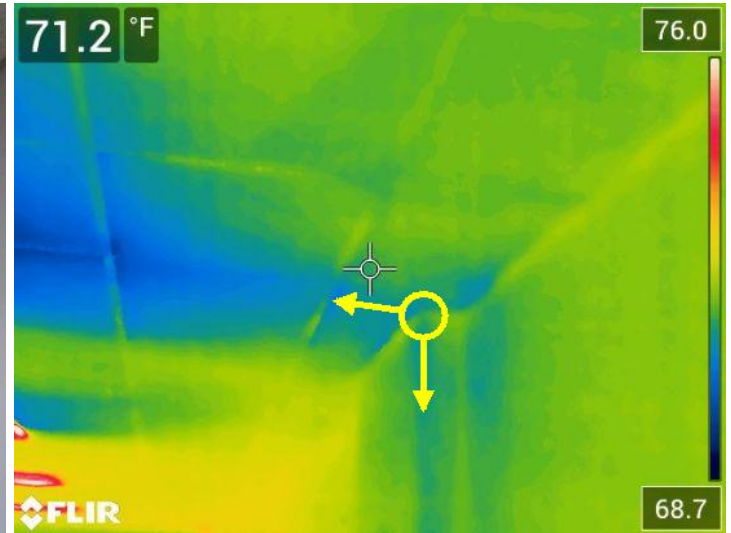
Infrared imaging of water entry into wall area.

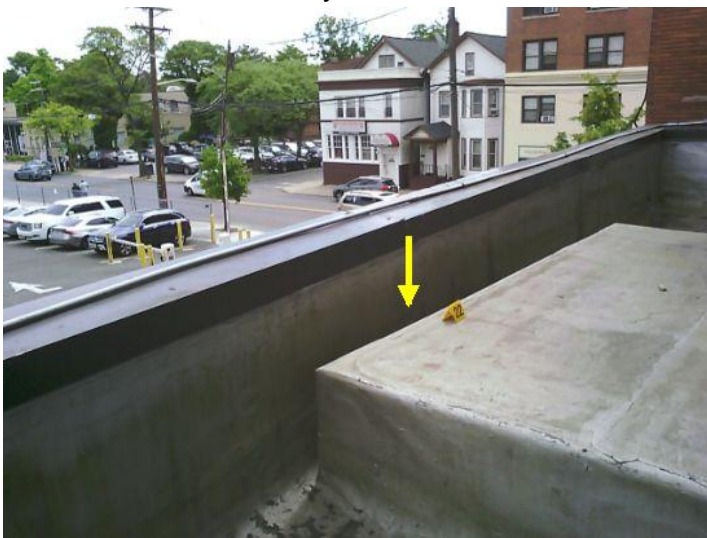
- **Source & Origin:** Parapet Wall Flashing Cap / Rear Brick Facade.
 - **Description:** Heavy wind-driven rain water is entering through the parapet wall flashing cap joints and rear brick facade, back flowing into the substrate and cascading down into the internal wall areas below.
 - **Repairs / Scope of Work:**
 - d. Remove parapet wall flashing cap.
 - e. Repoint and seal upper rear brick facade.
 - f. Waterproof top-side of parapet wall.
 - g. Install new flashing cap atop the parapet wall with proper segment overlay of at least 4 inches.
-

Water entering through parapet wall flashing cap joints and outer brick facade, cascading down and depositing into the wall areas below.

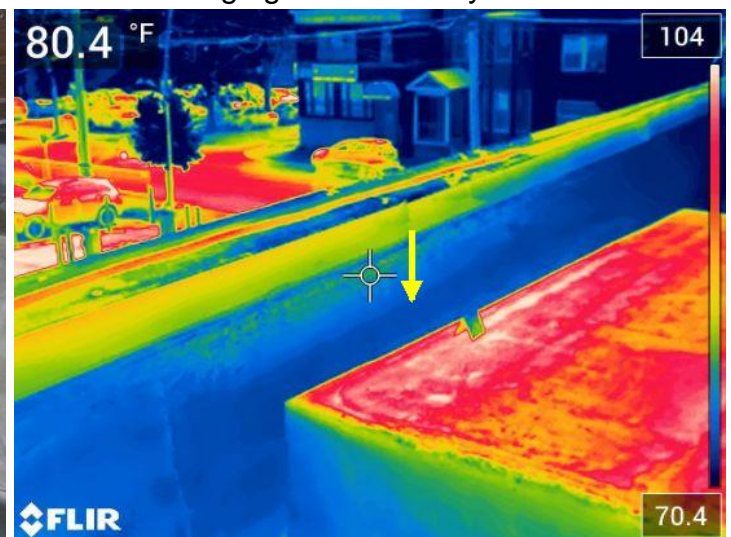
Infrared imaging of water entering through parapet wall flashing cap joints and outer brick facade, cascading down and depositing into the wall areas below.

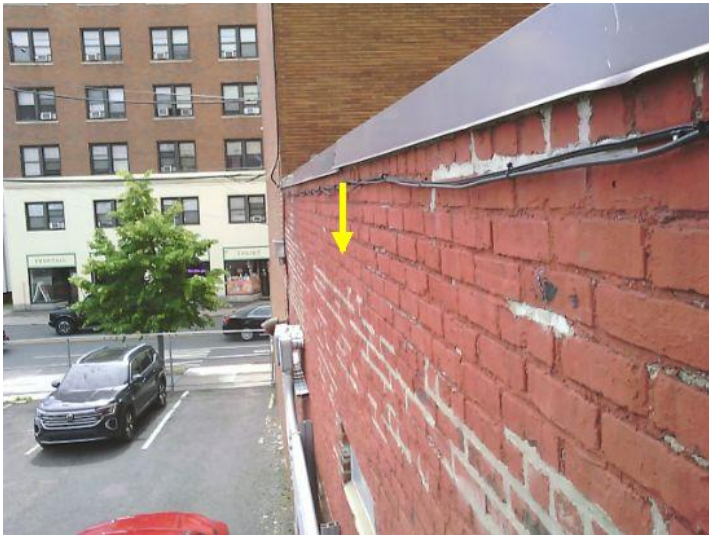
Water entering through parapet wall flashing cap joints and outer brick facade, cascading down and depositing into the wall areas below.

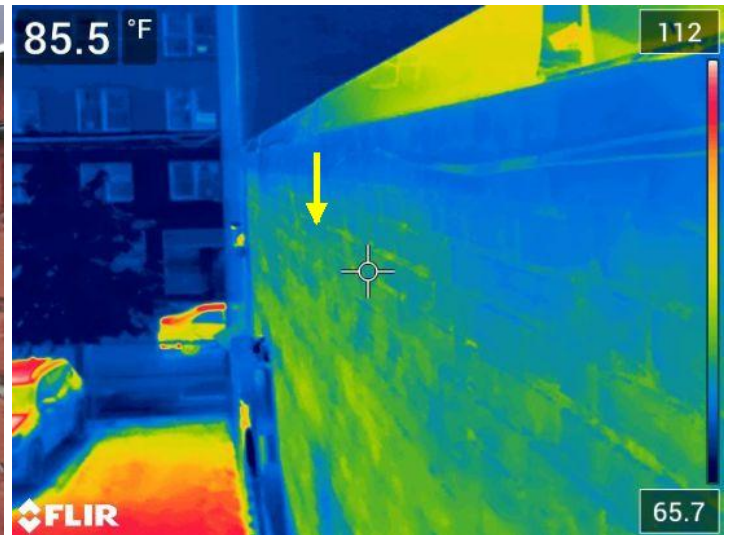
Infrared imaging of water entering through parapet wall flashing cap joints and outer brick facade, cascading down and depositing into the wall areas below.

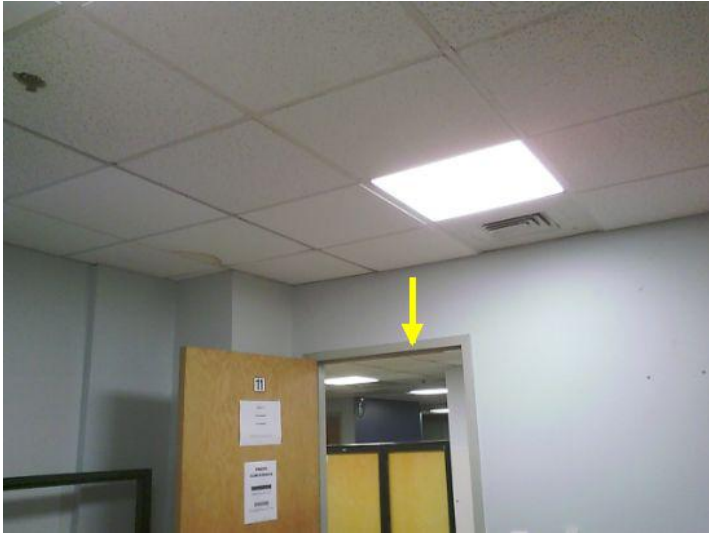
Water entry into wall area.

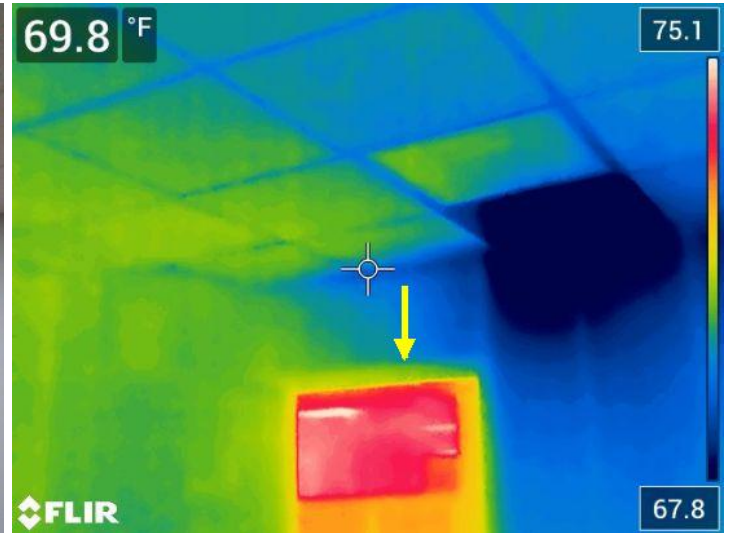
Infrared imaging of water entry into wall area.

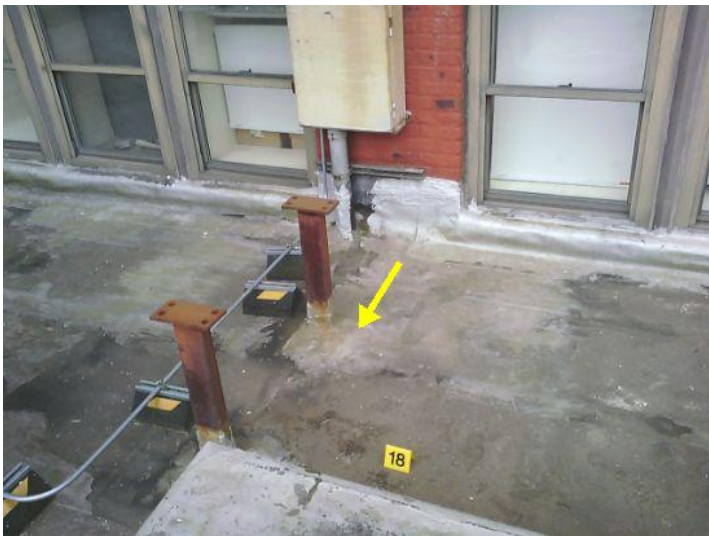
- **Source & Origin:** **Window Sill(s) / Brick Facade.**
- **Description:** Heavy wind-driven rain water is entering through the window sills and surrounding brick facade structure, cascading down into the roof membrane system and depositing into the internal wall areas below.
- **Repairs / Scope of Work:**
 - h. Waterproof window sills.
 - i. Waterproof surrounding brick facade area.

NOTE: Because the brick is severely deteriorated, we suggest consulting with your contractor as to the exact repair protocol for this area.

Water entering through the window sill and brick facade areas, cascading down and depositing into the internal wall areas below.

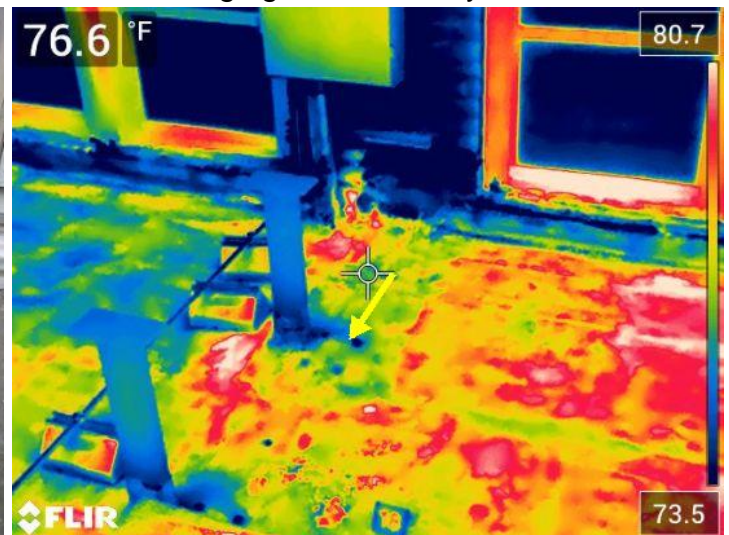
Infrared imaging of water entering through the window sill and brick facade areas, cascading down and depositing into the internal wall areas below.

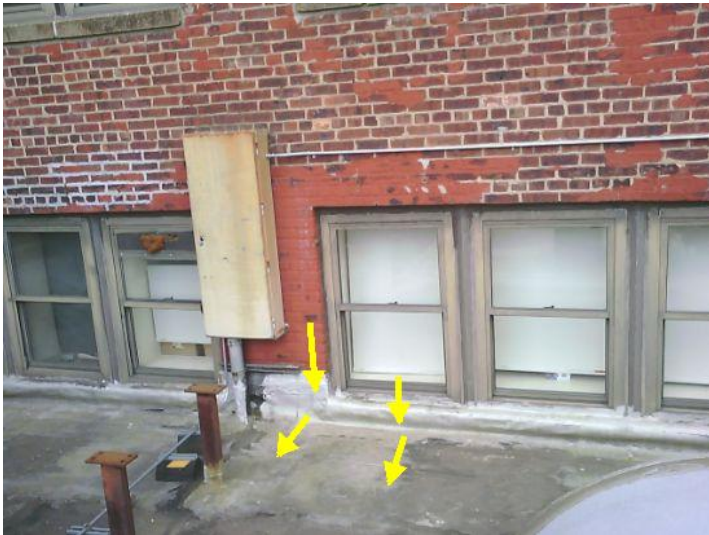
Water entering through the window sill and brick facade areas, cascading down and depositing into the internal wall areas below.

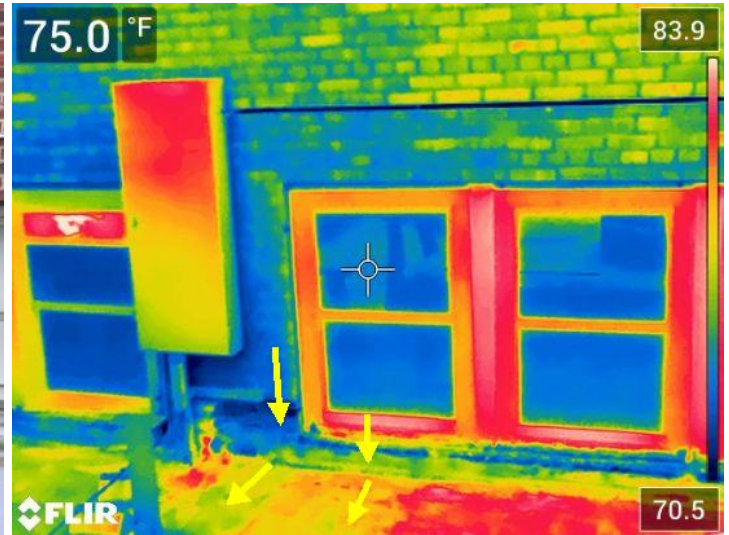
Infrared imaging of water entering through the window sill and brick facade areas, cascading down and depositing into the internal wall areas below.

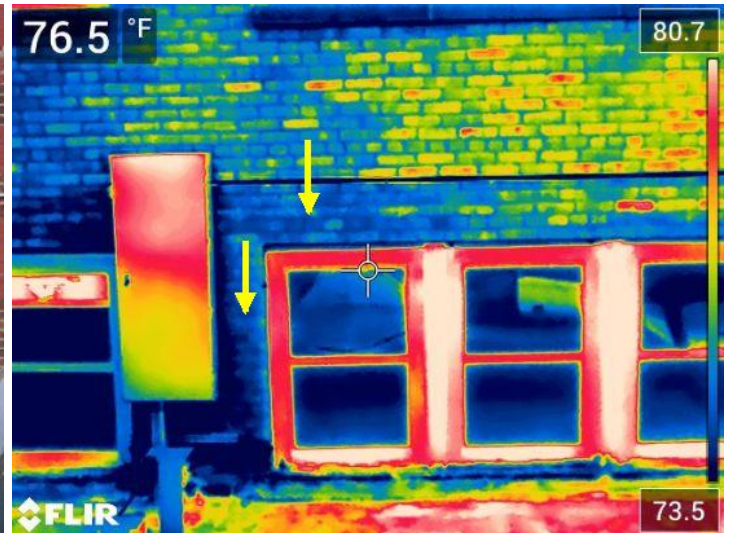
Infrared imaging of water entering through the window sill and brick facade areas, cascading down and depositing into the internal wall areas below.

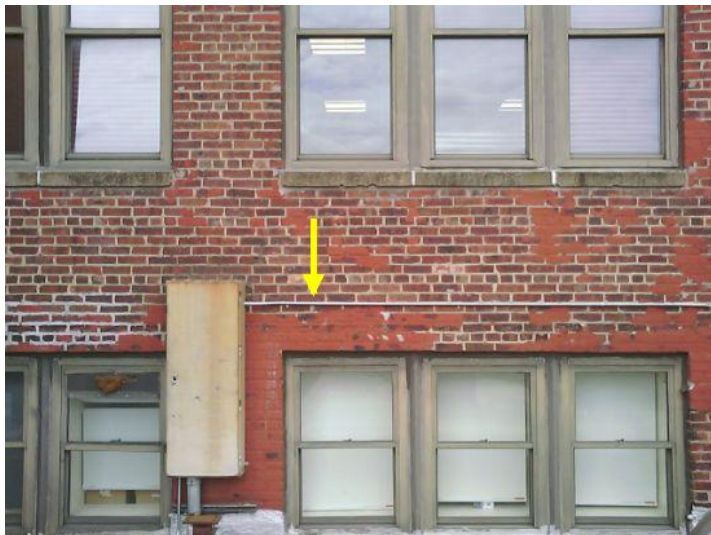
Water entering through the window sill and brick facade areas, cascading down and depositing into the internal wall areas below.

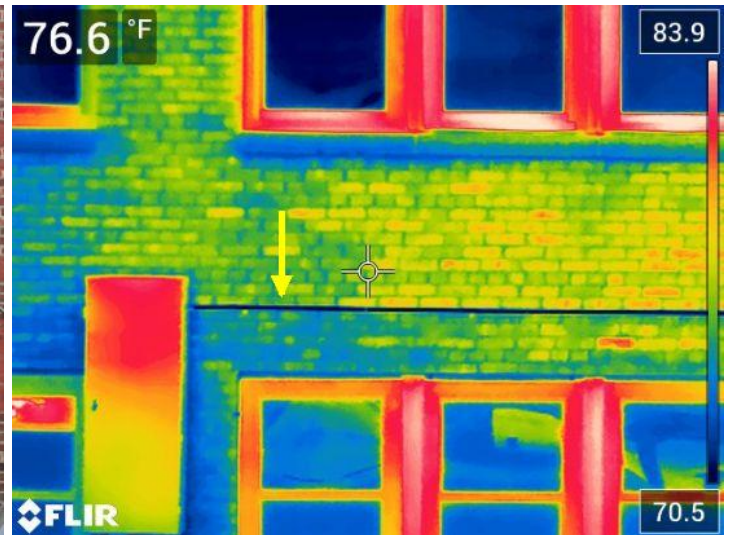
Infrared imaging of water entering through the window sill and brick facade areas, cascading down and depositing into the internal wall areas below.

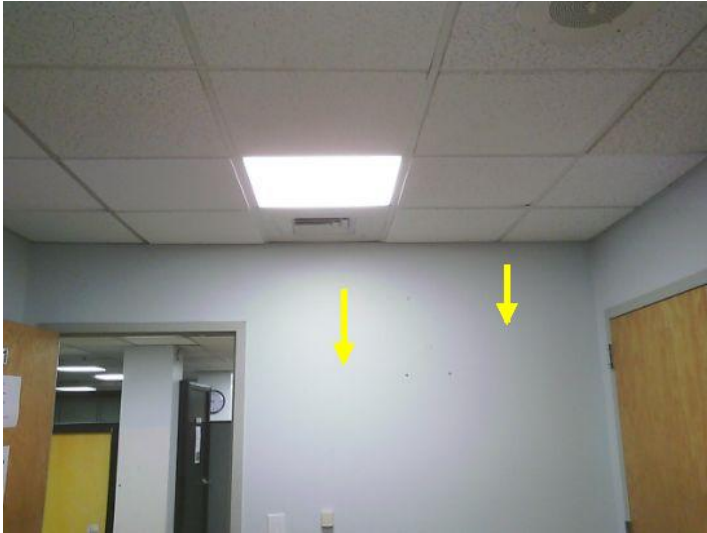
Water entry into wall area.

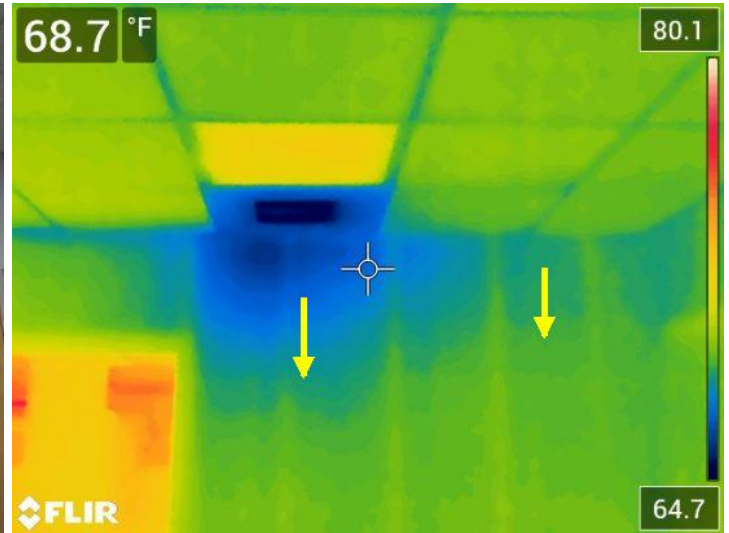
Infrared imaging of water entry into wall area.

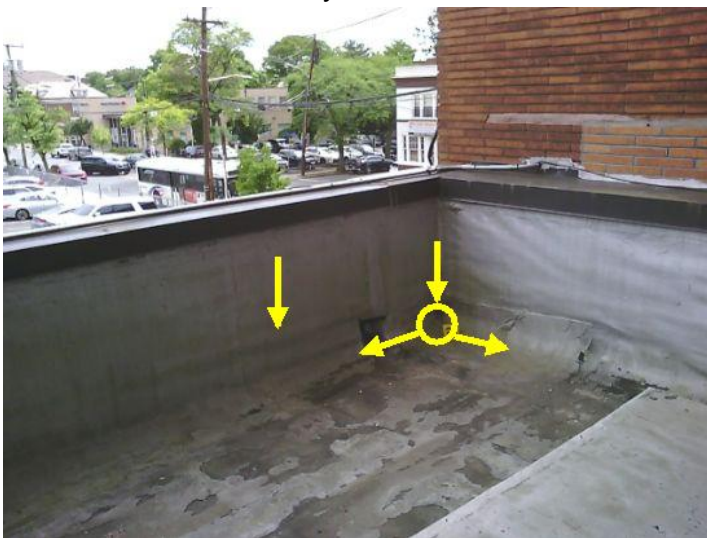
- **Source & Origin:** **Parapet Wall Flashing Cap / Brick Facade.**
- **Description:** Heavy wind-driven rain water is entering through the neighboring property's brick facade, cascading down and entering into the parapet wall flashing cap joints eventually depositing into the primary membrane system. Once inside the membrane, water is continuing down into the substrate and finally entering into the wall areas below.
- **Repairs / Scope of Work:**
 - j. Remove parapet wall flashing cap.
 - k. Excavate brick from neighboring property's facade, as outlined.
 - l. Waterproof and flash area accordingly.
 - m. Install proper drainage channels / weep holes to divert water outward.
 - n. Clear debris from roof membrane system.
 - o. Waterproof surrounding roof membrane system.
 - p. Install new flashing cap atop the parapet wall with proper segment overlay of at least 4 inches.

NOTE: Because the brick is multi-wythe and not veneer, we suggest consulting with your contractor as to the exact repair protocol for this area.

Water entering through the parapet wall flashing cap joints and connecting brick facade, cascading down and depositing into the wall areas below.

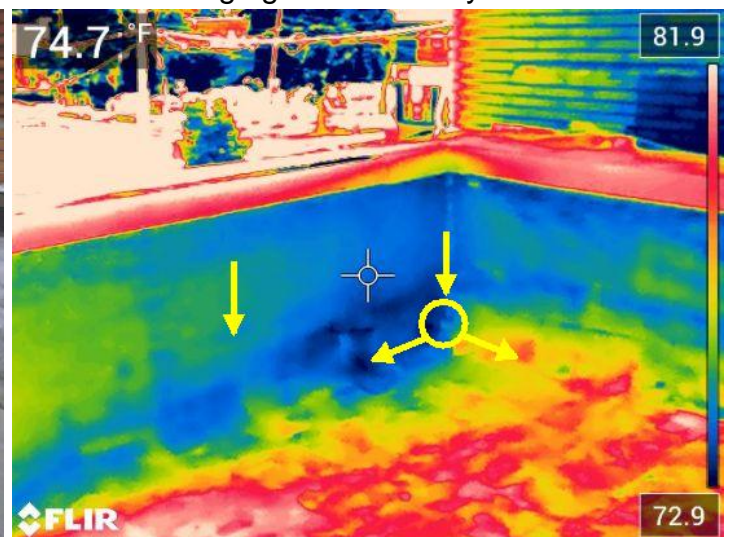
Infrared imaging of water entering through the parapet wall flashing cap joints and connecting brick facade, cascading down and depositing into the wall areas below.

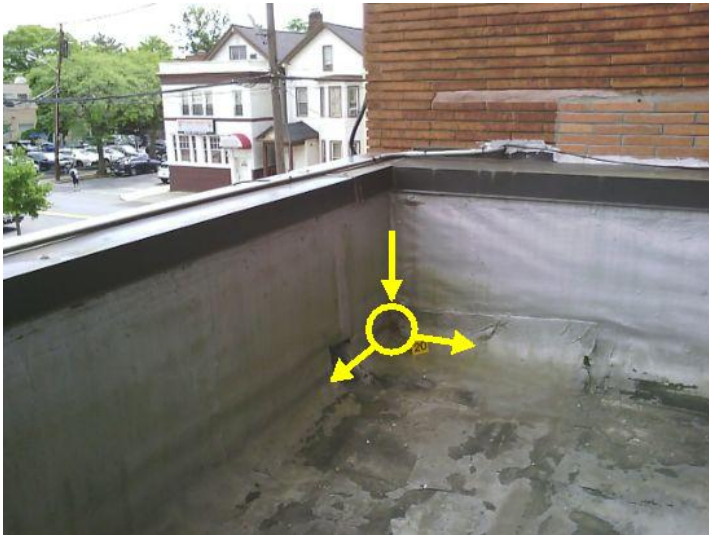
Water entering through the parapet wall flashing cap joints and connecting brick facade, cascading down and depositing into the wall areas below.

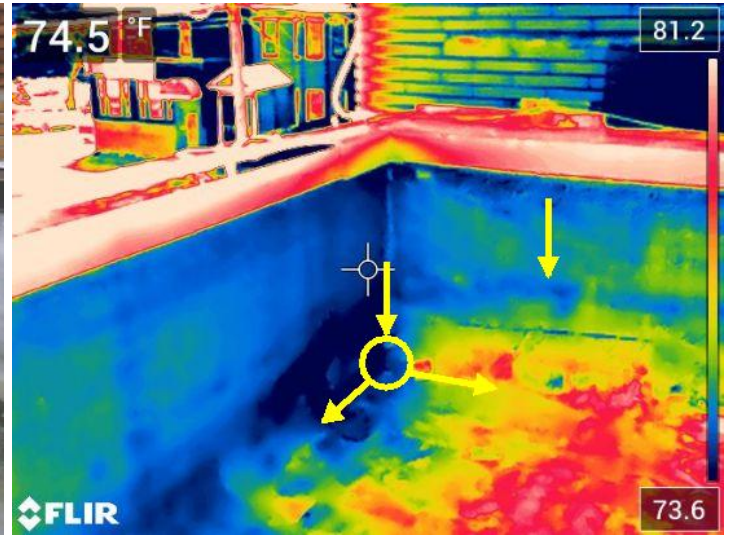
Infrared imaging of water entering through the parapet wall flashing cap joints and connecting brick facade, cascading down and depositing into the wall areas below.

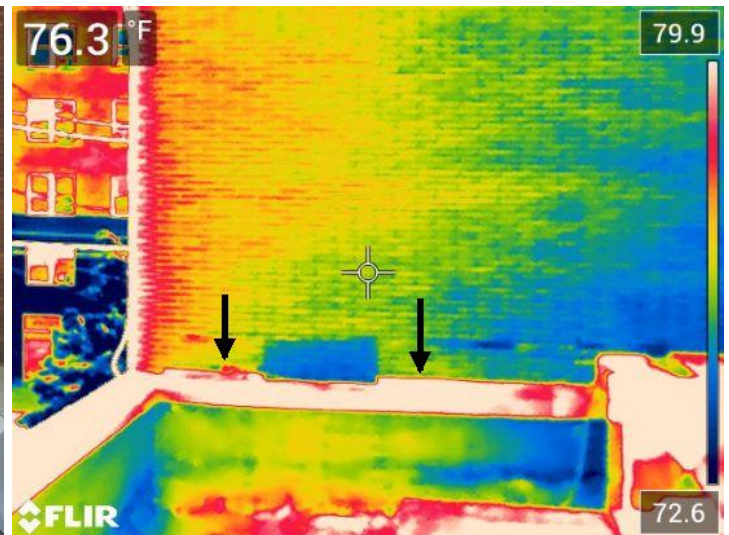
Infrared imaging of water entering through the parapet wall flashing cap joints and connecting brick facade, cascading down and depositing into the wall areas below.

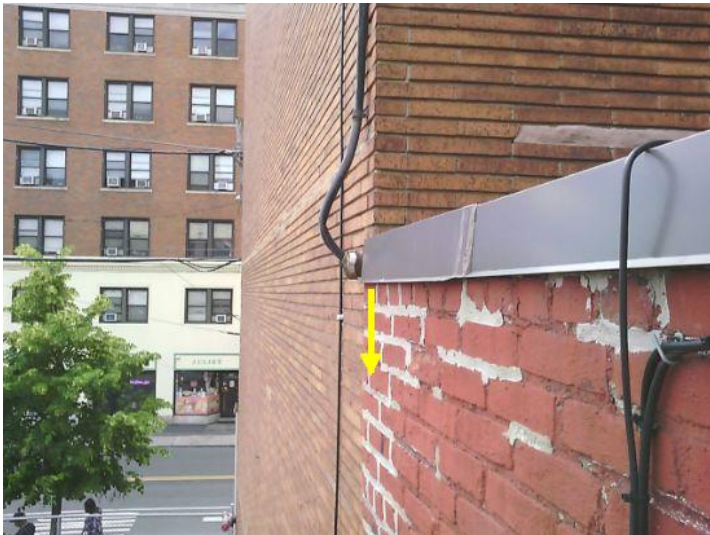
Water entering through the parapet wall flashing cap joints and connecting brick facade, cascading down and depositing into the wall areas below.

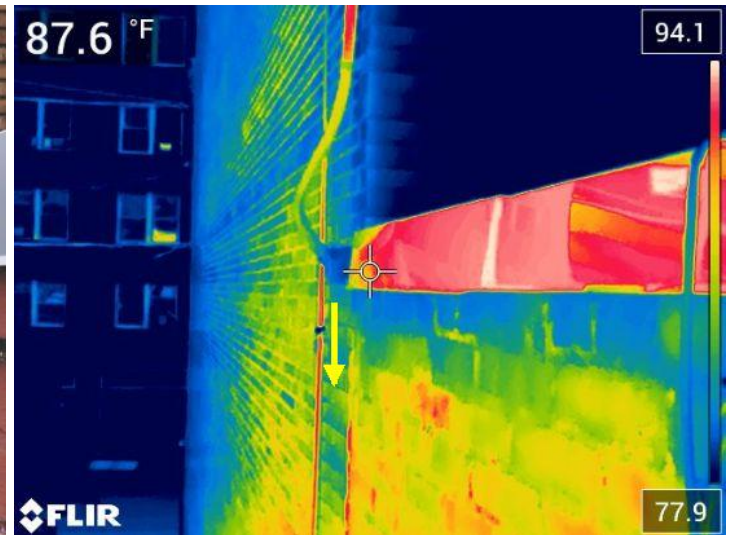
Infrared imaging of water entering through the parapet wall flashing cap joints and connecting brick facade, cascading down and depositing into the wall areas below.

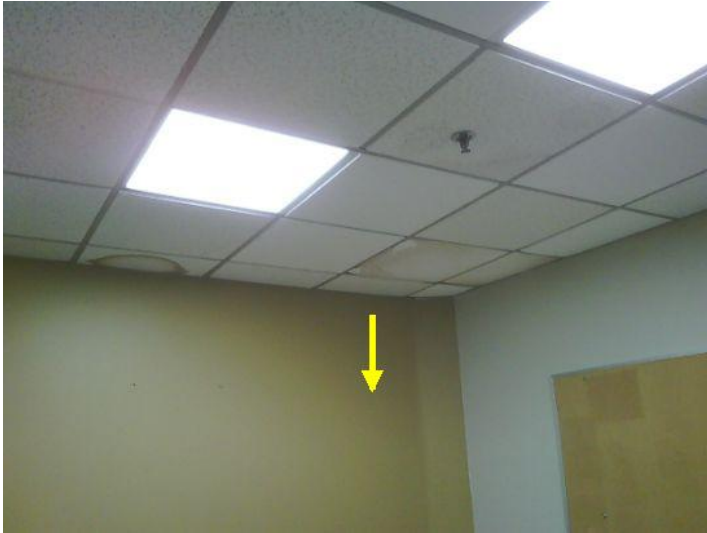
Water entry into wall / ceiling area.

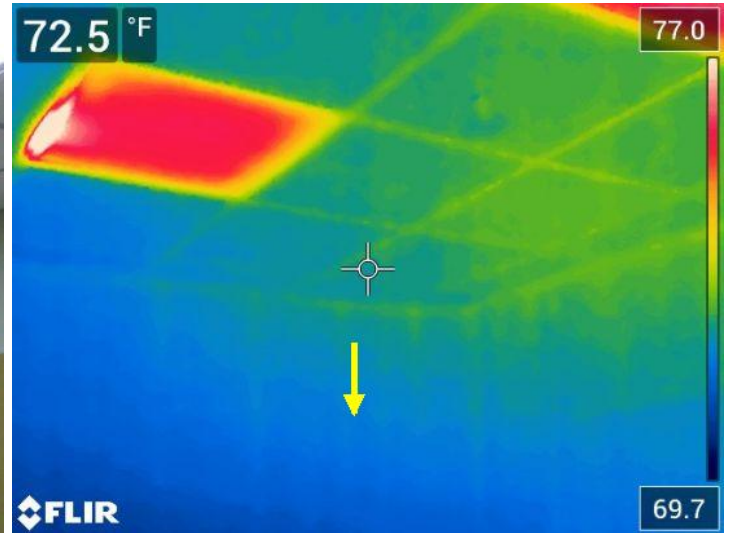
Infrared imaging of water entry into wall / ceiling area.

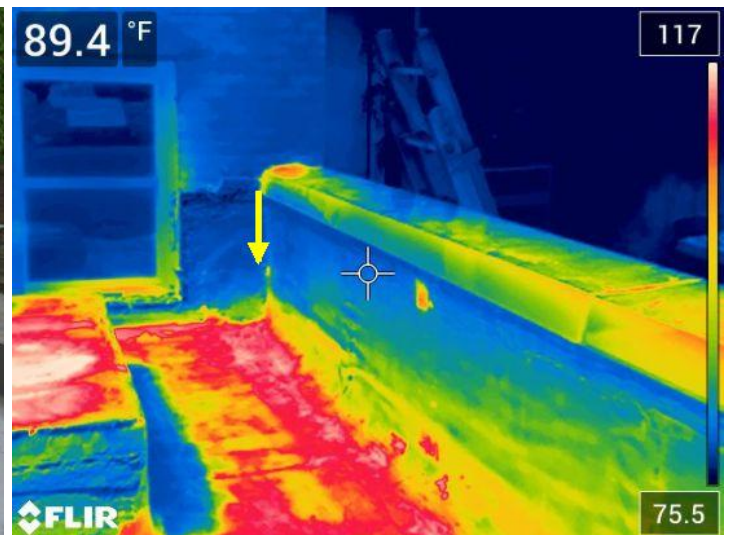
- **Source & Origin:** **Parapet Wall / Brick Facade.**
 - **Description:** Heavy wind-driven rain water is entering through the parapet wall connection point to the brick facade, cascading down into the primary roof membrane system and depositing into the ceiling / wall areas below.
 - **Repairs / Scope of Work:**
 - q. Remove parapet wall flashing cap.
 - r. Waterproof brick facade connection point to the parapet wall.
 - s. Reinstall flashing cap.
 - t. Seal all flashing cap joints.
-

Infrared imaging of water entering through brick facade connection point to the parapet wall and cascading down into the internal ceiling / wall areas below.

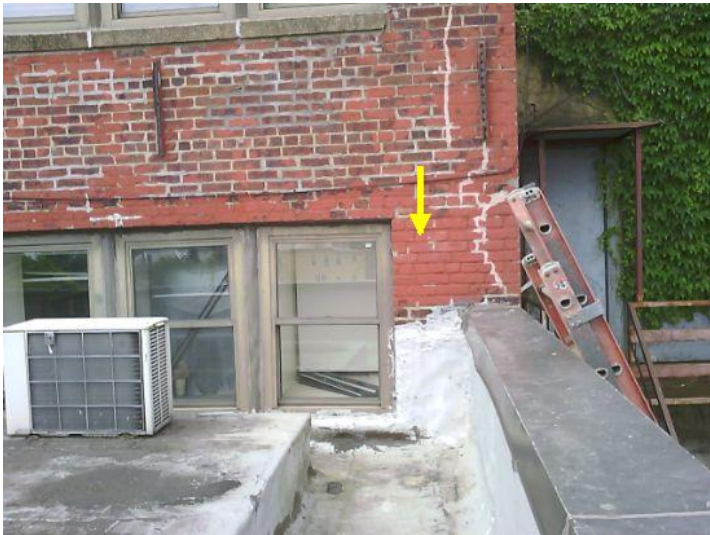
Water entering through brick facade connection point to the parapet wall and cascading down into the internal ceiling / wall areas below.

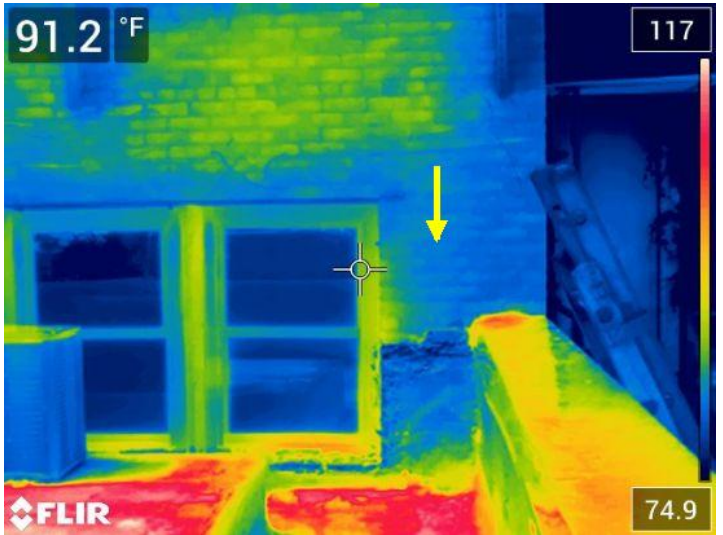
Infrared imaging of water entering through brick facade connection point to the parapet wall and cascading down into the internal ceiling / wall areas below.

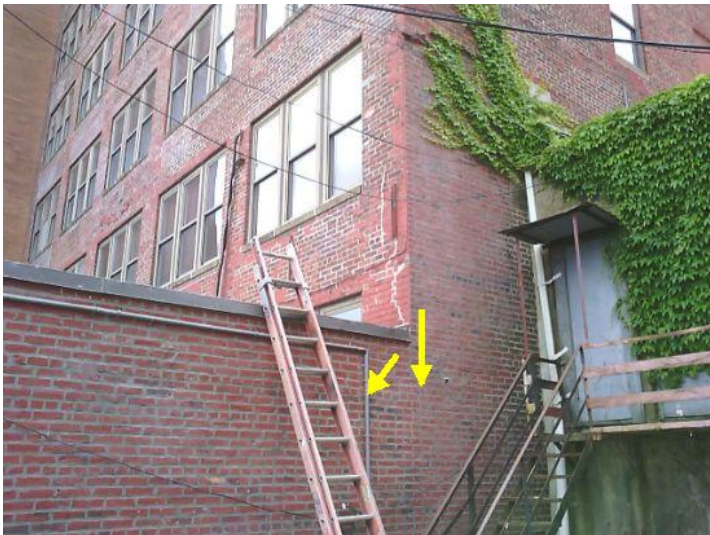
Water entering through brick facade connection point to the parapet wall and cascading down into the internal ceiling / wall areas below.

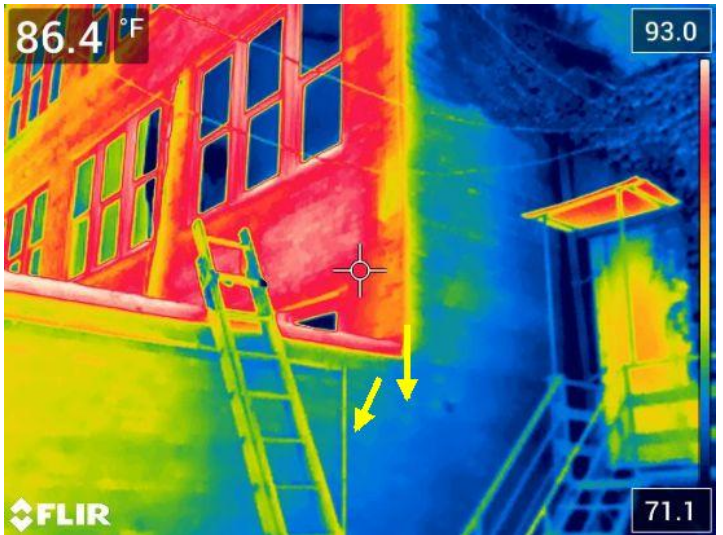
Infrared imaging of water entering through brick facade connection point to the parapet wall and cascading down into the internal ceiling / wall areas below.

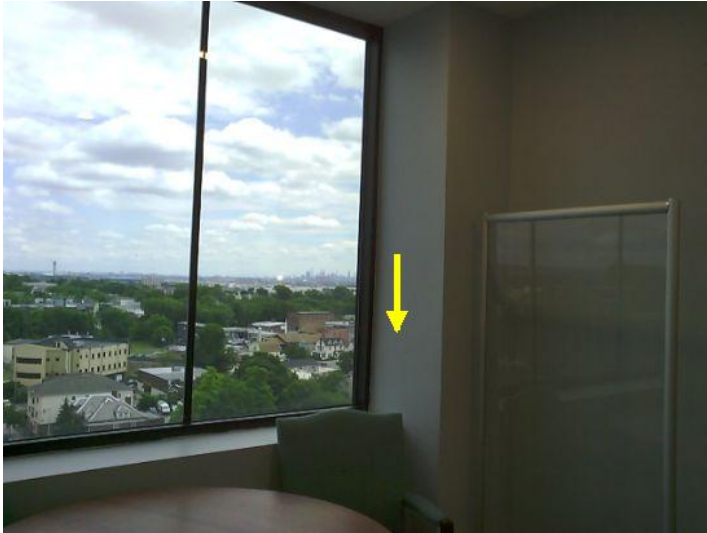
Water entry into window frame area.

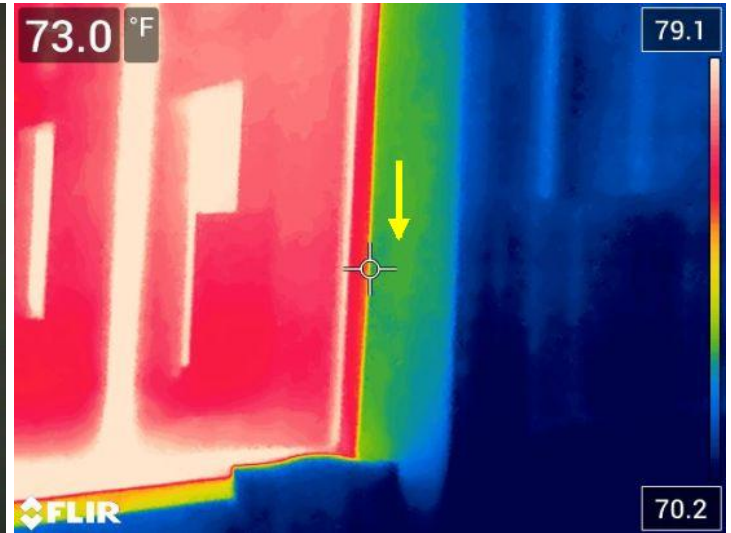
Infrared imaging of water entry into window frame area.

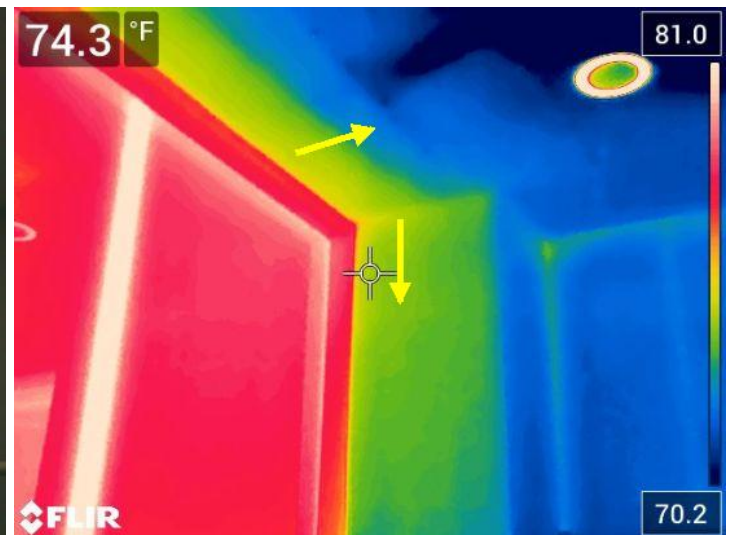
Infrared imaging of water entry into window frame area.

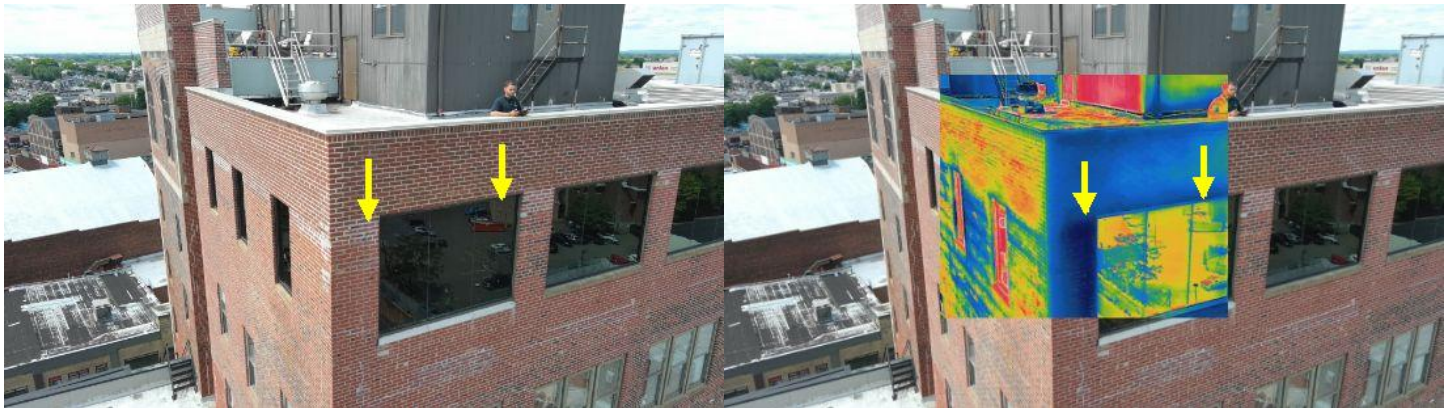
- **Source & Origin:** **Brick Facade.**
 - **Description:** Heavy wind-driven rain water is entering through the upper brick facade, back flowing into the substrate and cascading down into the internal window frame areas below.
 - **Repairs / Scope of Work:**
 - u. Seal outlined area of rear facade brick with an Elastoflex type sealant system.
-

Water entering through the brick facade and cascading down into the window frame areas below.

Infrared imaging of water entering through the brick facade and cascading down into the window frame areas below.

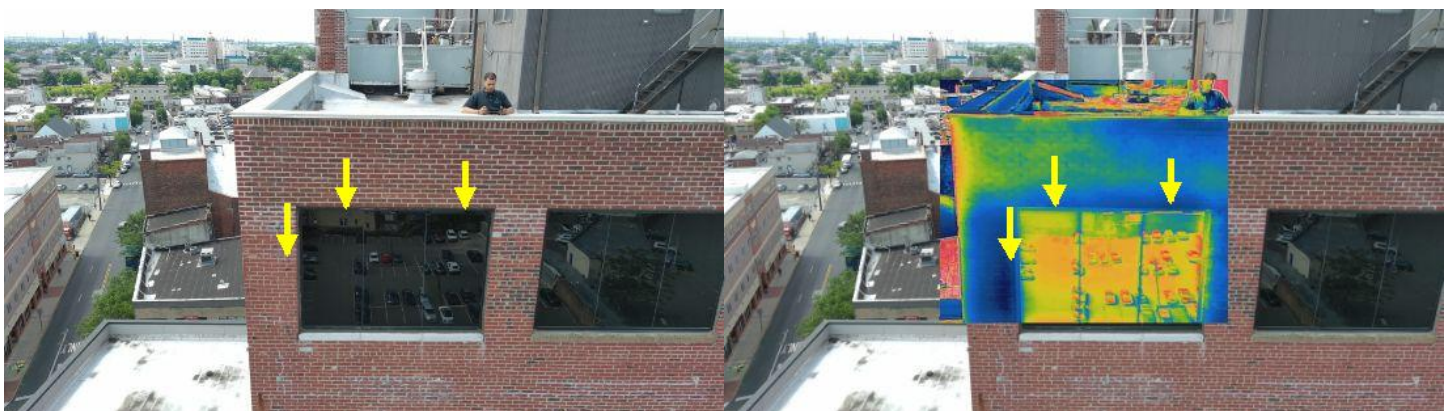
Water entering through the brick facade and cascading down into the window frame areas below.

Infrared imaging of water entering through the brick facade and cascading down into the window frame areas below.

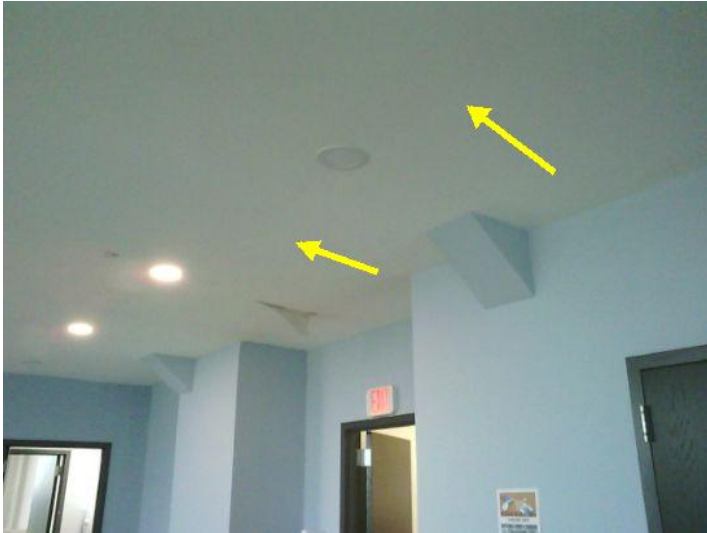
Water entry into ceiling area.

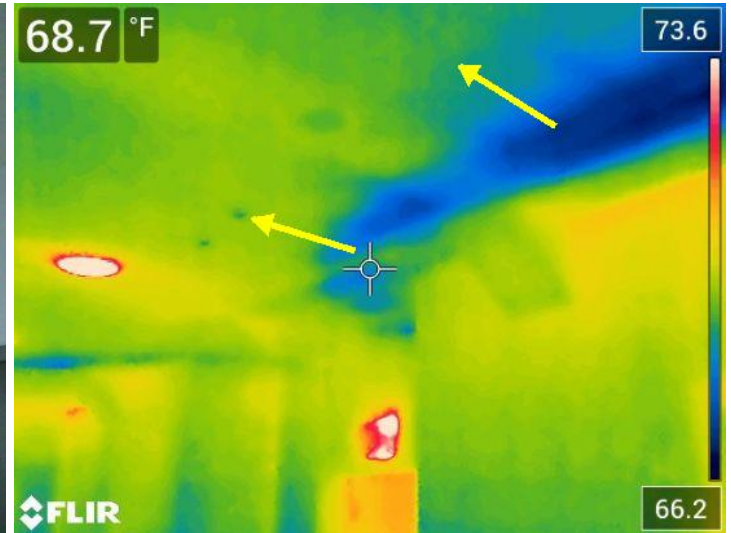
Infrared imaging of water entry into ceiling area.

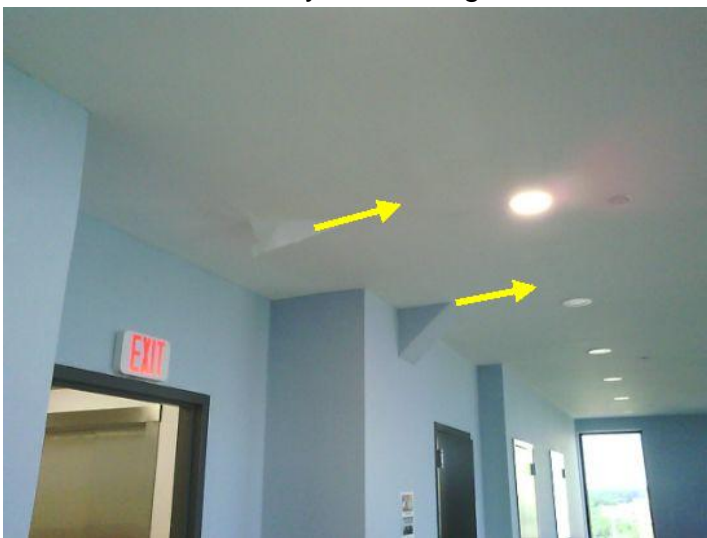
Water entry into ceiling area.

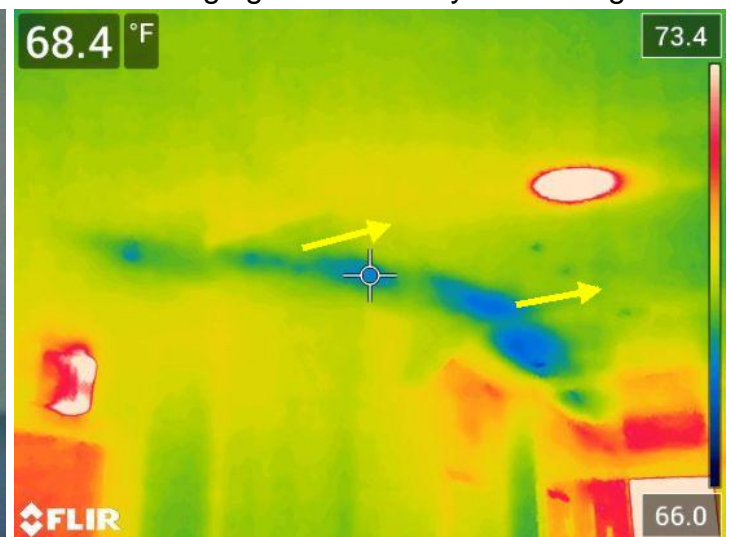
Infrared imaging of water entry into ceiling area.

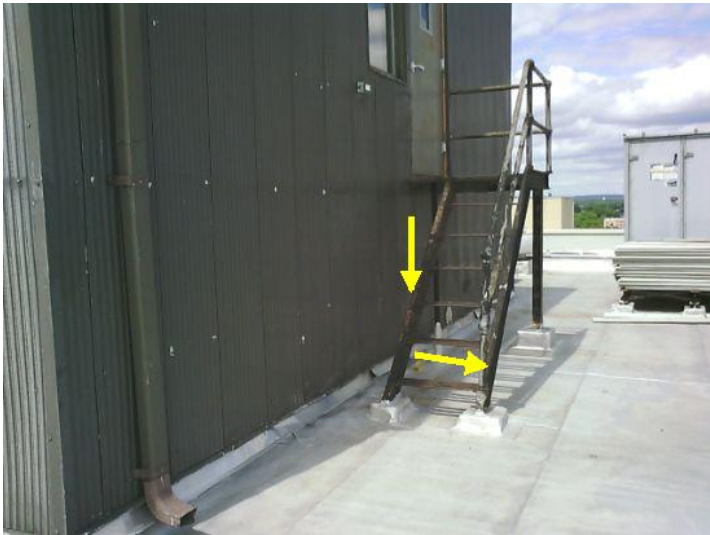
- **Source & Origin:** **Bulkhead Wall / Door Baseplate.**
- **Description:** Heavy wind-driven rain water is entering through the bulkhead wall panel system, especially around the elevator room access door baseplate assembly as well as the nearby window frame, back flowing into the substrate and cascading down into the internal ceiling areas below.
- **Repairs / Scope of Work:**
 - v. Remove panels from the bulkhead wall focusing on the areas around the elevator room access door frame and the nearby window frame, as outlined.
 - w. Waterproof and flash areas accordingly.
 - x. Install new panels.

Water entering through the bulkhead wall panels around the door baseplate and window, cascading down and depositing into the ceiling areas below.

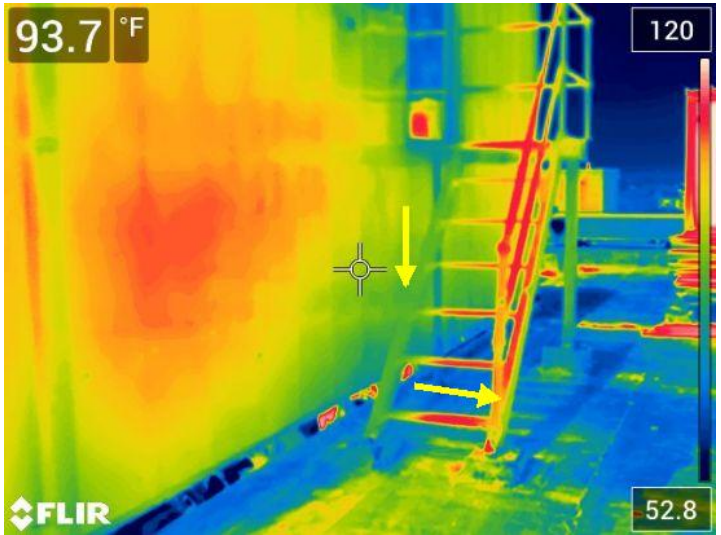
Infrared imaging of water entering through the bulkhead wall panels around the door baseplate and window, cascading down and depositing into the ceiling areas below.

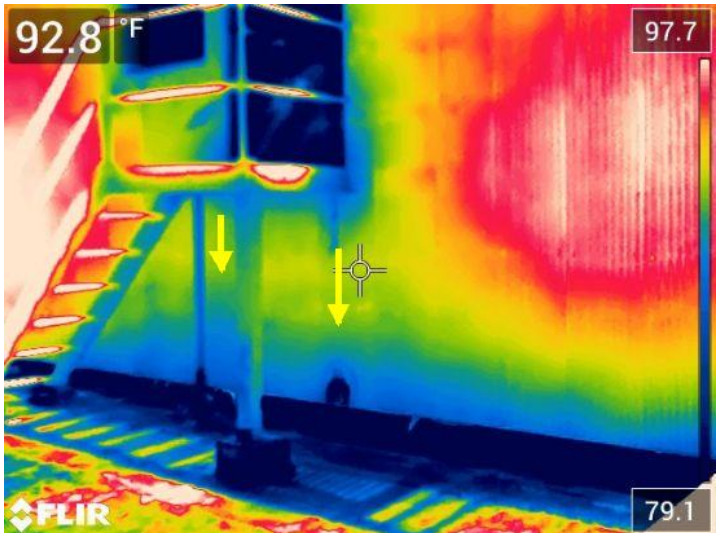
Infrared imaging of water entering through the bulkhead wall panels around the door baseplate and window, cascading down and depositing into the ceiling areas below.
