JP Diagnostics LLC

Infrared Leak Detection Report

Inspection prepared for:
Date of Inspection: 5/22/2024 Time: 0930 Size: Commercial
Weather: Clear - Warm/75df
Single-Leak Source and Origin (1L.SO)

First Floor Ceiling Leak

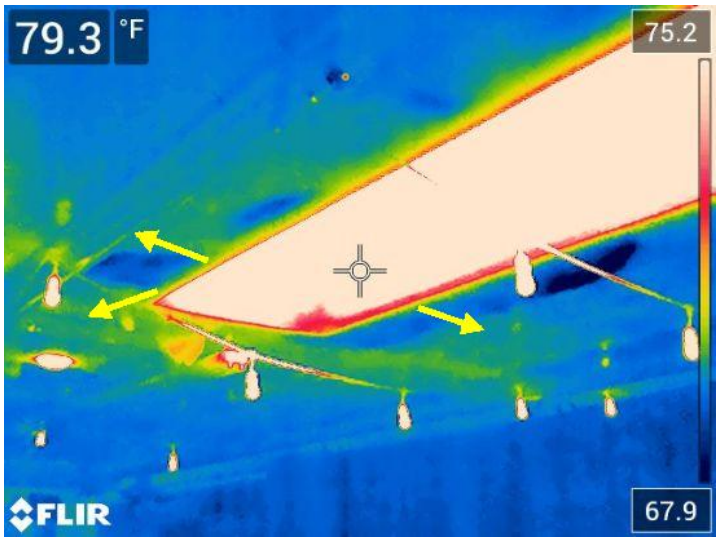
1. Water Leak Source / Origin: Skylight Glass and Frame

Water entry into ceiling area.

Repair Point: Seal skylight glass and frame. If possible, replace seals. If water entry continues, replace skylight and seal around frame.

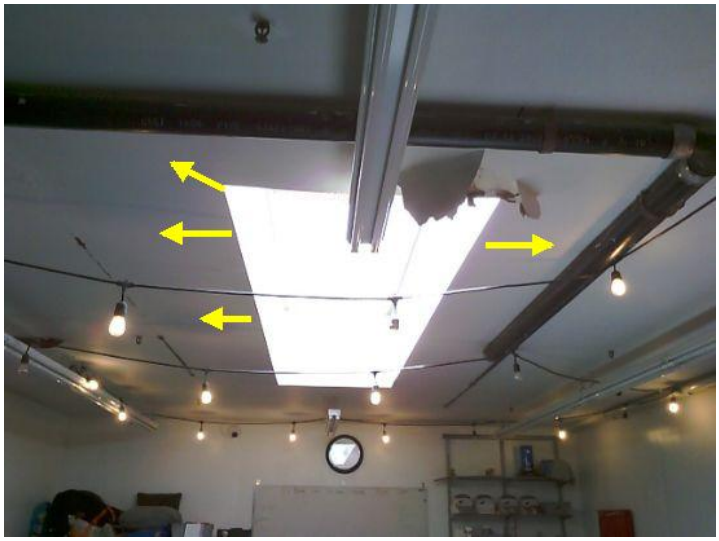
Infrared imaging of water entry into ceiling area.

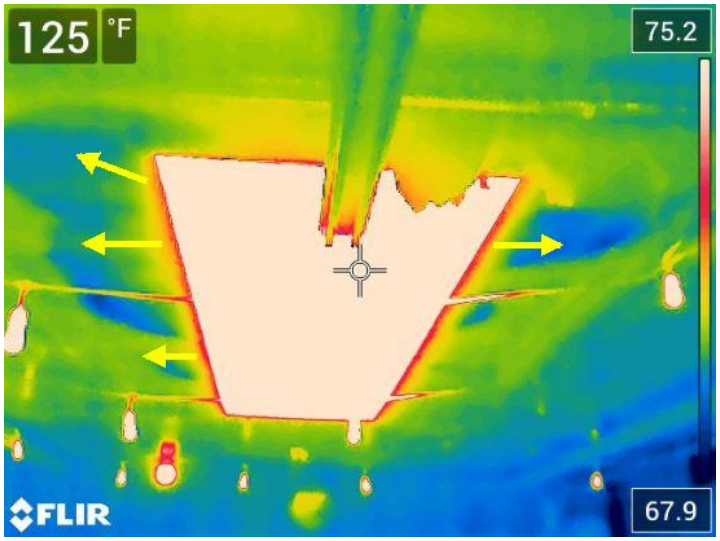
Water entry into ceiling area.

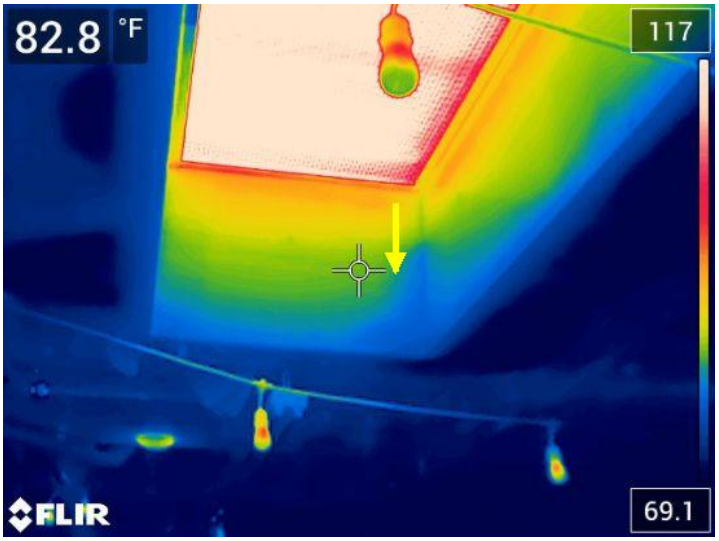
Infrared imaging of water entry into ceiling area.

Water entering through the skylight glass and frame, cascading down and depositing into the ceiling areas below.

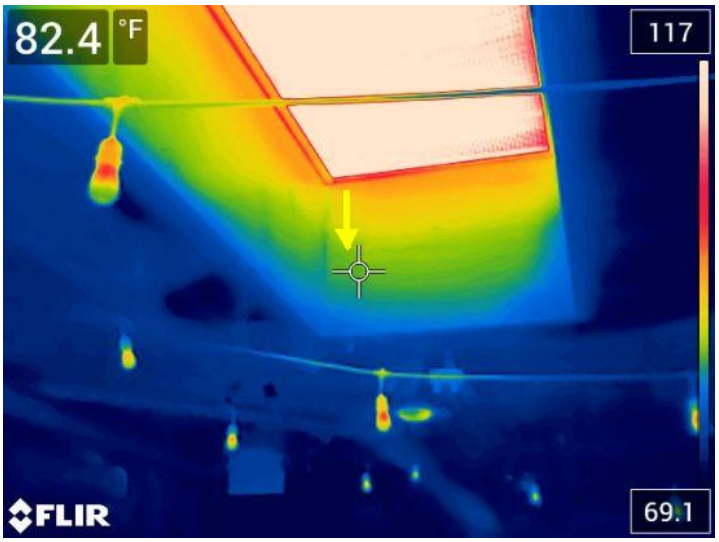
Infrared imaging of water entering through the skylight glass and frame, cascading down and depositing into the ceiling areas below.

Water entering through the skylight glass and frame, cascading down and depositing into the ceiling areas below.
