JP Diagnostics *Leak Detection Report*

Date of Inspection: 6/20/2022 Time: 0900 Size: Brick / Masonry

Full Building Infrared Audit (FB.IR.AUD)

2065 West 7th Street, 2nd Floor, Brooklyn, NY 11223

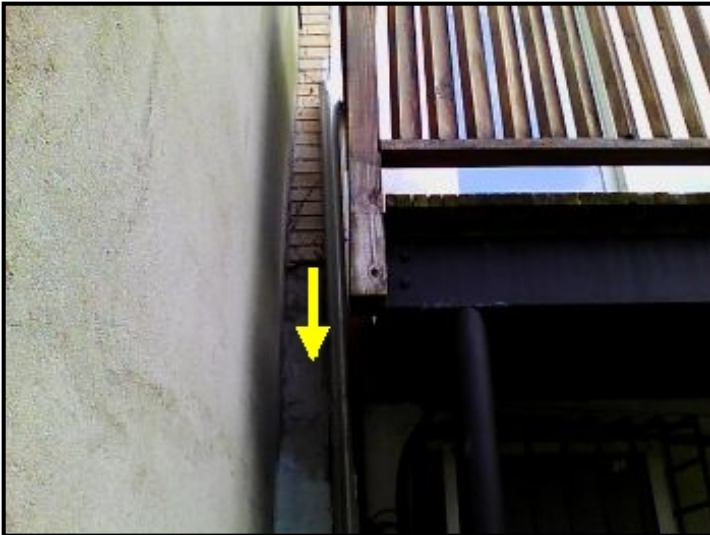
Water entering through rear facade and backflowing into the internal wall area.

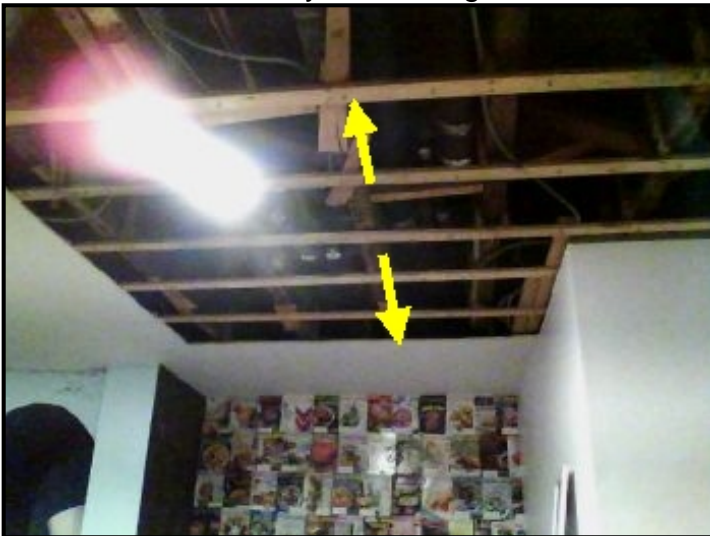
Water entry into ceiling area.

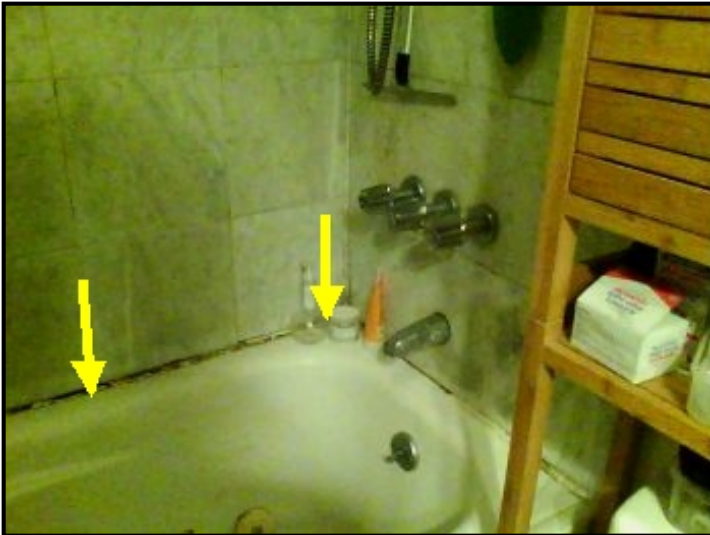
2. **Unit 1 Basement Ceiling Leak Source and Origin: Shower Stall Tile Wall.** During shower stall operation, water is entering through the deteriorated grout joints of the shower stall tile wall, backflowing into the substrate and cascading down into the ceiling area below causing minor damage to the surrounding area.

Water entering through shower stall tile wall area and cascading down into the ceiling area below.

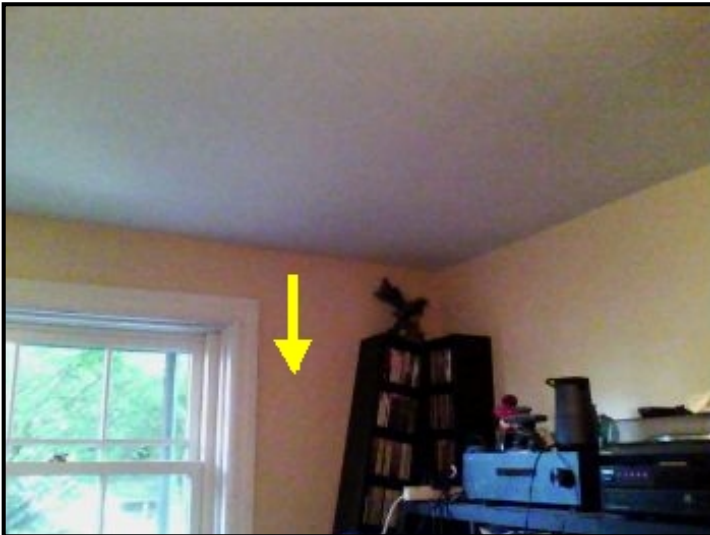
Water entry into wall/ceiling area.

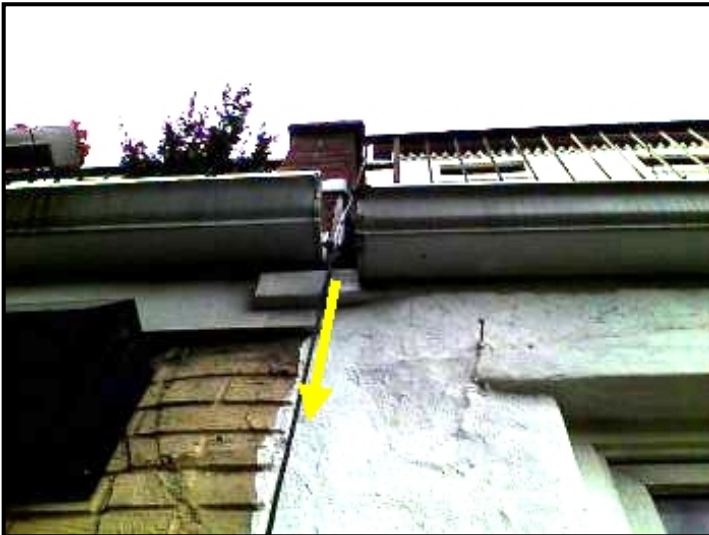
Water entering through the rear facade between the gutter trays and through the brick parapet wall above.

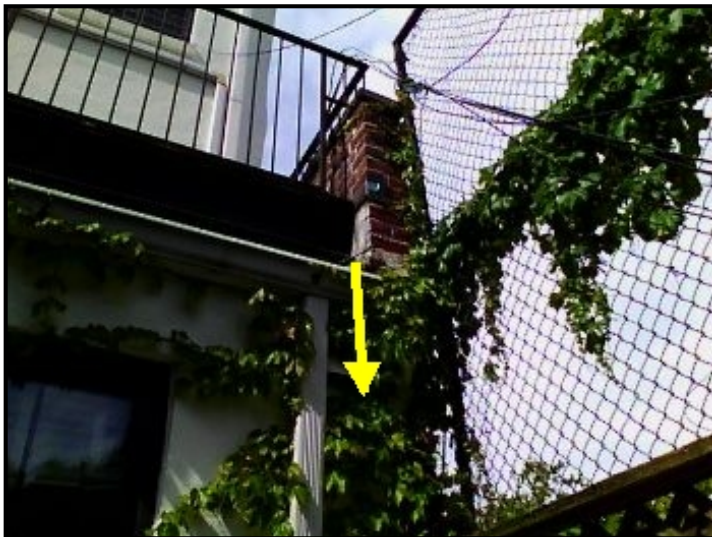
Water entering through parapet wall and cascading down into the ceiling/wall area below.

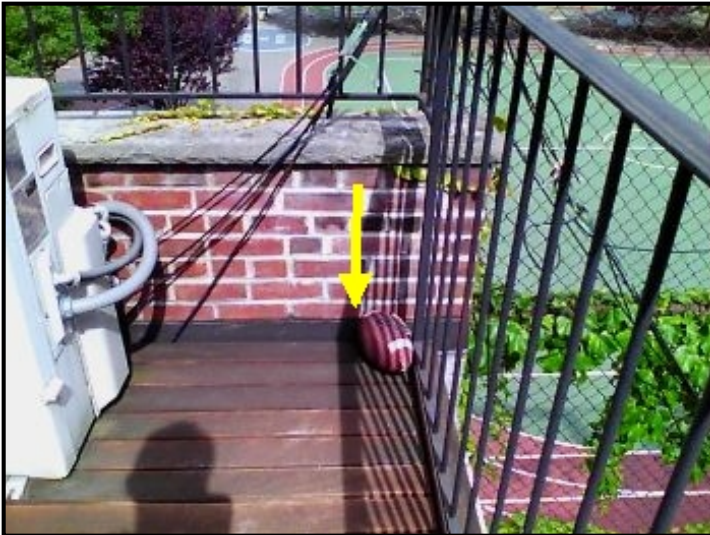
Water entering through parapet wall and cascading down into the ceiling/wall area below.

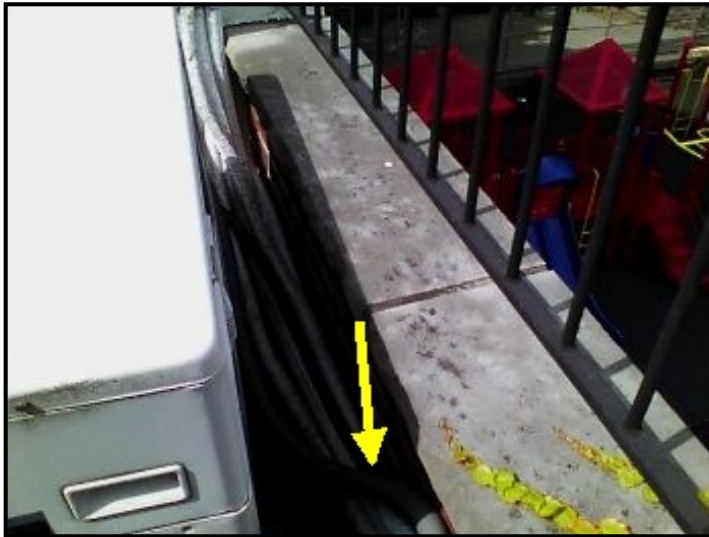
Water entering through parapet wall coping stone system and cascading down into the ceiling/wall area below.

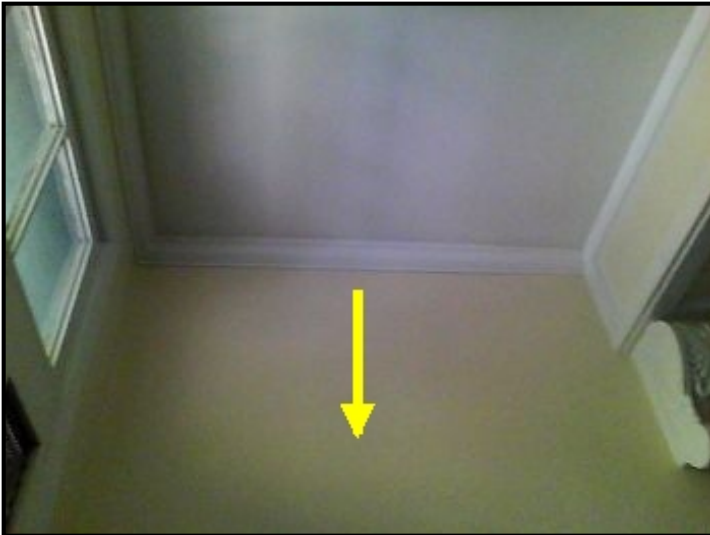
Water entry into wall area.

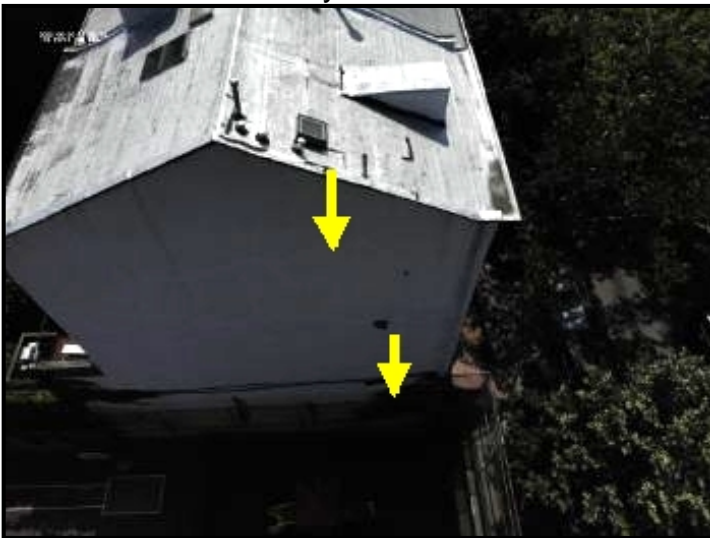
Water entering through roof membrane/parapet wall coping stone connection point, cascading down through the side facade and depositing into the internal wall areas below.

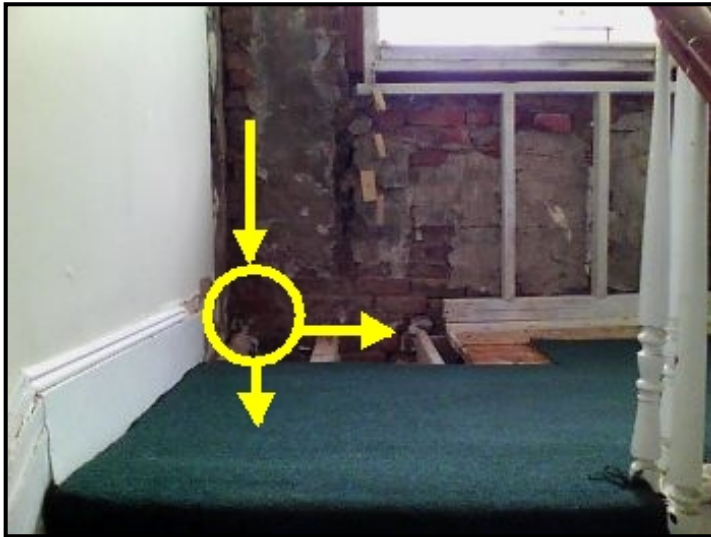
Water cascading down through wall area.

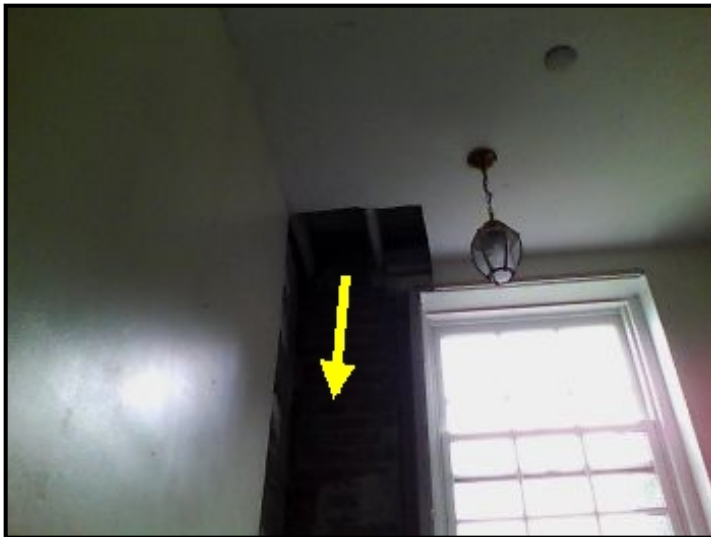
Severe water entry into corner wall area from upper roof membrane system.

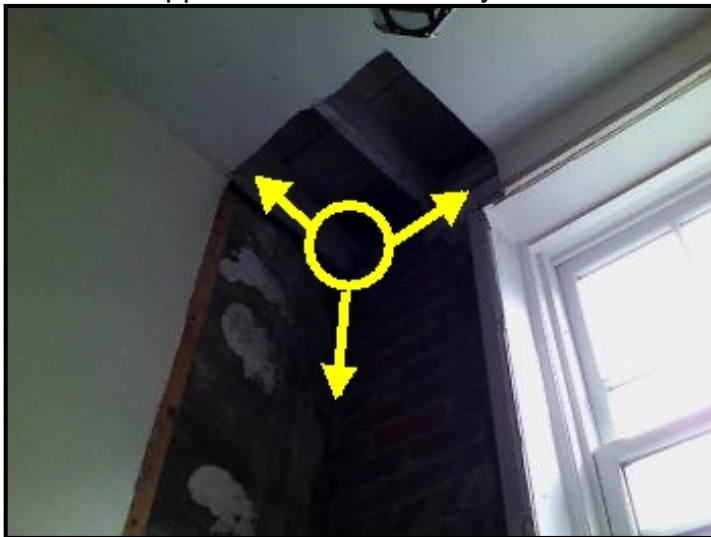
Severe water entry into corner wall area from upper roof membrane system.

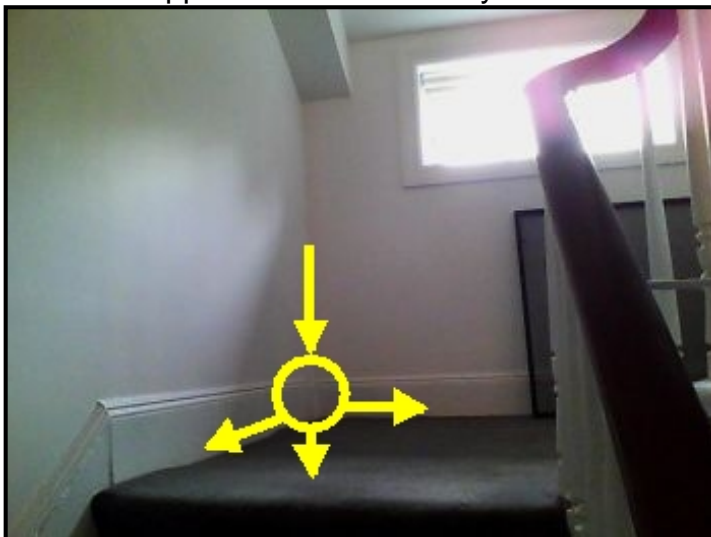
Severe water entry into corner wall area from upper roof membrane system.

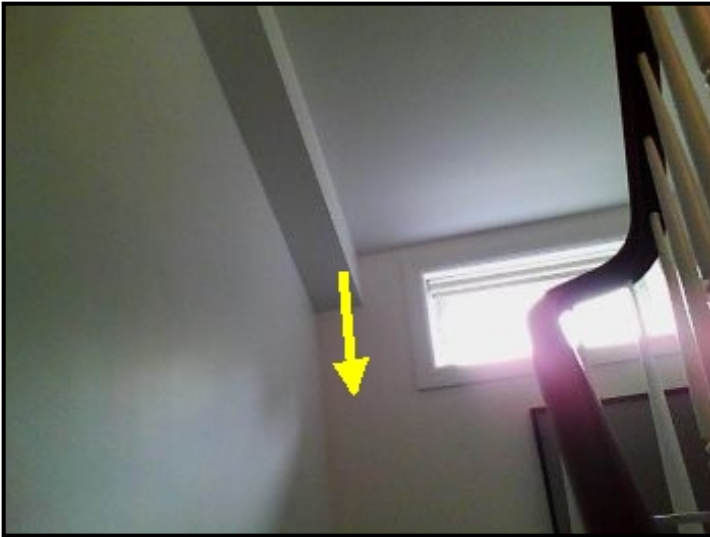
Severe water entry into corner wall area from upper roof membrane system.

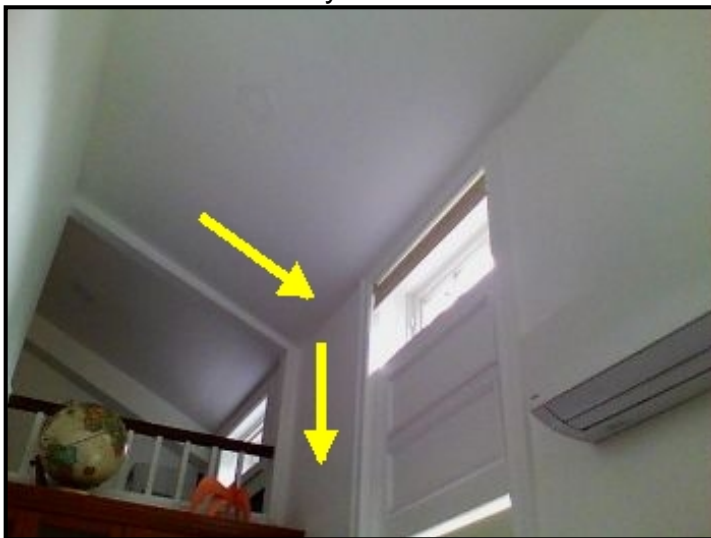
Water entry into ceiling/wall area.

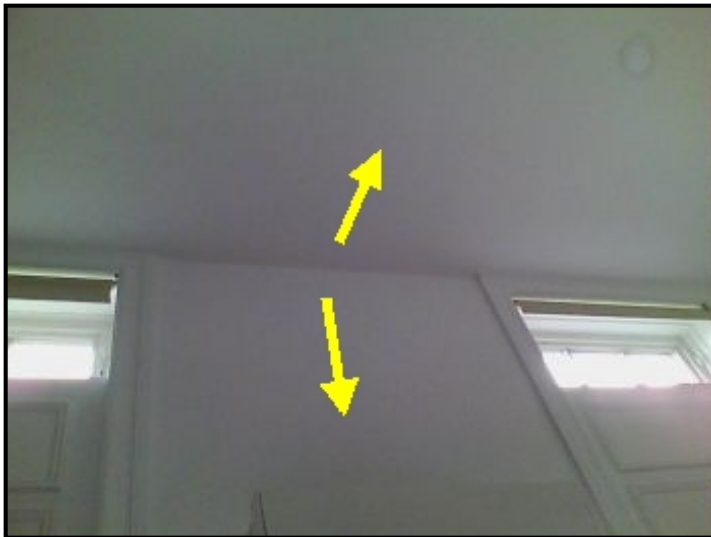
Water entry into ceiling/wall area.

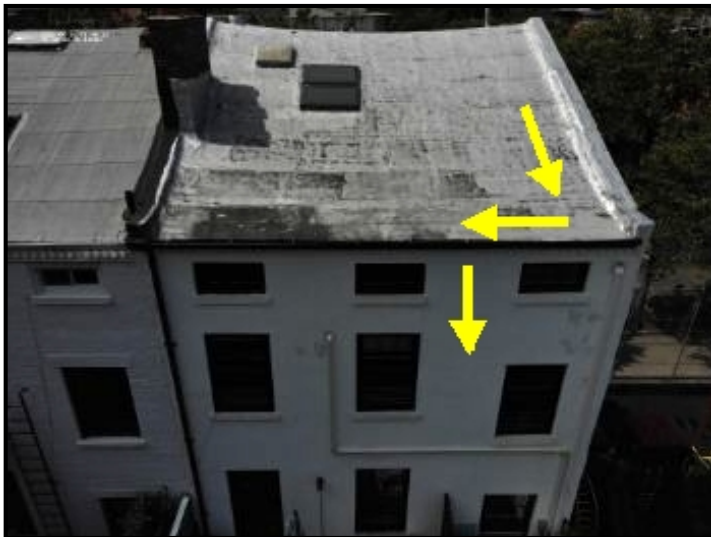
Water entering through the roof membrane system and cascading down into the rear facade.

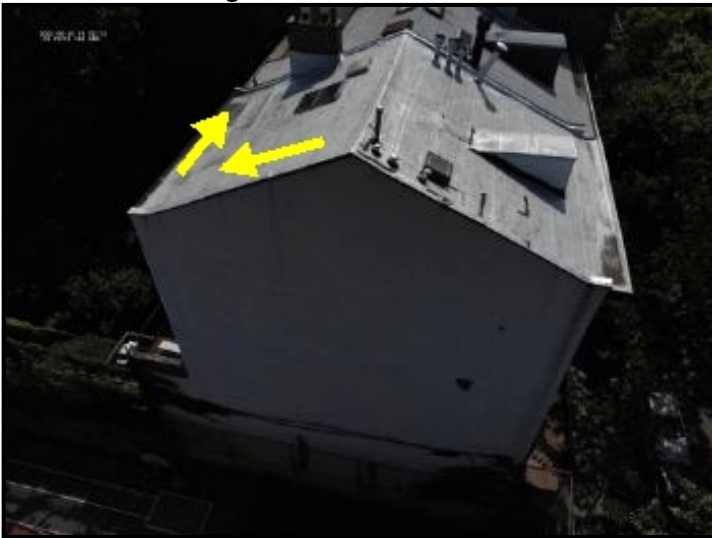
Water entering through roof membrane system connection point to the coping stone and cascading down into the rear facade.
