JP Diagnostics *Leak Detection Report*

Date of Inspection: 3/22/2022 Time: 1400 Size: Brick Commercial

Full Building Infrared Audit (FB.IR.AUD)

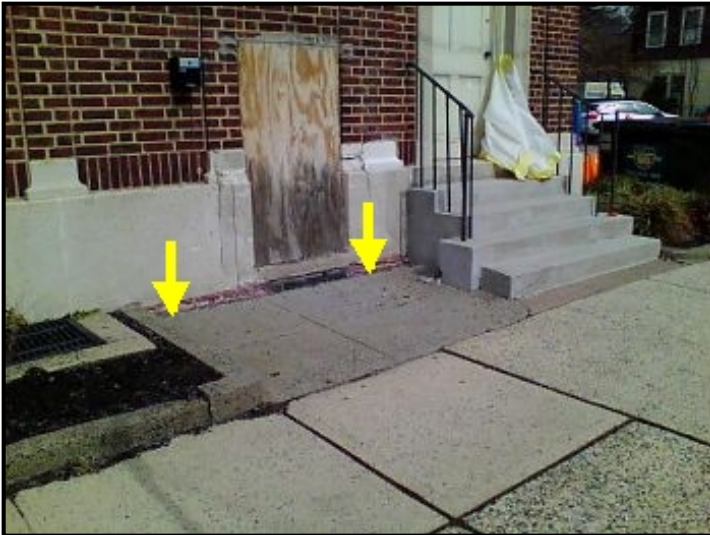
Infrared imaging of water entry into wall/window frame area.

Water entering through sidewalk connection point to facade and cascading down into the wall area below.

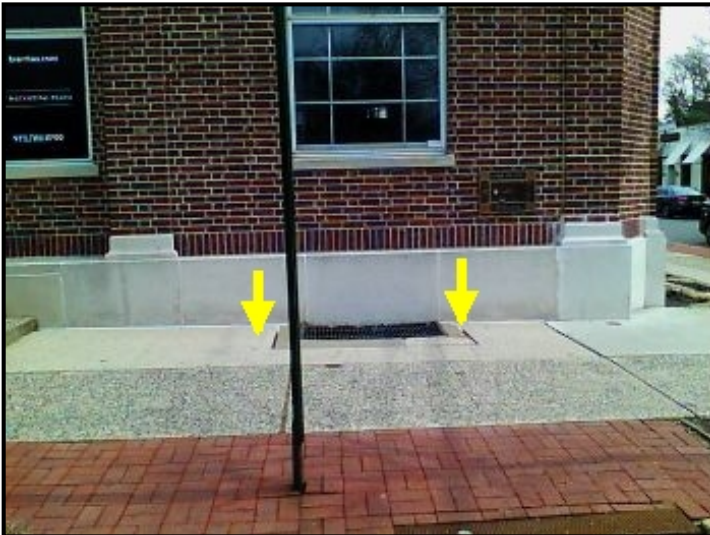
Infrared imaging of water entry into wall/window frame area.

Water entering through sidewalk connection point to brick facade and cascading down into the wall/window frame area below.

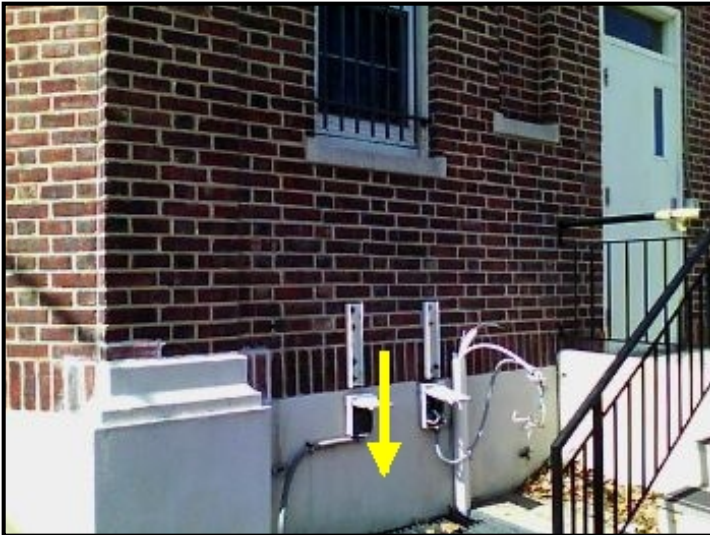
Infrared imaging of water entry into wall/window frame area.

Water entering through brick facade and cascading down into wall/window frame area below.

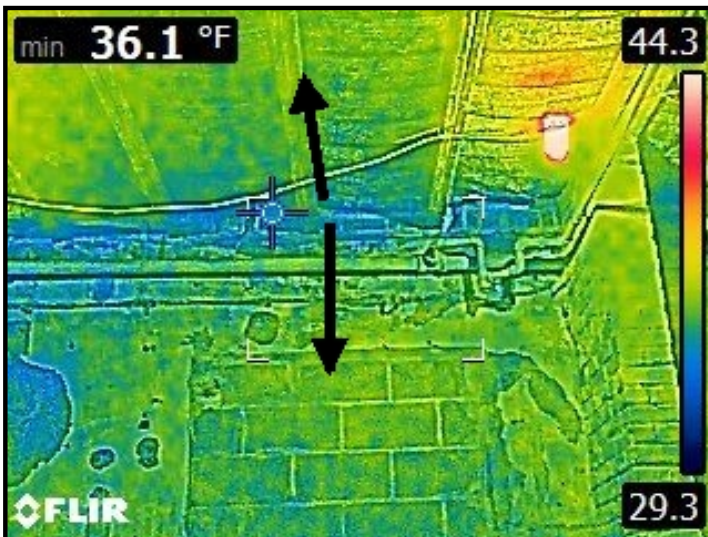
Water entry into wall area.

Infrared imaging of water entry into wall area.

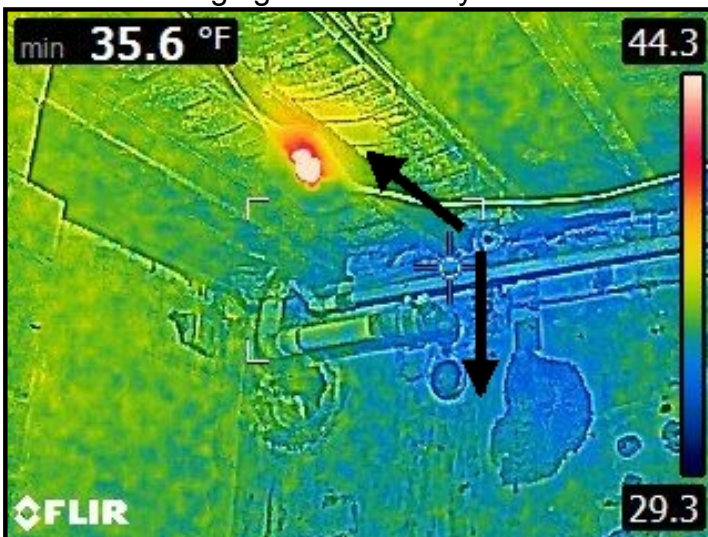
Water entry into wall area.

Infrared imaging of water entry into wall area.

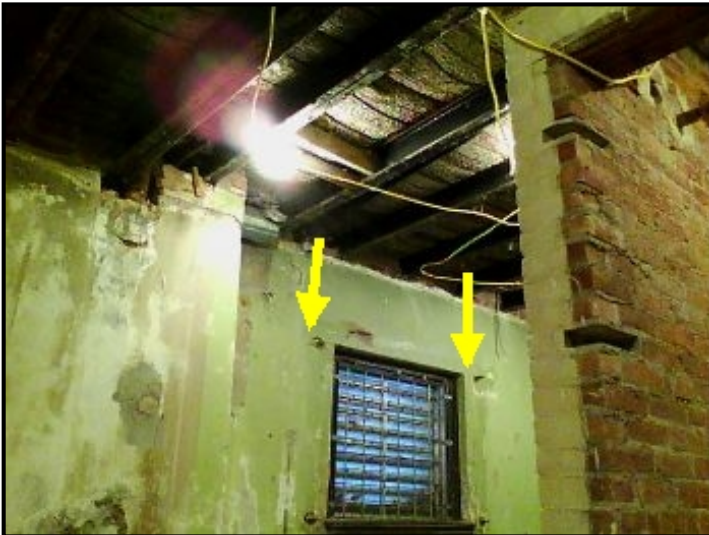
Infrared imaging of water entry into wall/window frame area.

Water entry into wall/window frame area.

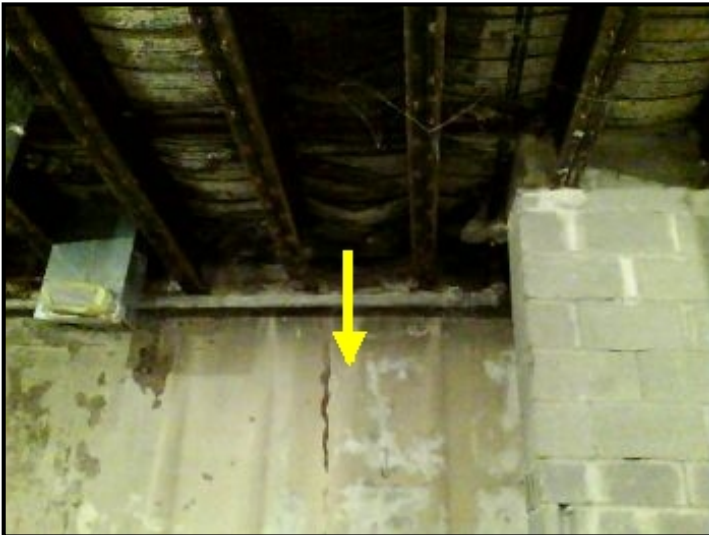
Infrared imaging of water entry into wall/ceiling area.

Water entry into wall/ceiling area.

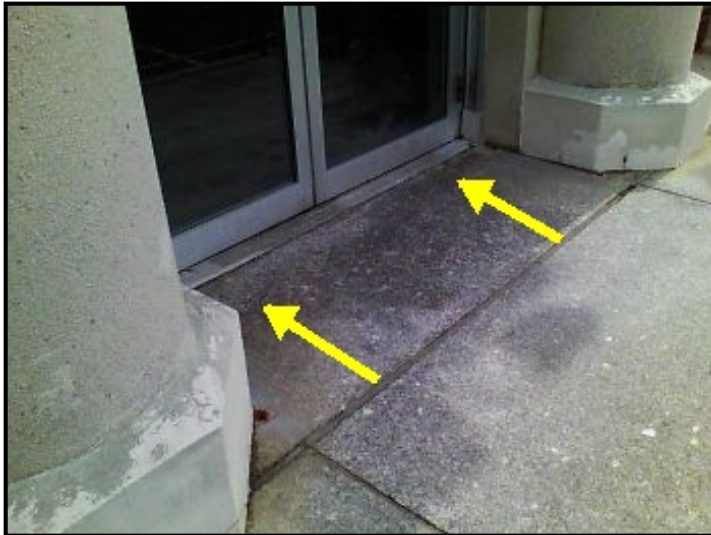
Infrared imaging of widespread and severe water entry through the front access stairs/stoop and cascading down into the ceiling/wall area below.

Widespread and severe water entry through the front access stairs/stoop and cascading down into the ceiling/wall area below.

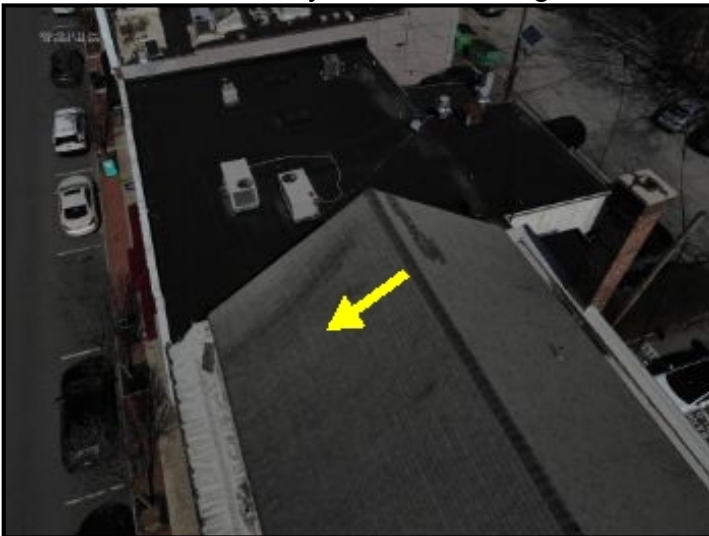
Infrared imaging of water entry into attic ceiling.

Water entering through roof peak shingles and cascading down into the attic ceiling area below.
