Infrared Leak Detection Report

Inspection prepared for:
Date of Inspection: 6/11/2024 Time: 0900 Size: Commercial
Weather: Clear - Warm/68df
Seven-Leak Source and Origin (7L.SO)

Inspector: Jarrod Parslow

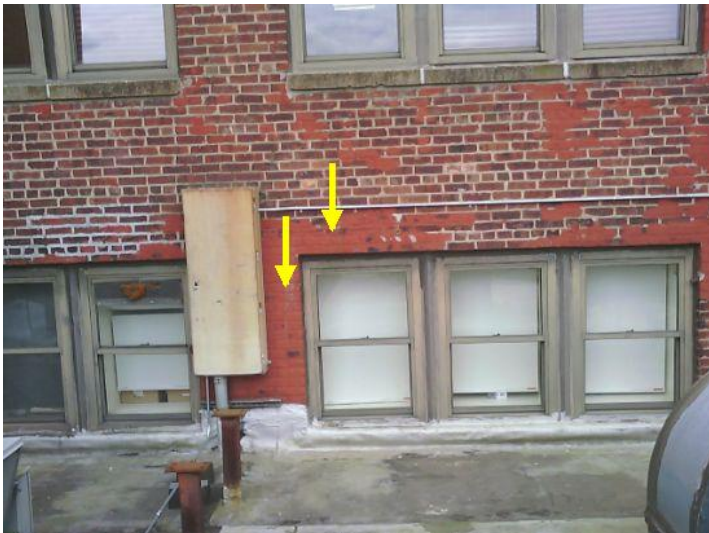
- **Source & Origin:** **Window Sill(s) / Brick Facade.**
- **Description:** Heavy wind-driven rain water is entering through the window sills and surrounding brick facade structure, cascading down into the roof membrane system and depositing into the internal wall areas below.
- **Repairs / Scope of Work:**
 - h. Waterproof window sills.
 - i. Waterproof surrounding brick facade area.

Infrared imaging of water entering through the window sill and brick facade areas, cascading down and depositing into the internal wall areas below.

Water entering through the window sill and brick facade areas, cascading down and depositing into the internal wall areas below.

NOTE: Because the brick is severely deteriorated, we suggest consulting with your contractor as to the exact repair protocol for this area.

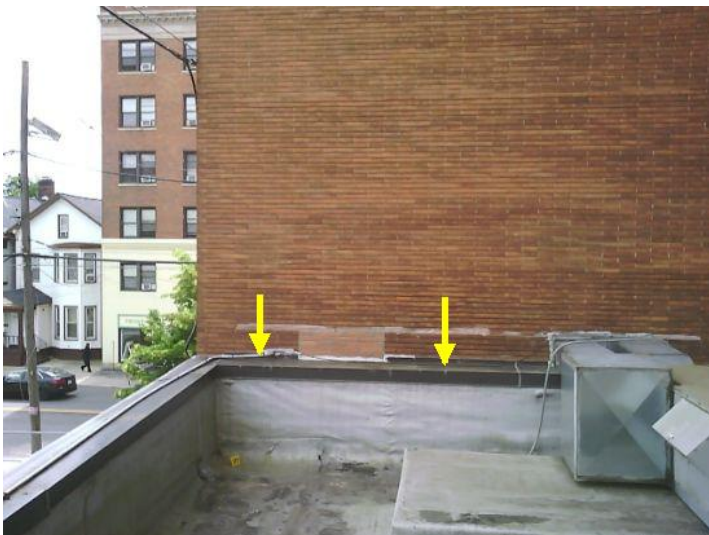
- **Source & Origin:** **Parapet Wall Flashing Cap / Brick Facade.**
- **Description:** Heavy wind-driven rain water is entering through the neighboring property's brick facade, cascading down and entering into the parapet wall flashing cap joints eventually depositing into the primary membrane system. Once inside the membrane, water is continuing down into the substrate and finally entering into the wall areas below.
- **Repairs / Scope of Work:**
 - j. Remove parapet wall flashing cap.
 - k. Excavate brick from neighboring property's facade, as outlined.
 - l. Waterproof and flash area accordingly.
 - m. Install proper drainage channels / weep holes to divert water outward.
 - n. Clear debris from roof membrane system.
 - o. Waterproof surrounding roof membrane system.
 - p. Install new flashing cap atop the parapet wall with proper segment overlay of at least 4 inches.

Infrared imaging of water entering through the parapet wall flashing cap joints and connecting brick facade, cascading down and depositing into the wall areas below.

Water entering through the parapet wall flashing cap joints and connecting brick facade, cascading down and depositing into the wall areas below.

NOTE: Because the brick is multi-wythe and not veneer, we suggest consulting with your contractor as to the exact repair protocol for this area.

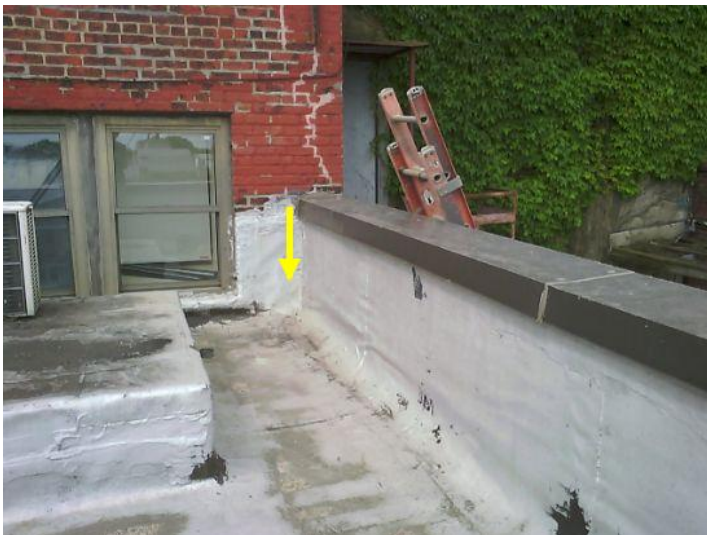
- **Source & Origin:** **Parapet Wall / Brick Facade.**
 - **Description:** Heavy wind-driven rain water is entering through the parapet wall connection point to the brick facade, cascading down into the primary roof membrane system and depositing into the ceiling / wall areas below.
 - **Repairs / Scope of Work:**
 - q. Remove parapet wall flashing cap.
 - r. Waterproof brick facade connection point to the parapet wall.
 - s. Reinstall flashing cap.
 - t. Seal all flashing cap joints.
-

Infrared imaging of water entry into wall / ceiling area.

Water entering through brick facade connection point to the parapet wall and cascading down into the internal ceiling / wall areas below.

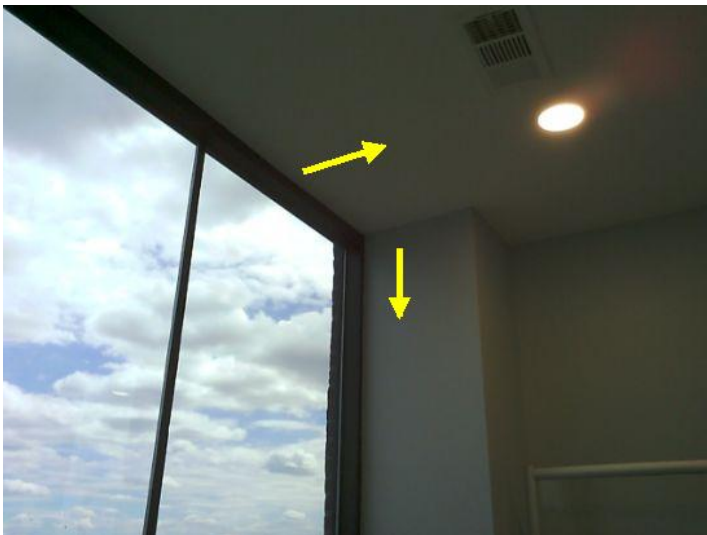
Infrared imaging of water entry into window frame area.

Water entry into window frame area.

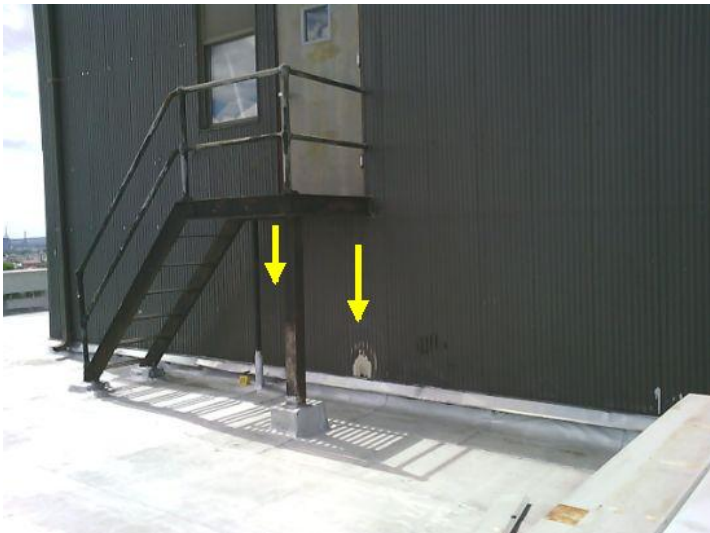
Infrared imaging of water entering through the bulkhead wall panels around the door baseplate and window, cascading down and depositing into the ceiling areas below.

Water entering through the bulkhead wall panels around the door baseplate and window, cascading down and depositing into the ceiling areas below.
