JP Diagnostics *Leak Detection Report*

Date of Inspection: 6/20/2022 Time: 0900 Size: Brick / Masonry

Full Building Infrared Audit (FB.IR.AUD)

2065 West 7th Street, 2nd Floor, Brooklyn, NY 11223

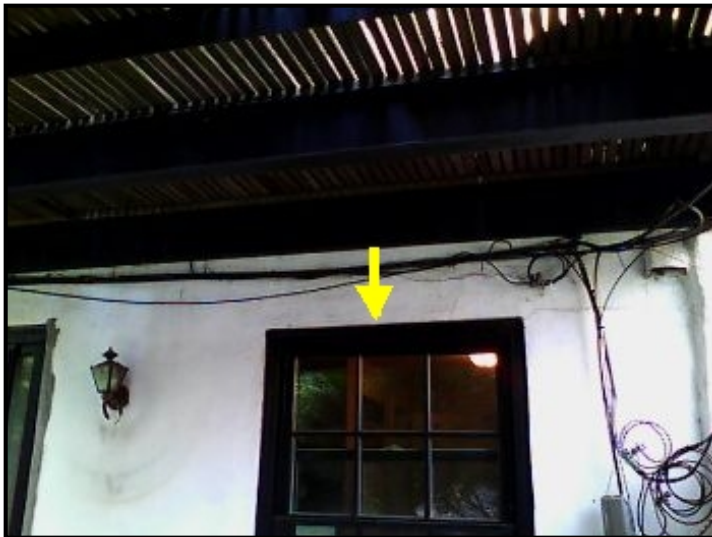
Water cascading down through rear facade and backflowing into the internal wall/ceiling area.
