JP Diagnostics LLC

Infrared Leak Detection Report

Date of Inspection: 10/17/2024 Time: 1200 Size: Residential

Ten-Leak Source and Origin (10L.SO)

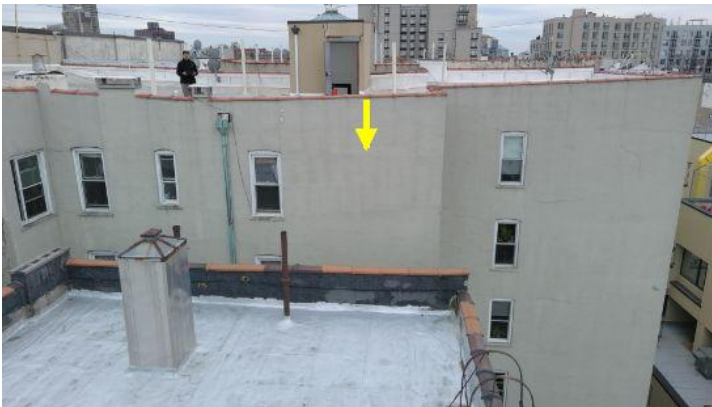
Water entering through side facade and parapet wall coping stone, cascading down and depositing into the wall areas below.

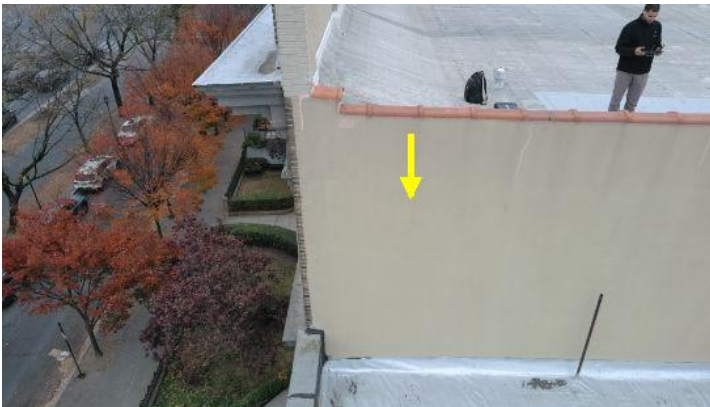
Water entering through the parapet wall coping stones and cascading down into the wall areas below.
